***A case study: evaluation of state of conservation of wood panels and beams of a CLT kindergarten.***

***Proposal of a diagnostic approach and realization of an Italian register of service life condition of recent wooden buildings.***

*Sabrina Palanti and Nicola Macchioni*

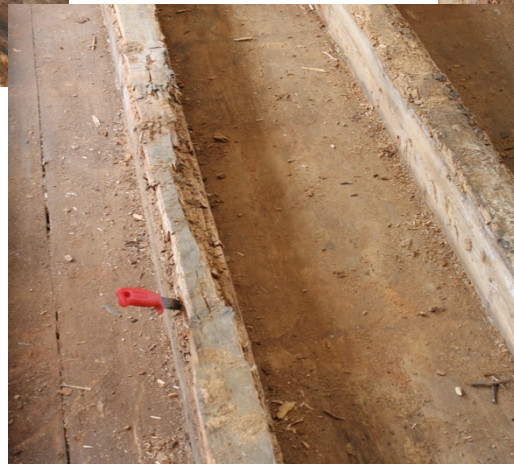
*The beams on the roof of building after the opening of the sheath.*

*Extensive brown rot on the roof joists*

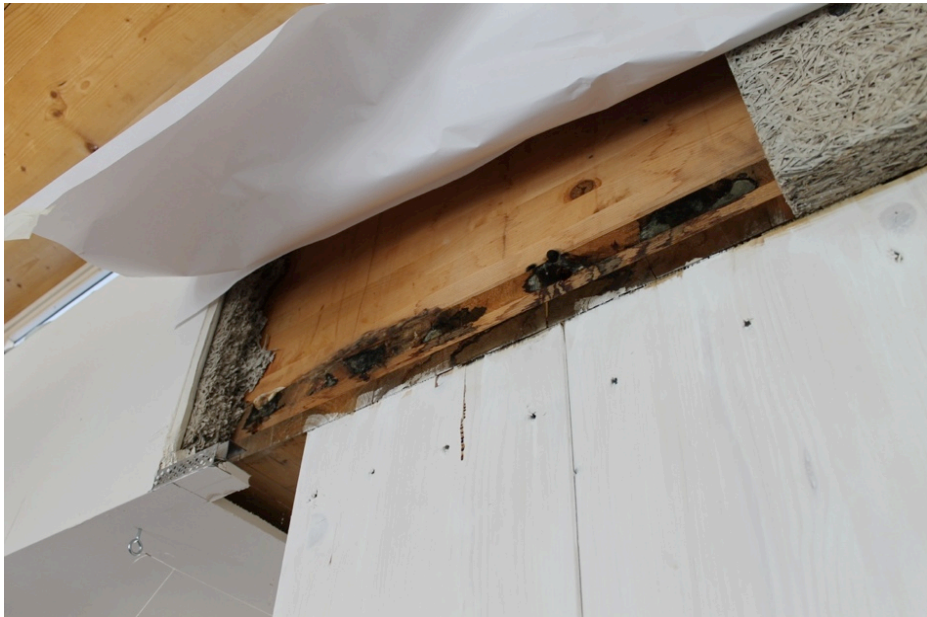
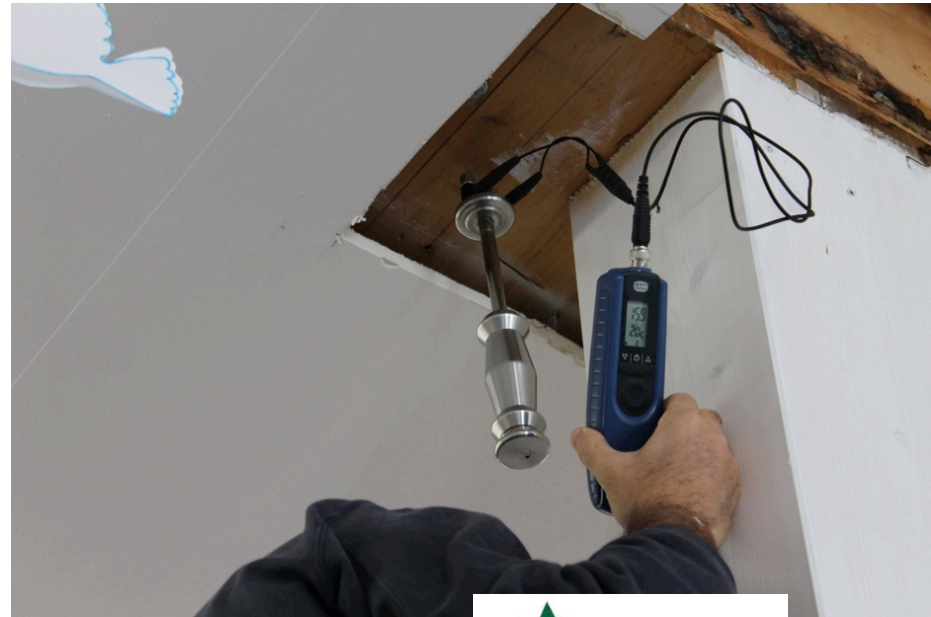
- The request of evaluation of wood decay was asked after two years of service life, in spring 2014. The users saw some humidity spots in the plasterboard inside the buildings, so they asked for a survey to establish their origin. The users thought that this high level of humidity was due to the condensation of inside water vapour. So a first survey on the glue-lam beams and CLT panels showed that the moisture content was in some cases higher than 20% and a fungal mycelium was already visible on wood surfaces.

*The CLT panels and glulam beams of the building*

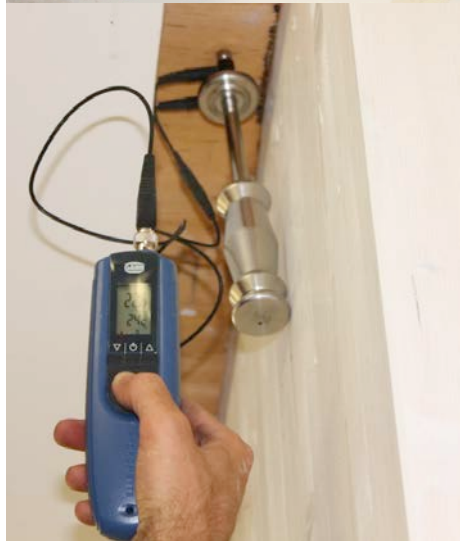
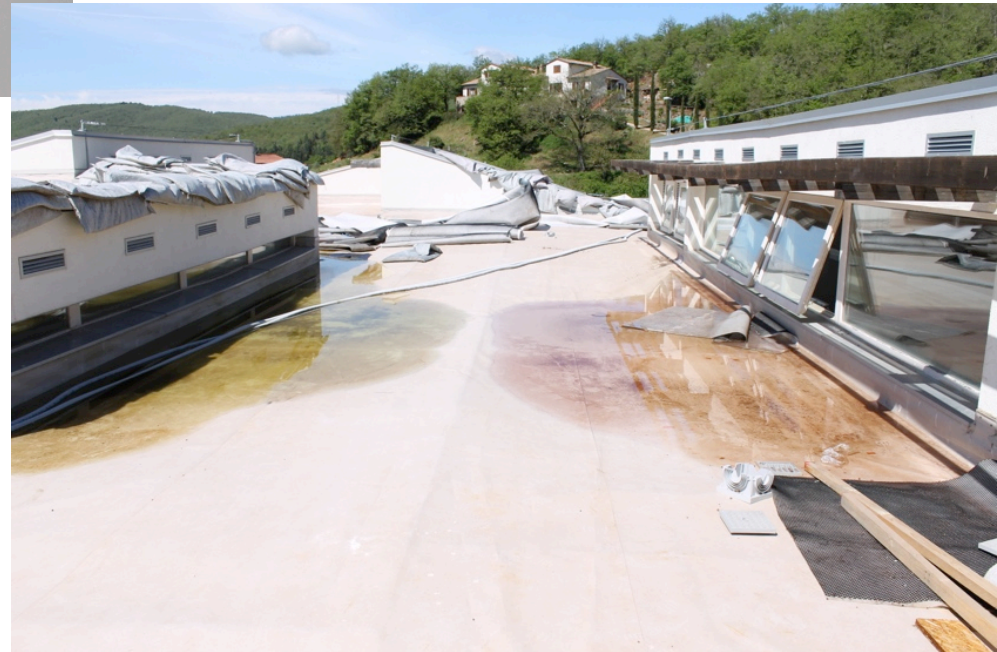
On the outside roof it was visible a great deflection, due to the collapse of OSB panels, completely decayed; we asked to analyse the wood structure from the extrados, directly by the roof, in order to correctly evaluate the state of preservation of the CLT panels.

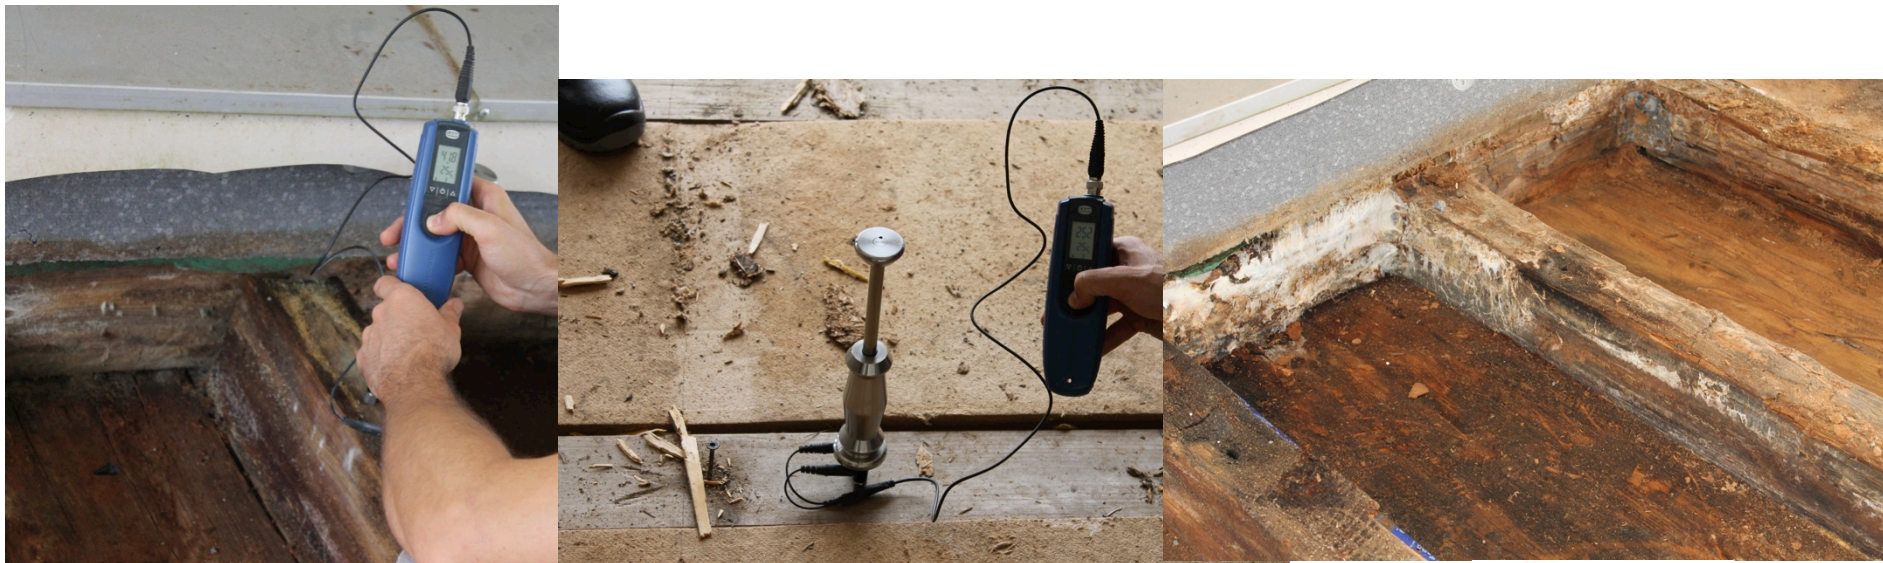
- During the second survey it was measured the moisture content on the extrados side of the CLT panels in correspondence with inspection windows opened on the roof. A large inspection window was opened above the main entrance of the building, removing the impermeable layer and the OSB panels. In this area a severe decay of the rafters and of CLT panel, due a fungal attack (brown rot), was clearly visible.
- The moisture content of wood in this area was high, always more than 20 %, up to 58 %.

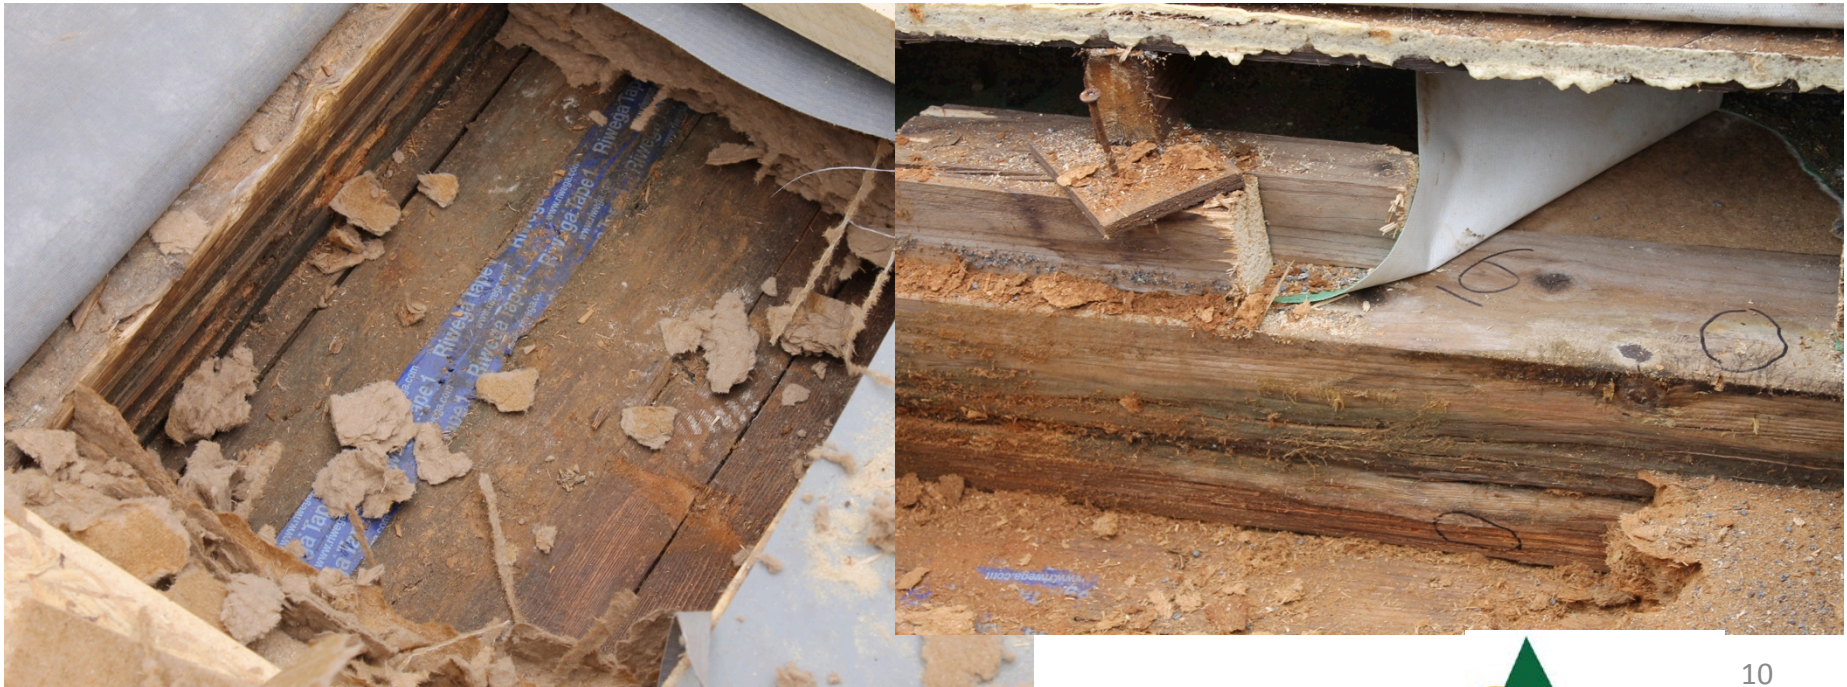
- During this survey four inspection windows were opened on the roof and in some of these high moisture content of the joists and on the CLT panel was measured. The higher moisture content was, as obvious, in correspondence of high fungal decay as shown in the images below.

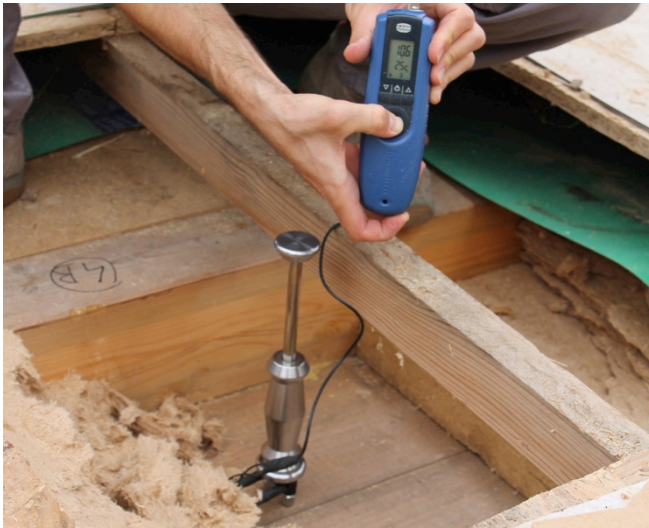
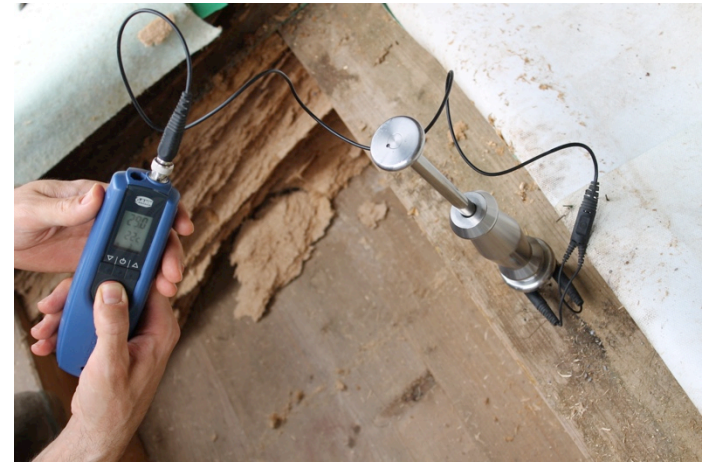
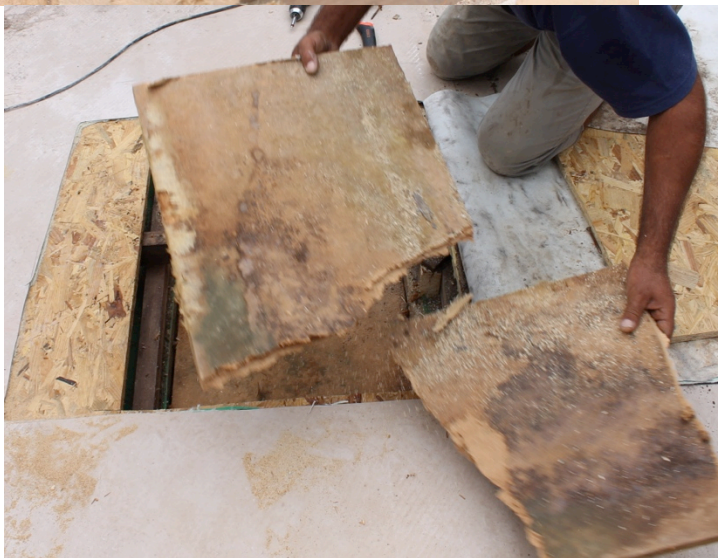
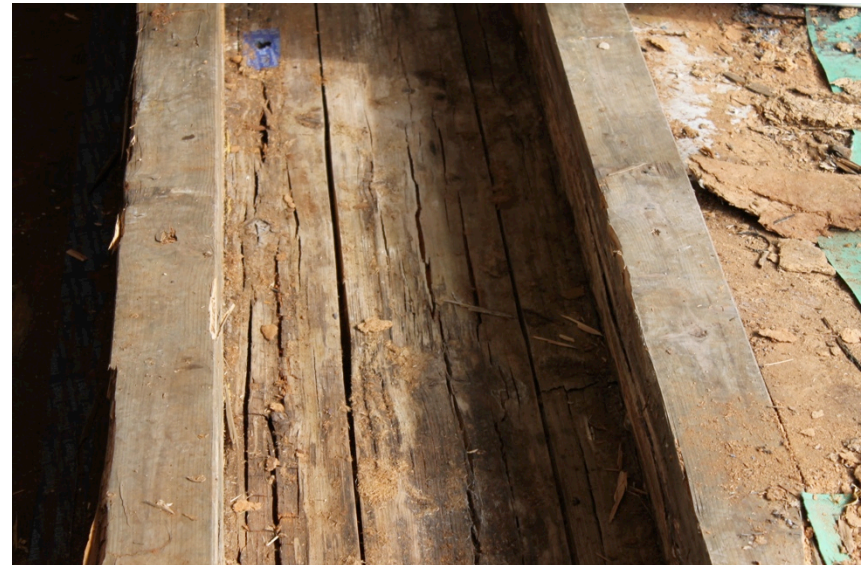
- The survey and the moisture measurements clearly showed that water entered from the roof, most probably due to not complete sealing of the impermeable sheath and not to water vapour condensation.
- A further cause of the fungal decay could be the water entrapped during the assembling of the structure, that lasted too much, due to a series of technical delays.

1. It is important to remark that a critical point during the construction of a CLT structure is the correct organisation of the **site building phases**, where it is really important to avoid the entrapping of water due to meteorological events. **Before sealing the wooden elements, moisture content should be checked.**
2. During the service life, some inspection windows should be accessible in order to check the moisture content, or even the presence of decay, on a regular base .
3. These inspection windows should be designed in correspondence with critical points into the building, e.g. bathroom, kitchen, etc.. This precaution permits of occurring very early in presence of high wood moisture, avoiding the developing of decay.
4. Or in alternative hand, moisture content sensors maintained during the service life in the critical points.
