Designing with bio-based building materials – Challenges and opportunities

The problem of exterior structures built in Northern Spain climate in *Picea abies* due wood destroying fungi attacks. The example of a wood exterior structure in Pontevedra, Spain and the importance of design in the performance

Lorenzo, David, Juan Fernández, Manuel Touza, Manuel Guaita, Alfonso Lozano, Teresa de Troya

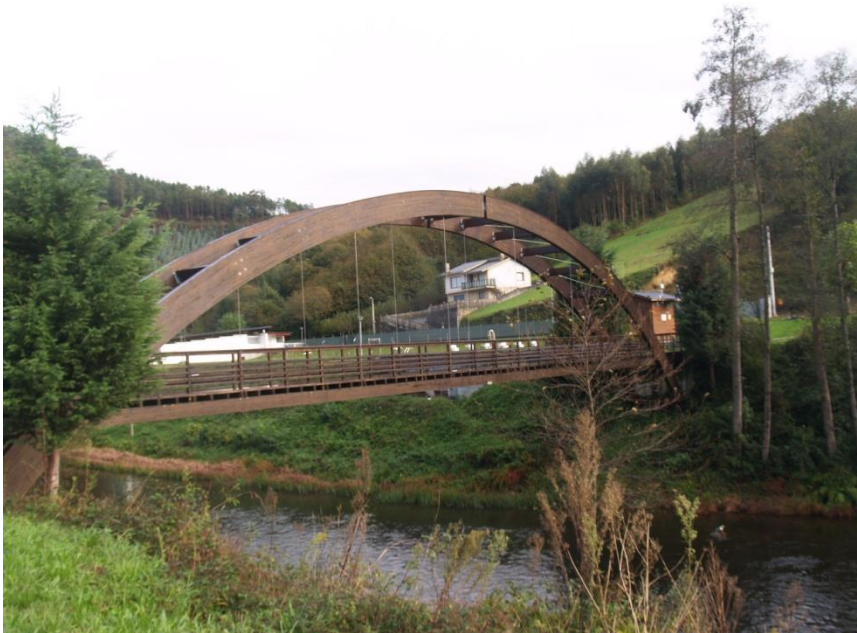
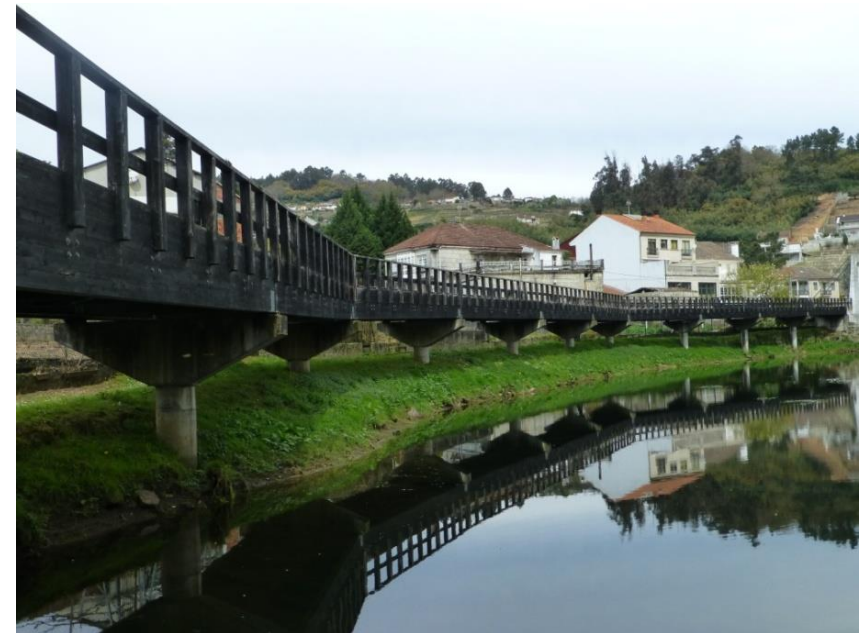
Spruce Bridges in North Spain

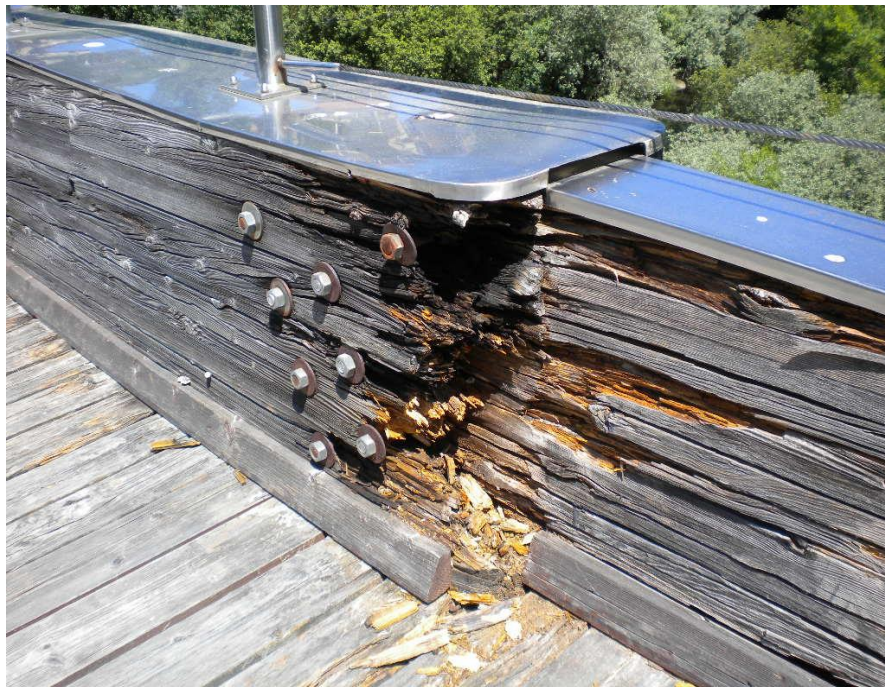
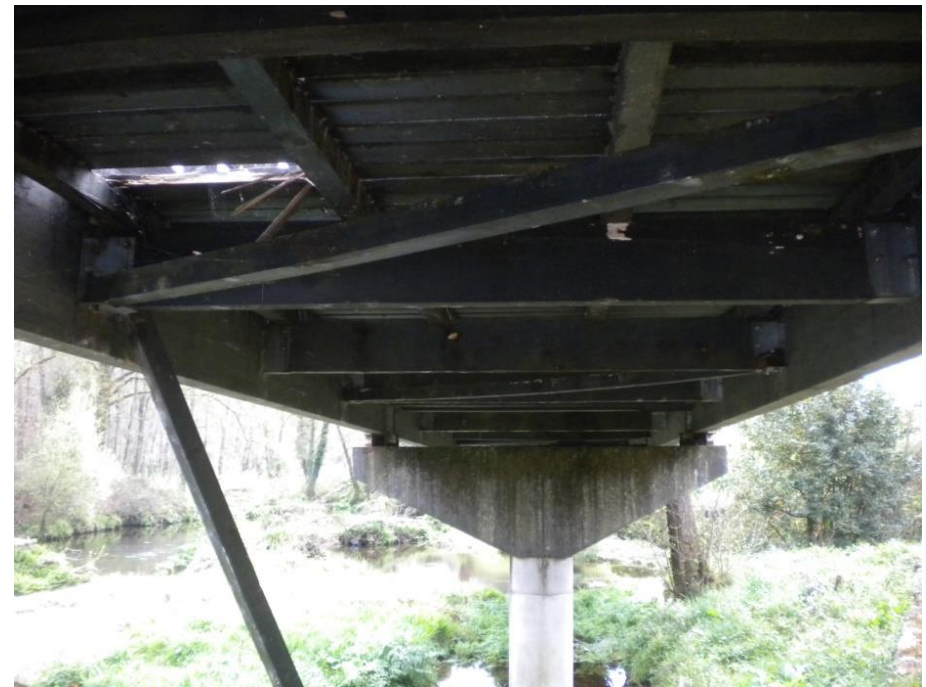
- **Durability** of wood species(spruce, fir, larch,...), “**treatments**” and **designs**, combined with the variability of **climate** and **microclimate** conditions (exposure to weathering) in northern Spain, have caused serious damage to the exterior structures.
- Major problems are related to **decays** (brown rot an white rot) and wood destroying insects in lesser extent (wood boring insects and termites).

Spruce Bridges in North Spain with severe decays (12 years)

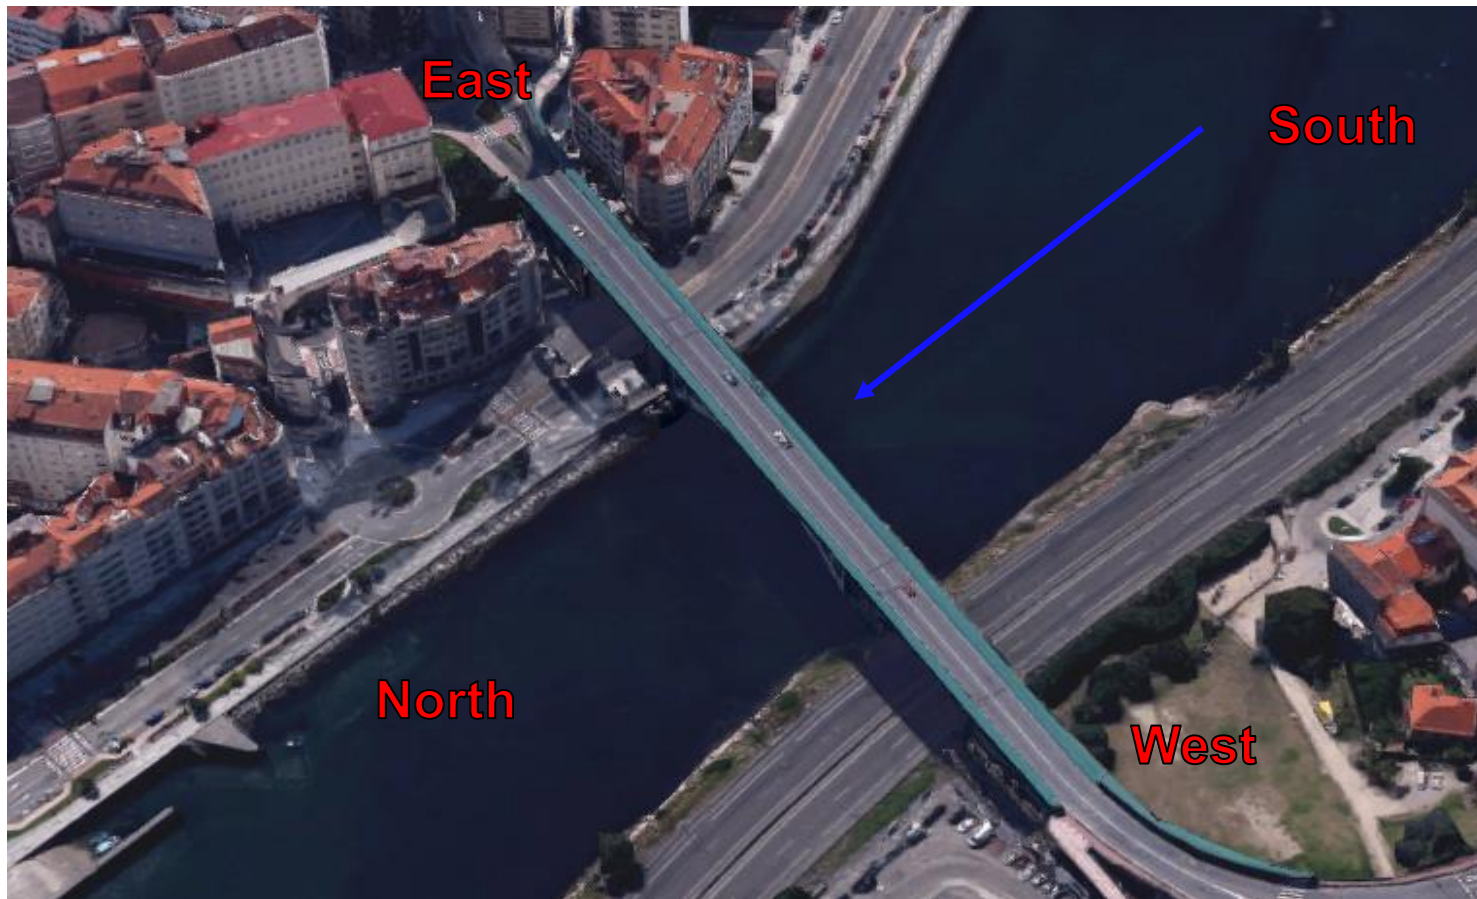
LOCAL CLIMATE: MICROCLIMATE

- Orientation of bridge: E-W.
- Driven rain: From South-West, rain exposure (moisture content).

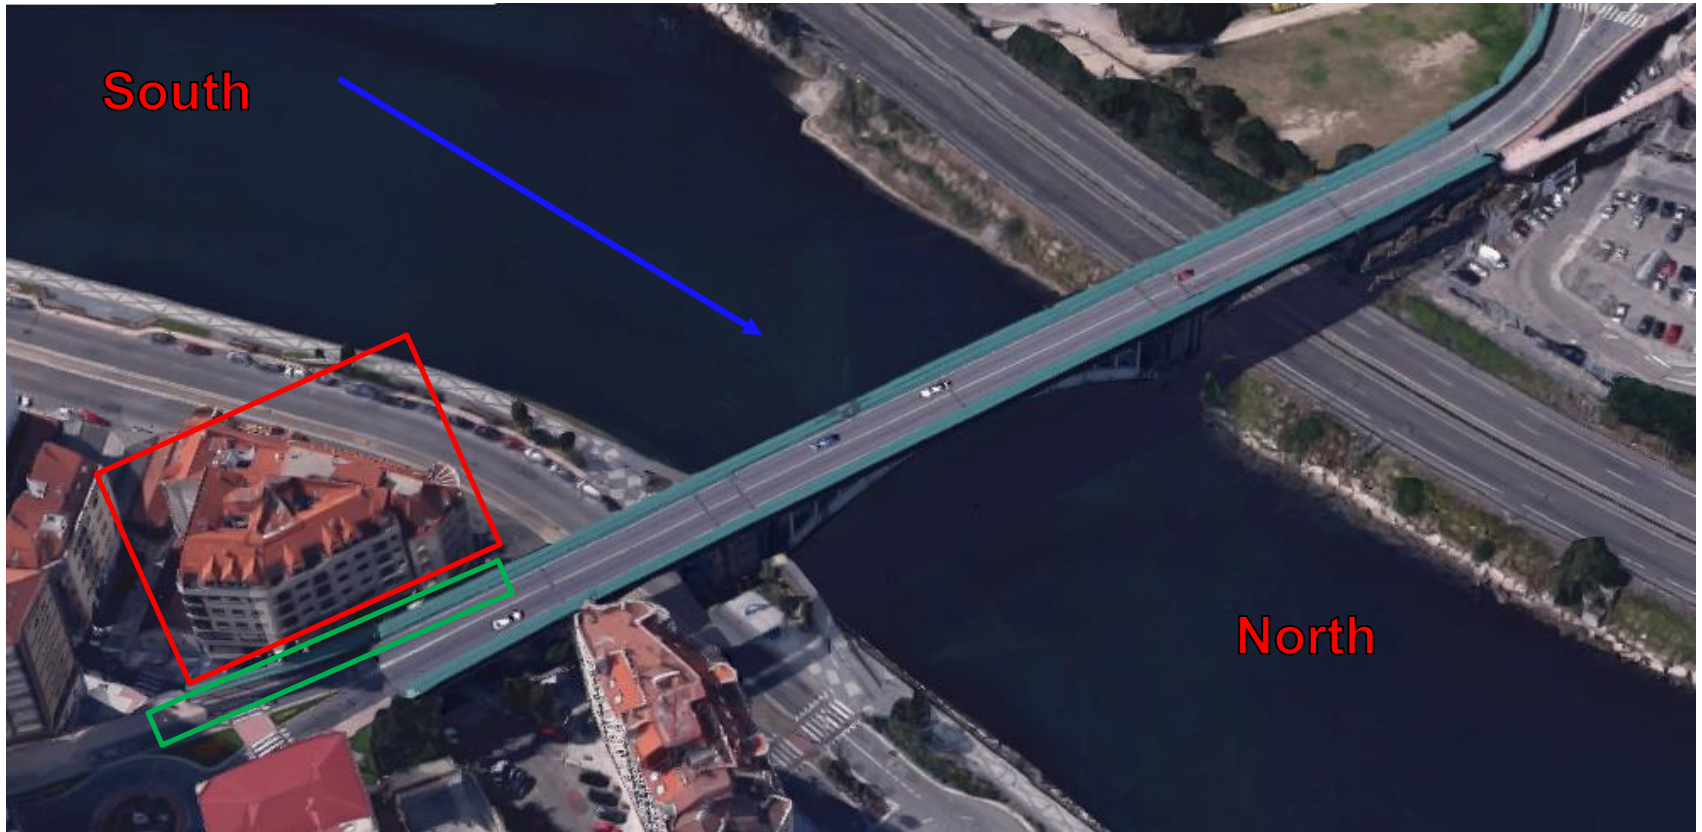
■ ROOF PROTECTION NORTH STRUCTURE: South Orientation

- Roof: Physical protection.
- Sheltering: Yes in North, Not in South Driven rain.

Major part of North structure **not exposed** to weather

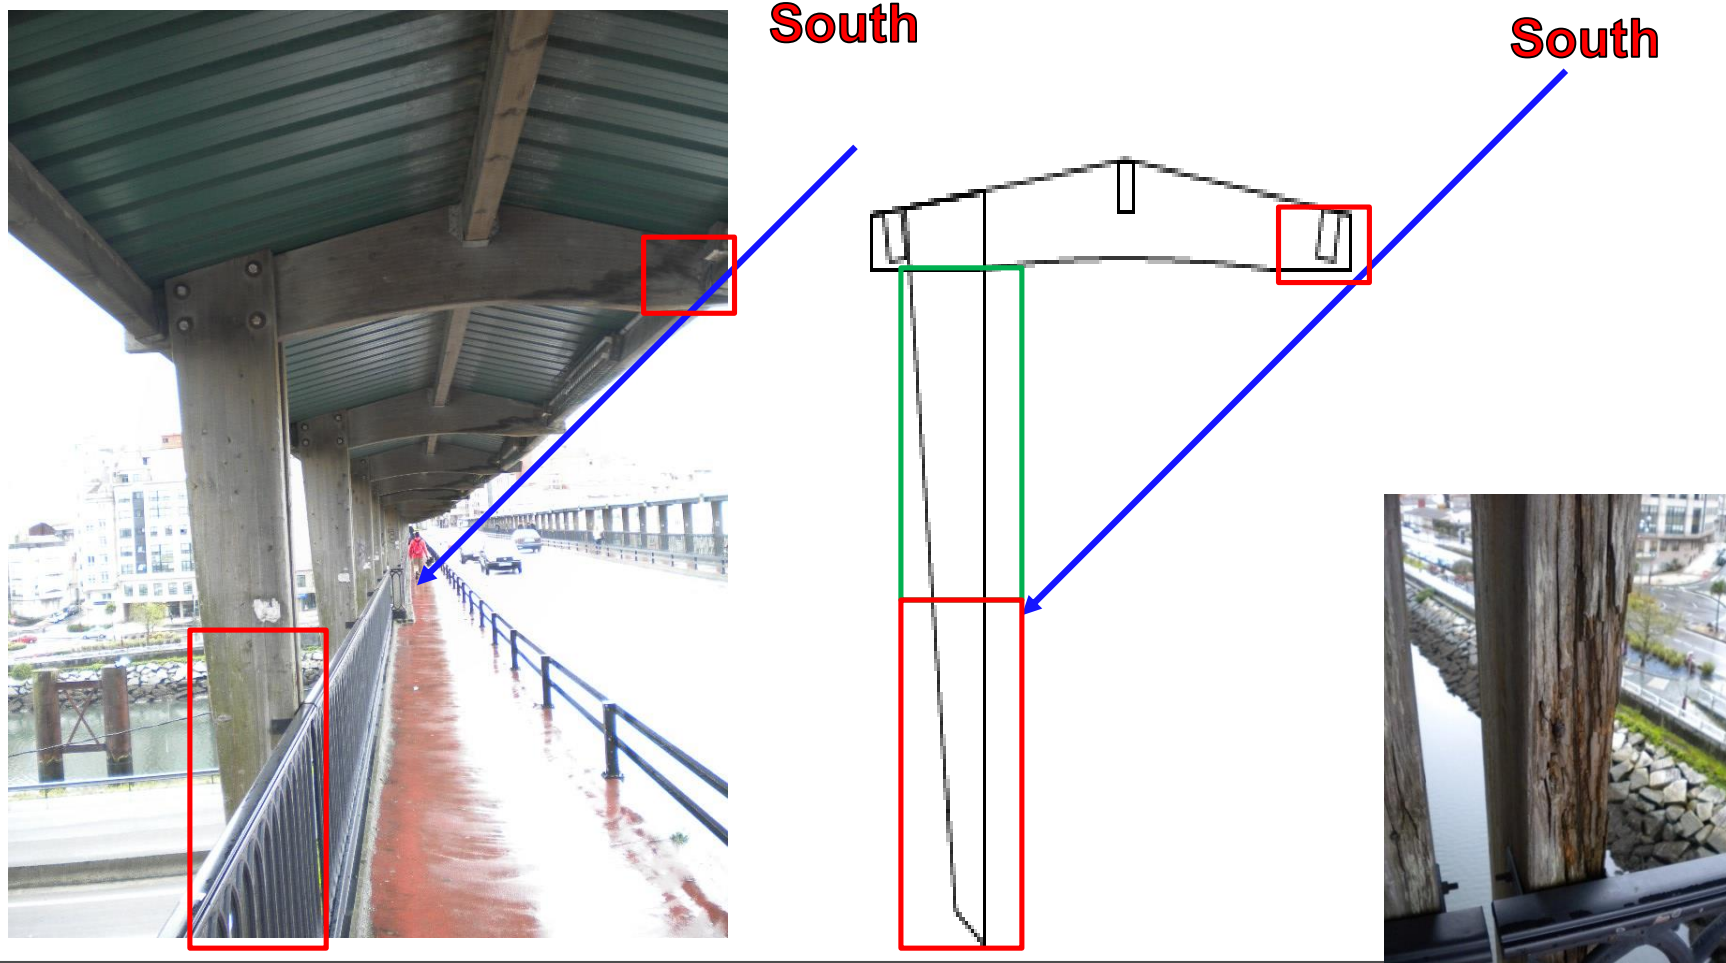
ROOF PROTECTION SOUTH STRUCTURE: South Orientation

- Roof: Physical protection.
- Sheltering: Driven rain.

Major part of South structure exposed to weather

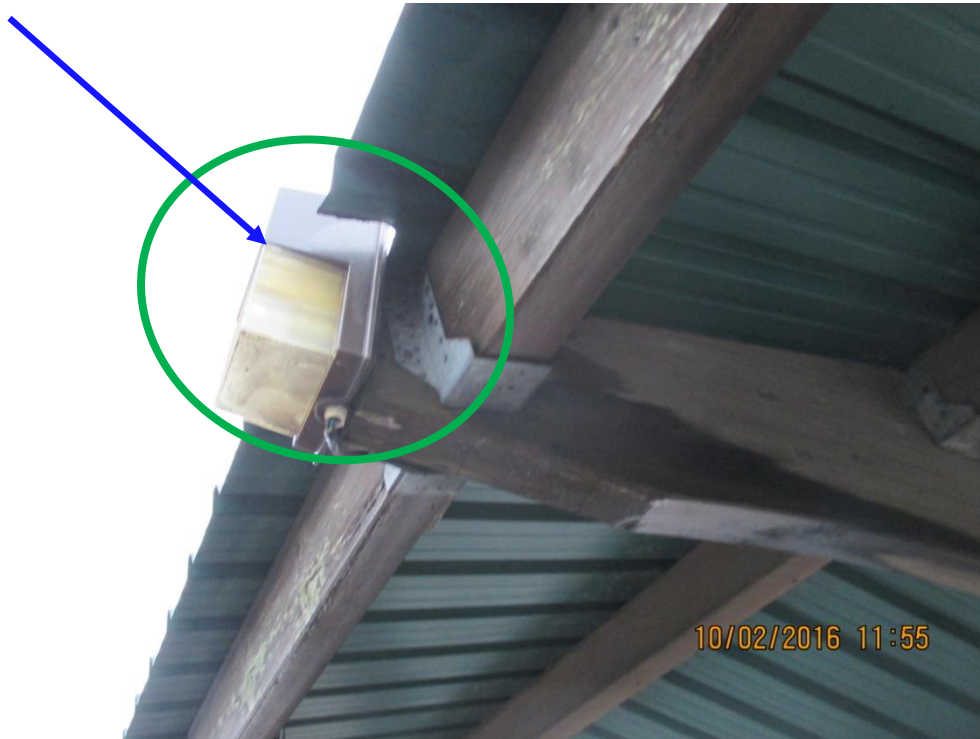
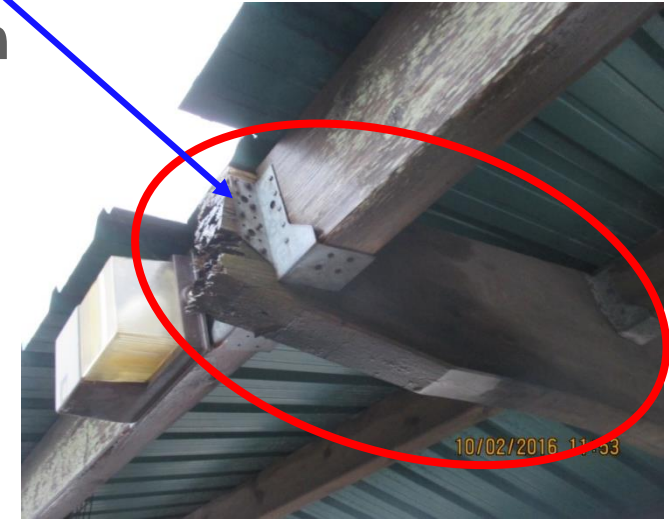
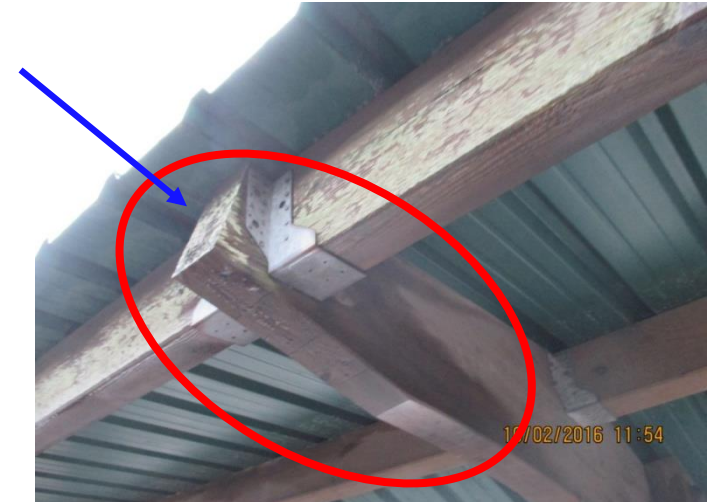
■ DETAILS DESIGN N.E: South Orientation

- Sheltering: No protection due strong South winds
- Lights: Protection

Directly exposed to rain (no protection sheltering)
End grain (unsealed) severe decay
Side grain

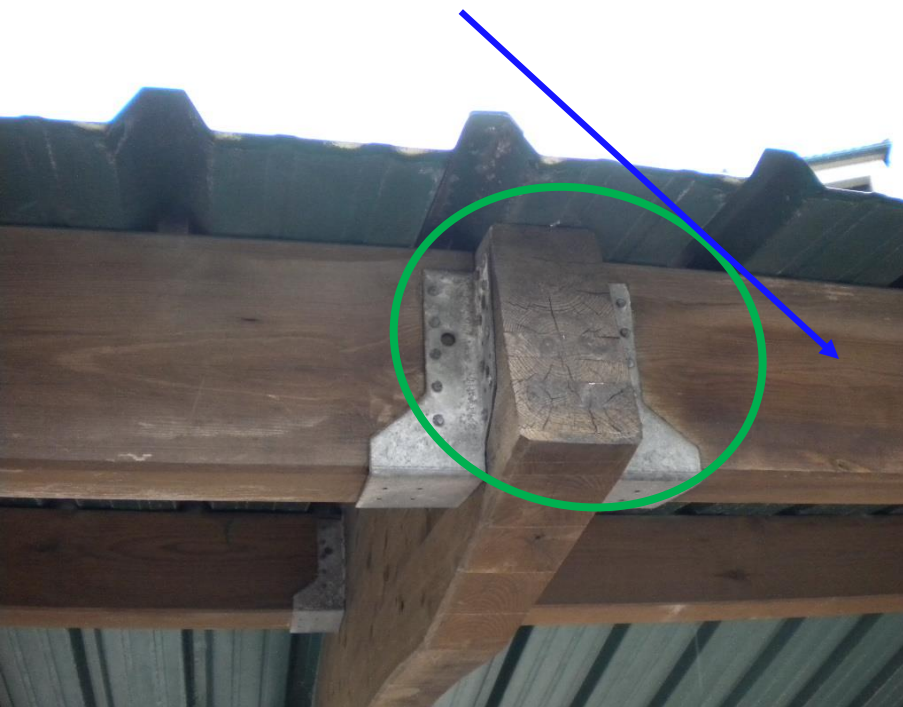
No directly exposed to South rain

Sheltering: Protection South winds

Sheltering end grain protection beam

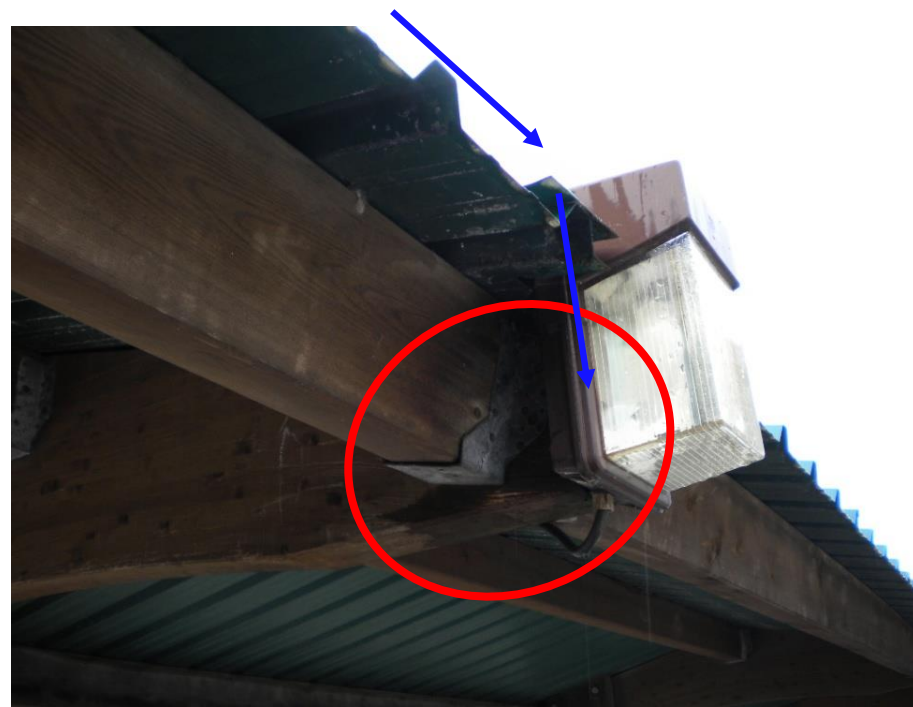
Lights: Driven rain water traps
