# Example of a diagnosis on a new X-Lam building in Italy: material decay and monitoring needs

# X-Lam building diagnosis

The presentation shows a diagnosis performed on a pretty new X-Lam, box-framed building.

The building is located in Cervia, a summer vacation town on the Adriatic coast. It is a 4 storeys building, the three storeys above the ground are entirely made of X-Lam panels.

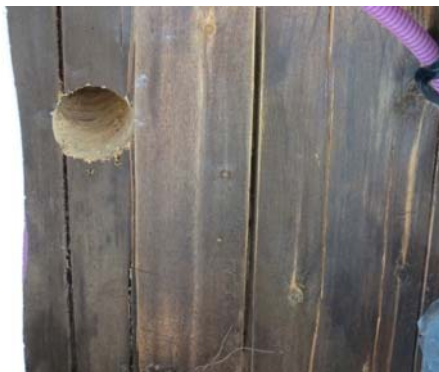
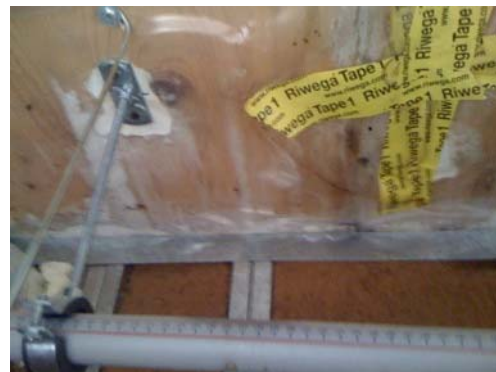
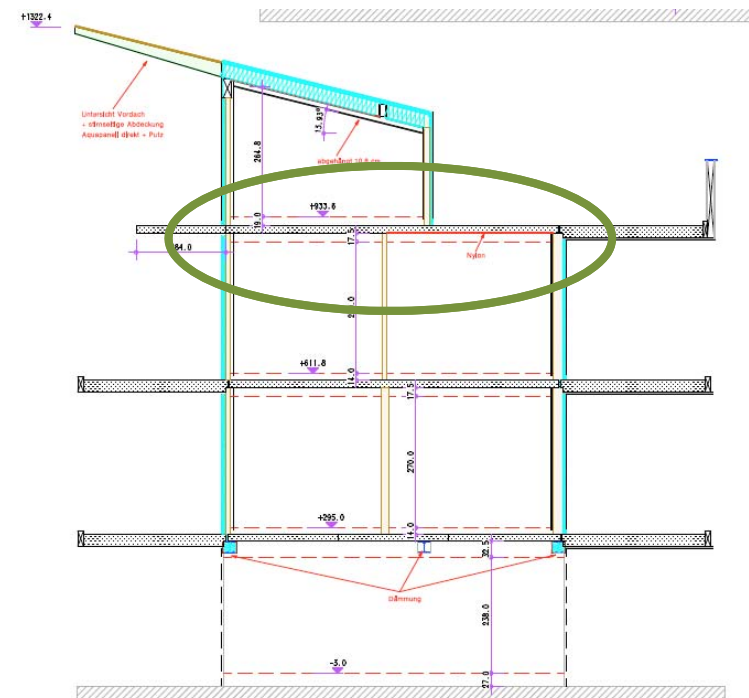
The request of *in situ* inspection was due to the fact that in the last level floor some staining and fungal attack on the wood panels were found at the end of winter season.

Apparently most of the problems correspond to the floor located below the solarium – terrace, partly overhanging.

A nylon vapour barrier in the bathroom caused the development of mycelium between the nylon sheet and the panel.

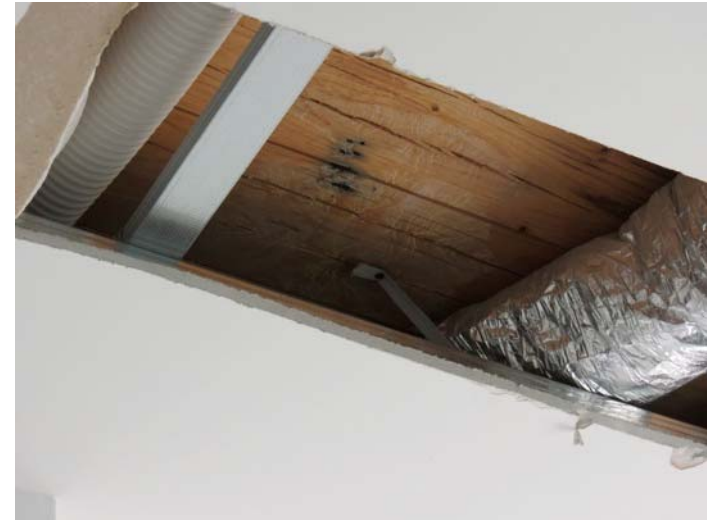
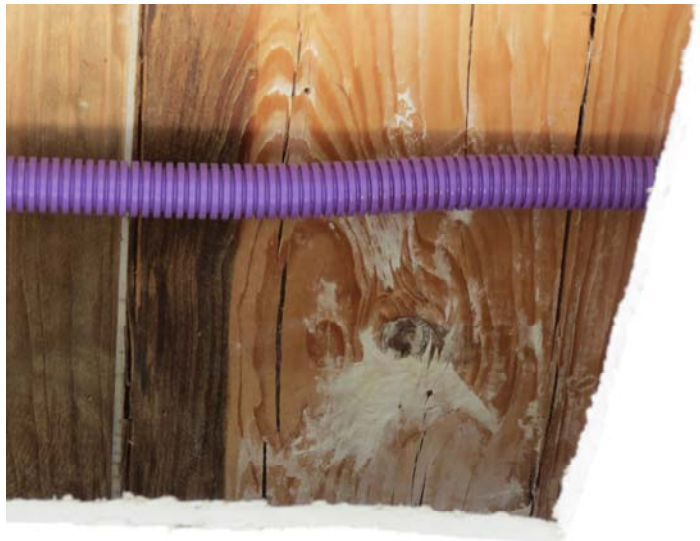
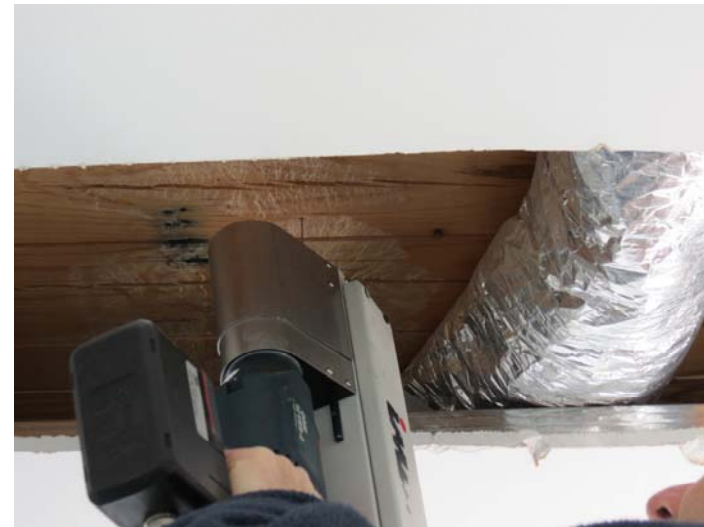
- Wooden panels are never directly visible, but hidden by a false ceiling that hides in the meanwhile the plant engineering.
- For this reason, the inspection was carried out only in the places where the false ceiling was previously removed.

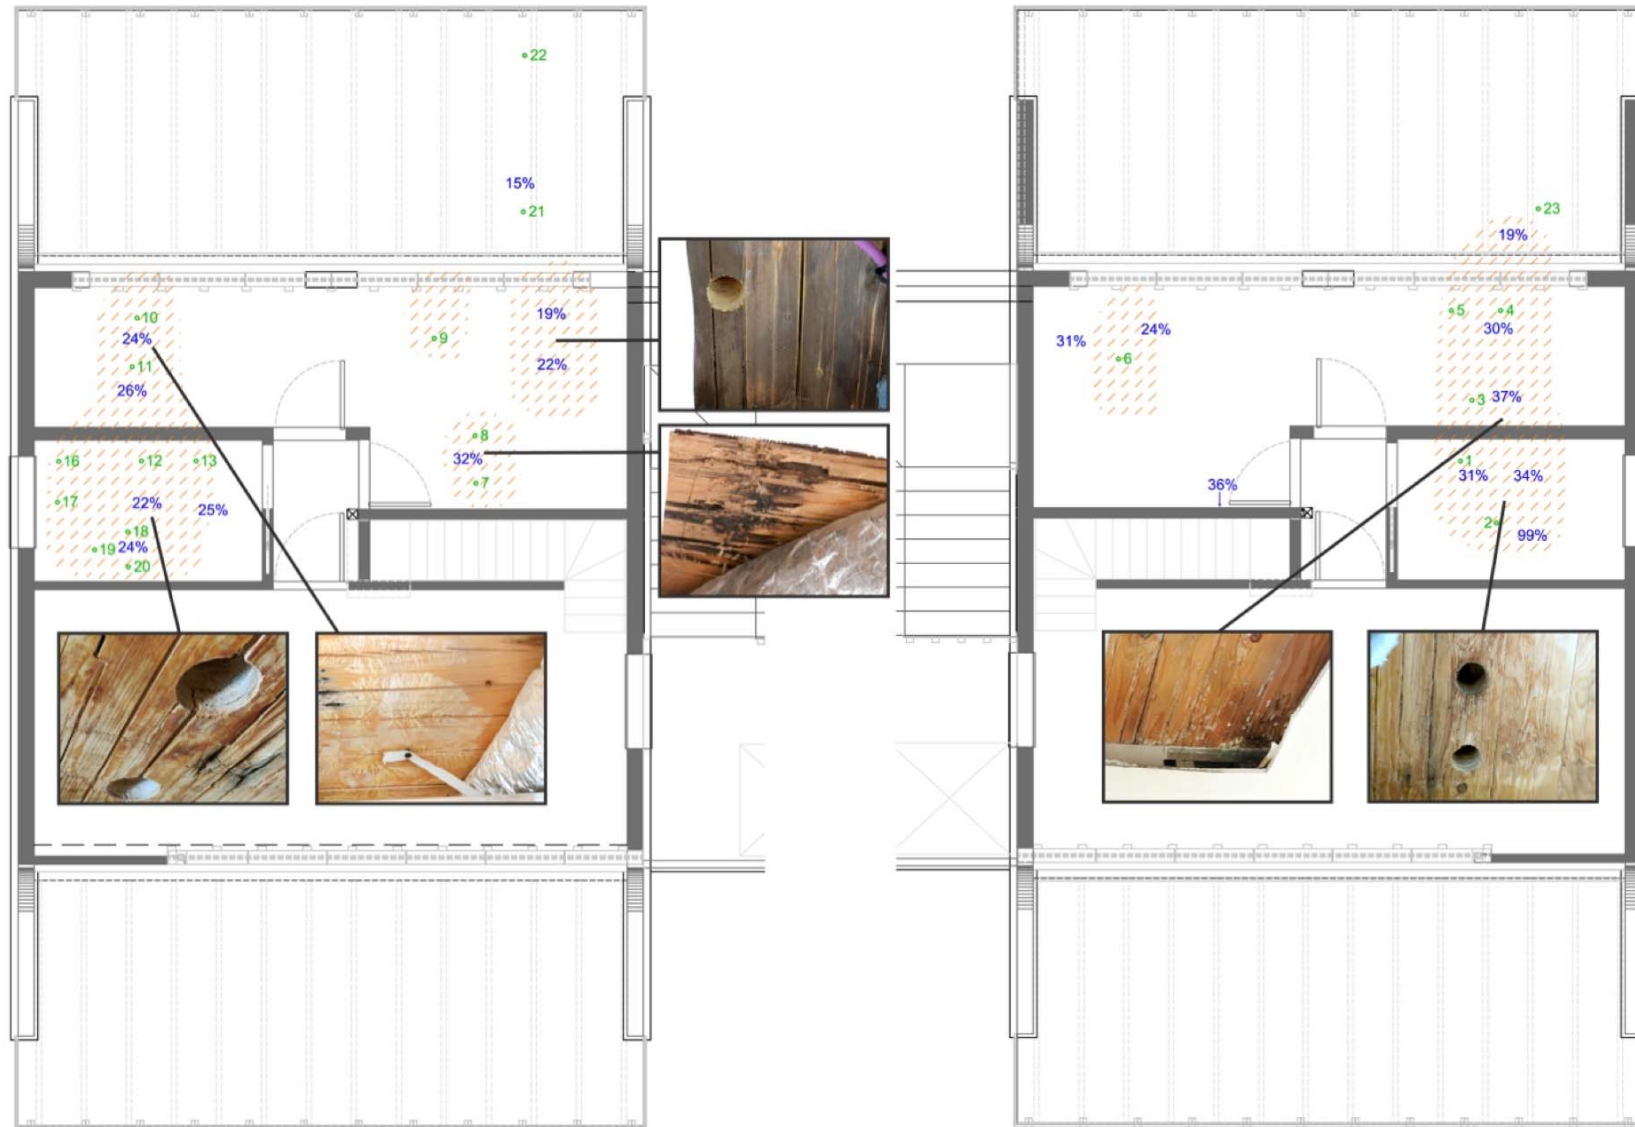
The results were expressed by means of maps of the ceiling with the MC determined in different points.

There is a correspondence between the high moisture content and the developing of fungal attack as evidenced by the photos.

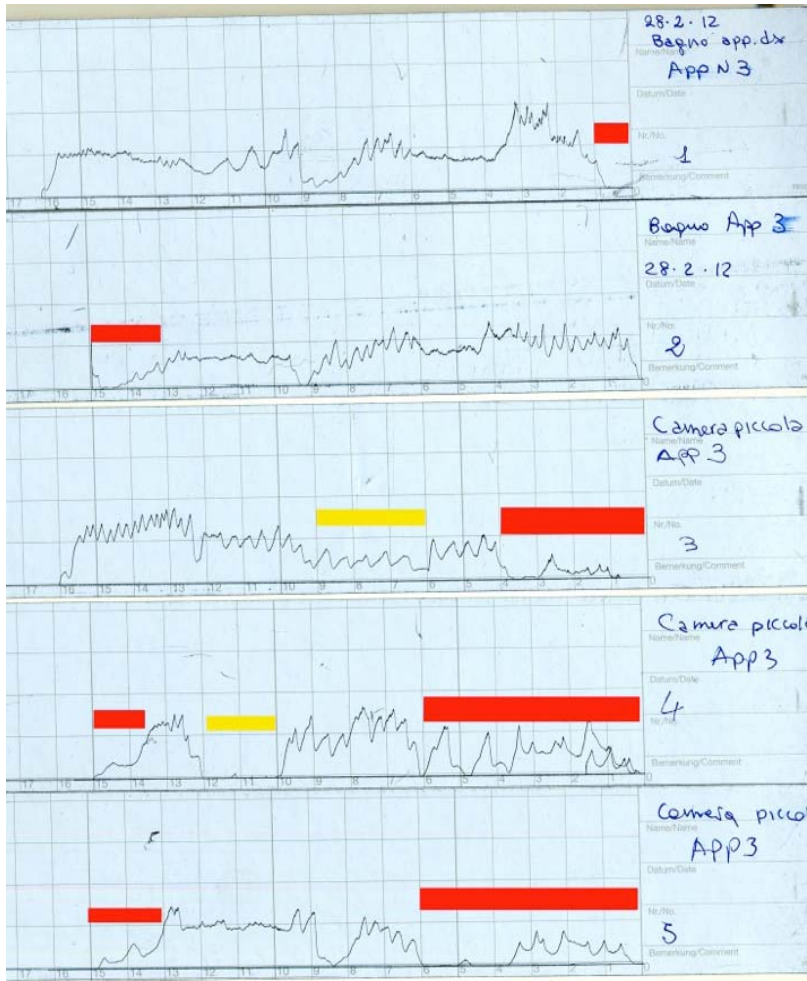
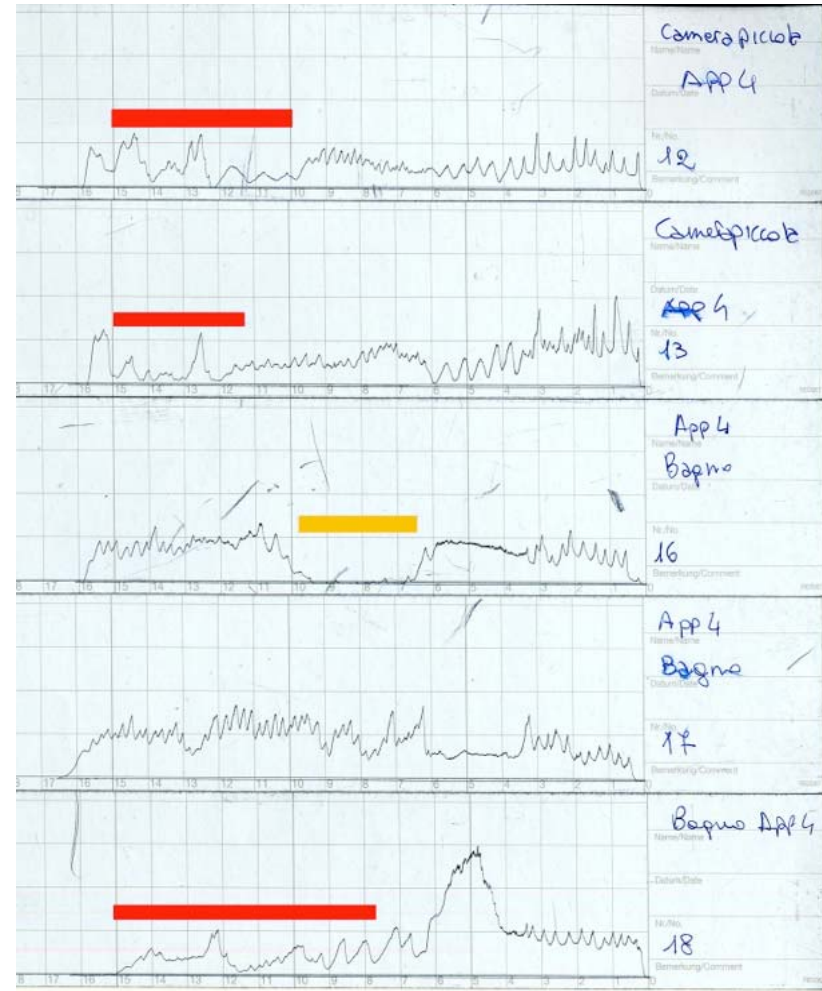
The drilling perforations performed in the area where the moisture was higher than 20% evidenced the extension of decay into the depth of the panels.

In this case study the X-Lam panels of the walls and floors have absorbed rainfall during construction, especially on the top floor.

Further, water percolation from the roof through the different floors of building occurred subsequently to the melting of an extraordinary snowfall in 2012 winter.

The tar paper on the outer surface and the layer of nylon on the inside part caused slower drying or even prevented the subsequent rebalancing of the wood with the relative humidity after the complete assembling of the building.

As consequence, severe fungal decay occurred during the first year after assembling.

This case study evidence the need for a monitoring of wood moisture content in critical parts of the building.

- clear assembling practices (a standard?)
- monitoring in possible critical points (bathroom floors?)
- let possible inspection windows in design practice
- Development of inspection practices
