**COST ACTION FP1303**

**THERMAL PERFORMANCE WOODEN  
WINDOWS DAMAGED BY DECAY / case study/**

# 9 years old wooden windows in wellness

Tatranská Polianka (Slovakia)

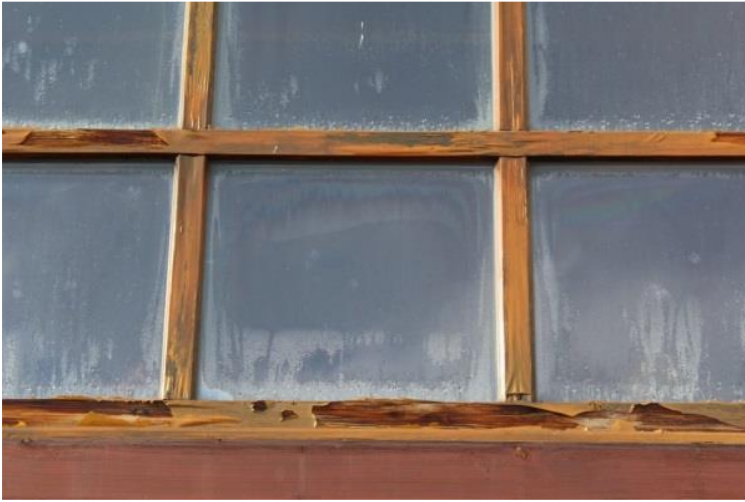
on the exterior side  
weathering of coating

on the interior side  
moisture condensation  
mould grow  
decay

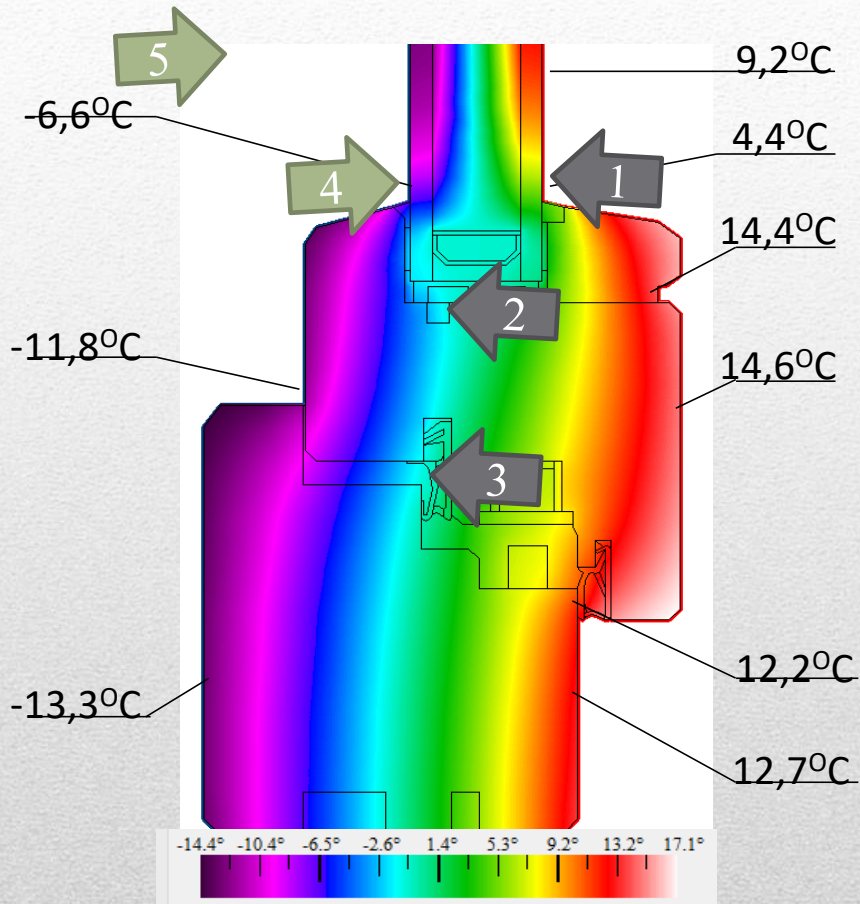
## Window A – used in wellness

**Condensation occurring in:**

- 1. indoor glazing condensation**
- 2. glazing joint condensation**
- 3. functional gap condensation**
- 4. external glazing condensation**
- 5. supplementary elements condensation (shutters)**

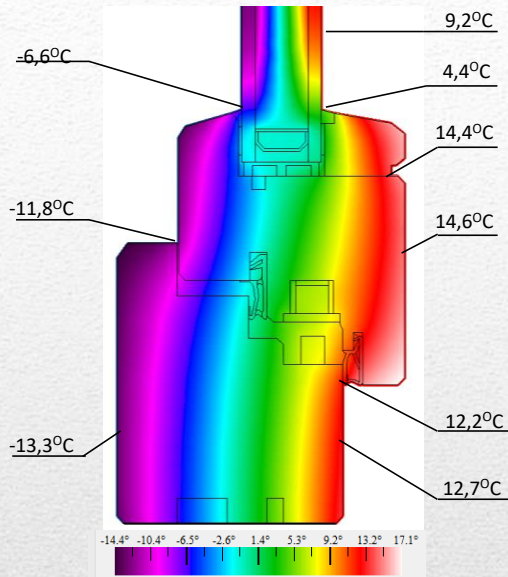
## Window A

$U_g = 1.3 \text{ W}\cdot\text{m}^{-2}\cdot\text{K}^{-1}$

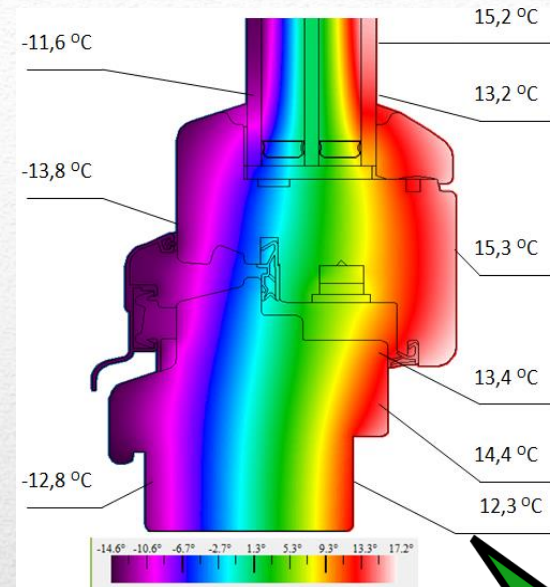
## Window B

$U_g = 0.9 \text{ W}\cdot\text{m}^{-2}\cdot\text{K}^{-1}$

## BETTER: Window B
