**“Designing, Application and Aesthetics of biobased building materials”**

**Performance of fir-spruce timber houses in North Spain. Examples of wood buildings. The importance of design details in the performance.**

***Lorenzo, David, Josu Benito, Juan Fernández-Golfín, Manuel Touza, Manuel Guaita, Alfonso Lozano***

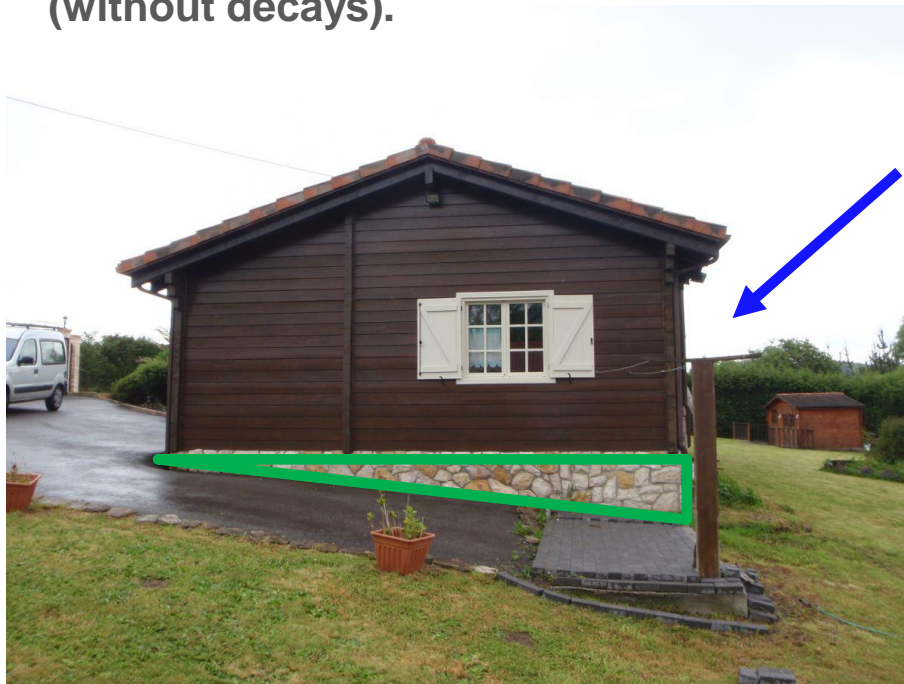
HOUSE 1

- Foundation (distance from ground), no driven rain, sheltering (eaves) and coating
- Timber walls: Good performance (without decays).

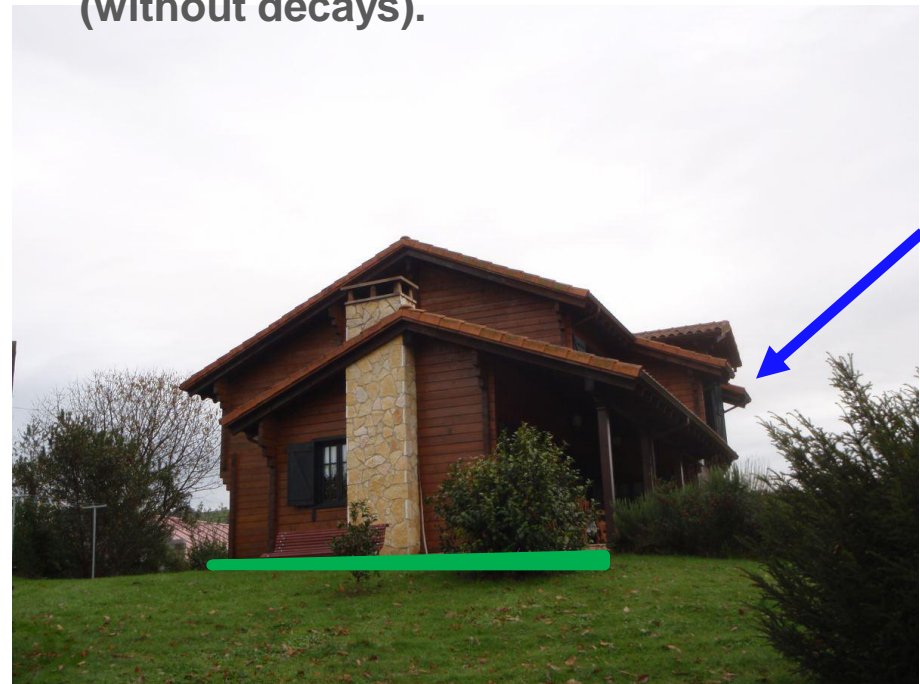
HOUSE 2

- Foundation (distance from ground), no driven rain, sheltering (eaves) and coating
- Timber walls: Good performance (without decays).

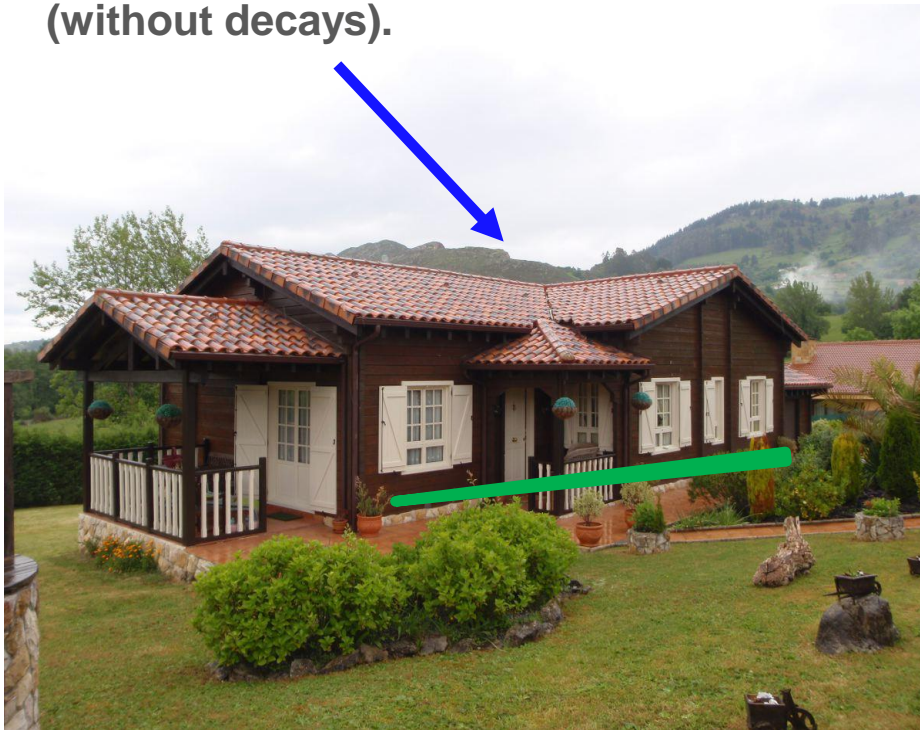
HOUSE 1

- Foundation (distance from ground), no driven rain, sheltering (eaves and porch) and coating.
- Timber walls: Good performance (without decays).

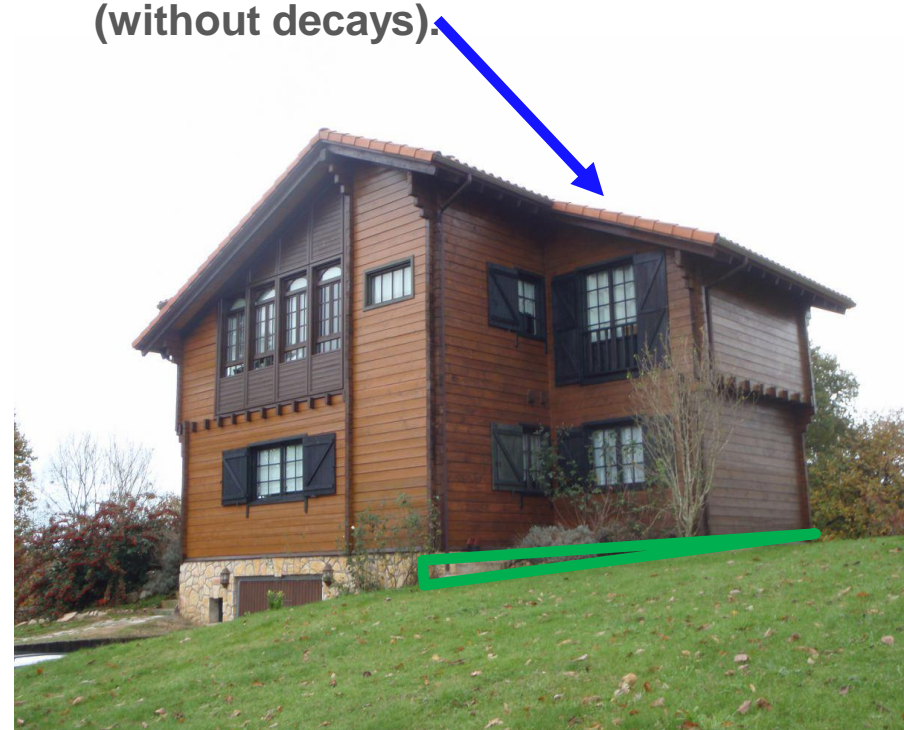
HOUSE 2

- Foundation (distance from ground), no driven rain, sheltering (eaves) and coating
- Timber walls: Good performance (without decays).

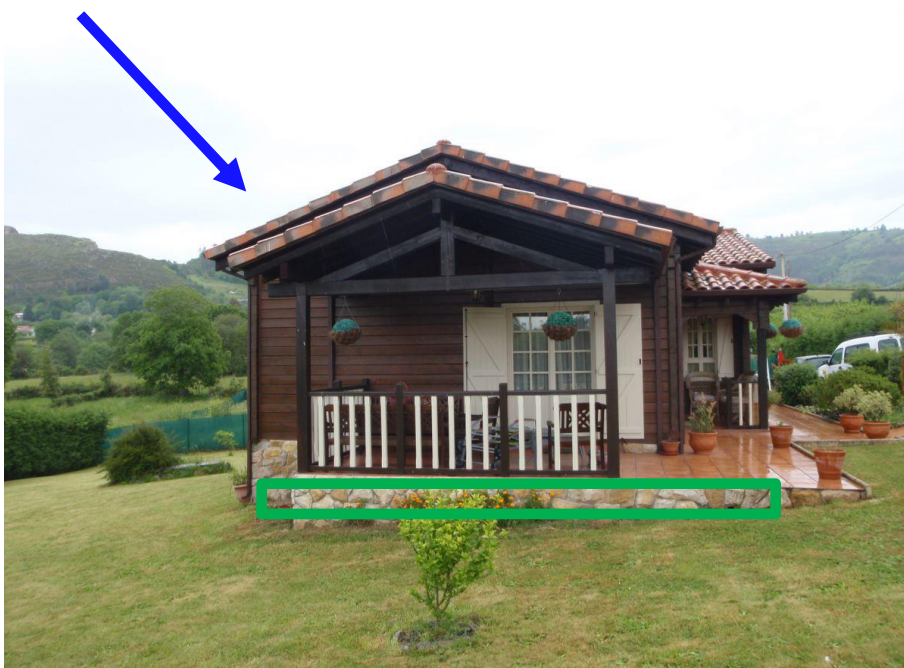
HOUSE 1

- Foundation (distance from ground), no driven rain, sheltering (eaves and porch) and coating.
- Timber walls: Good performance (without decays).

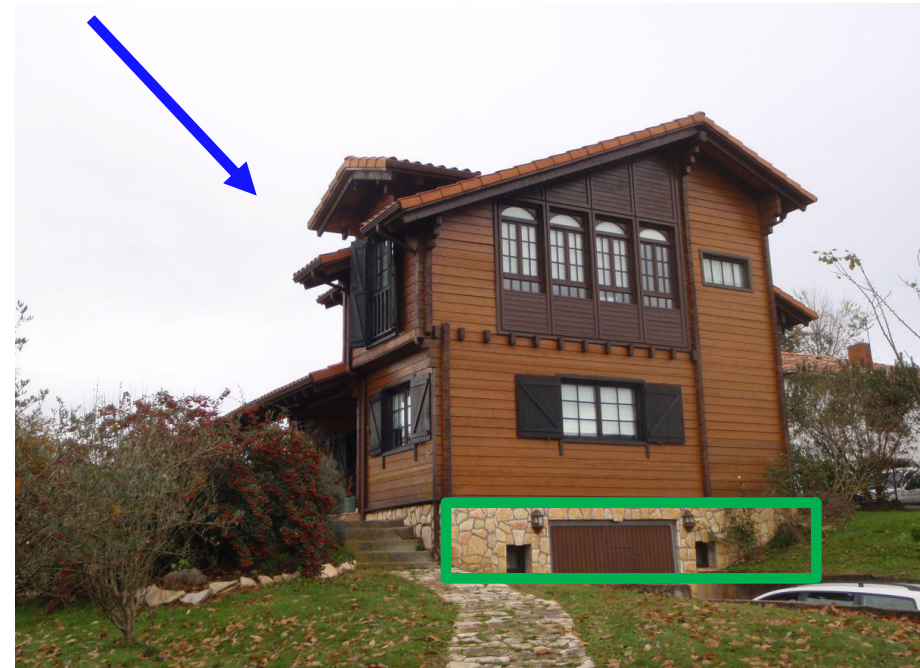
HOUSE 2

- Foundation and garage (distance from ground), no driven rain, sheltering (eaves) and coating
- Timber walls: Good performance (without decays).

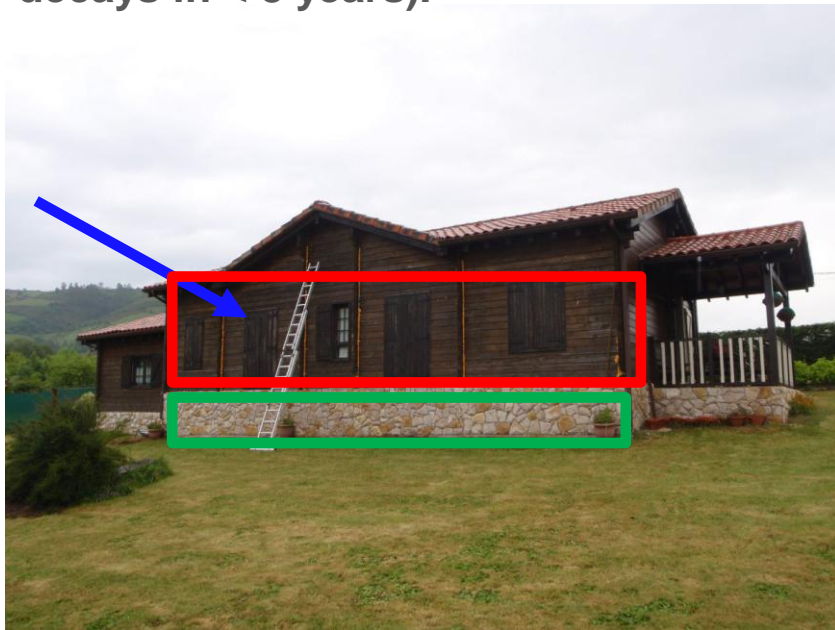
HOUSE 1

- Foundation (distance from ground), sheltering (eaves) and coating.
- Driven rain (early decays in water traps in timber walls). Insufficient design protection.
- Timber walls: Bad performance (early decays in < 8 years).

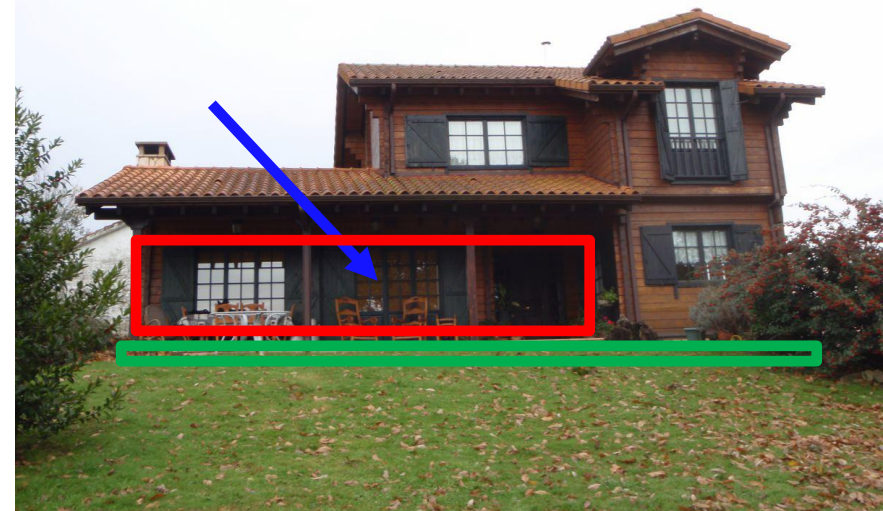
HOUSE 2

- Foundation (distance from ground), sheltering (Porch and eaves) and coating (maintenance).
- Driven rain (early decays in water traps in base pillars). Insufficient design protection.
- Timber walls: Bad performance (early decays in < 8 years).

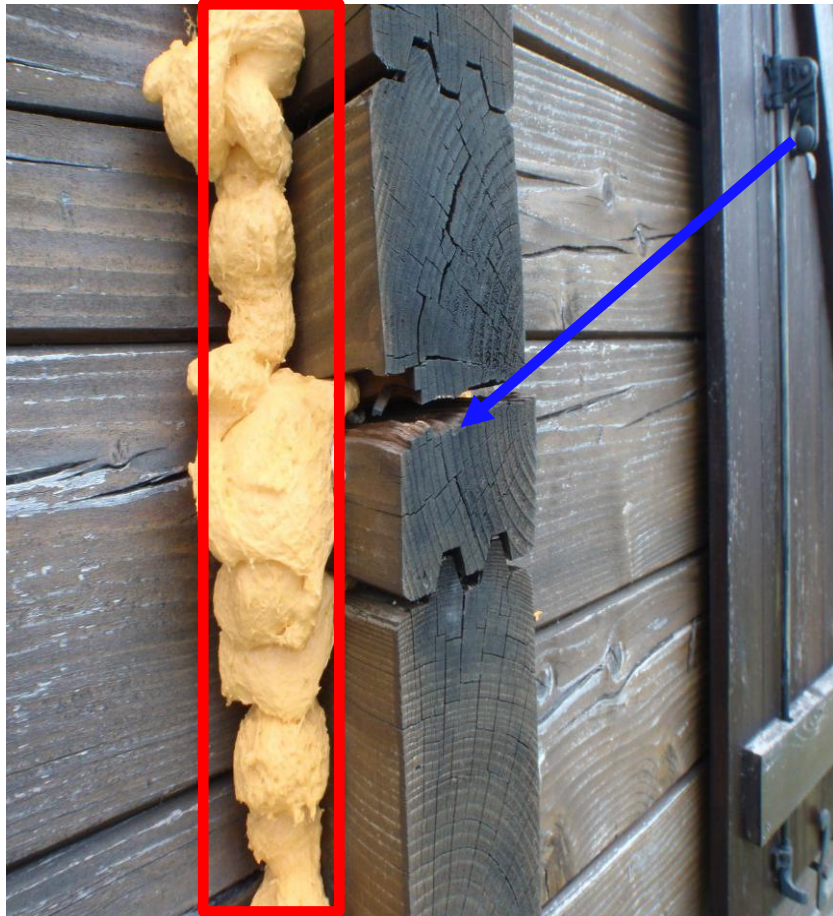
HOUSE 1

- Water traps (M.C>20%) driven rain in timber walls

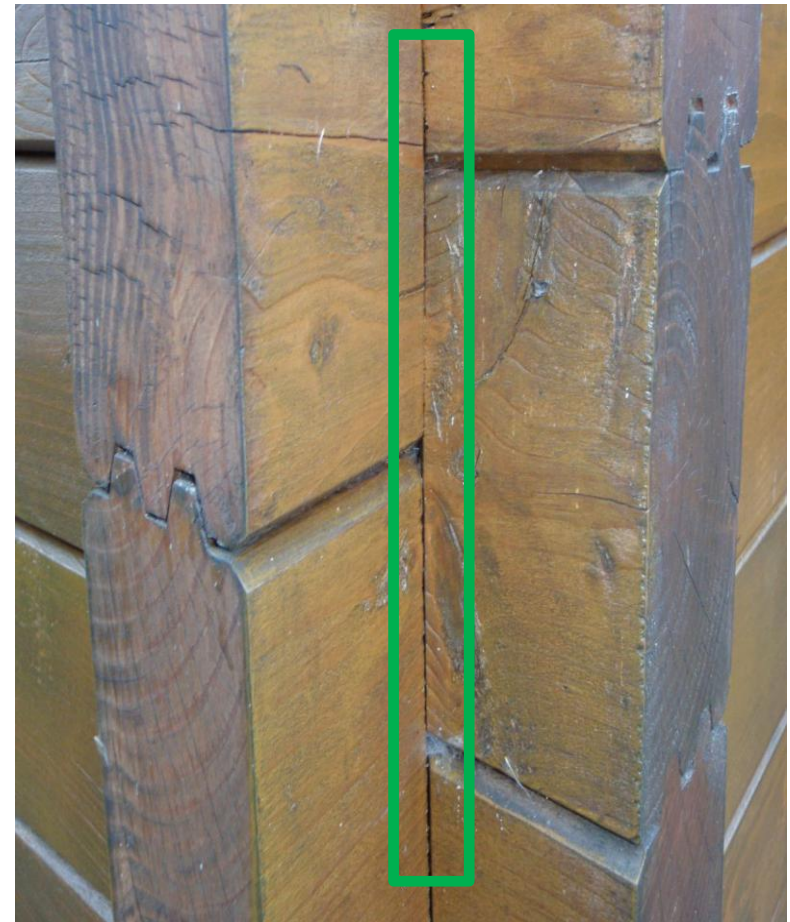
HOUSE 2

- Water traps (M.C<20%) no driven rain in timber walls (porch)

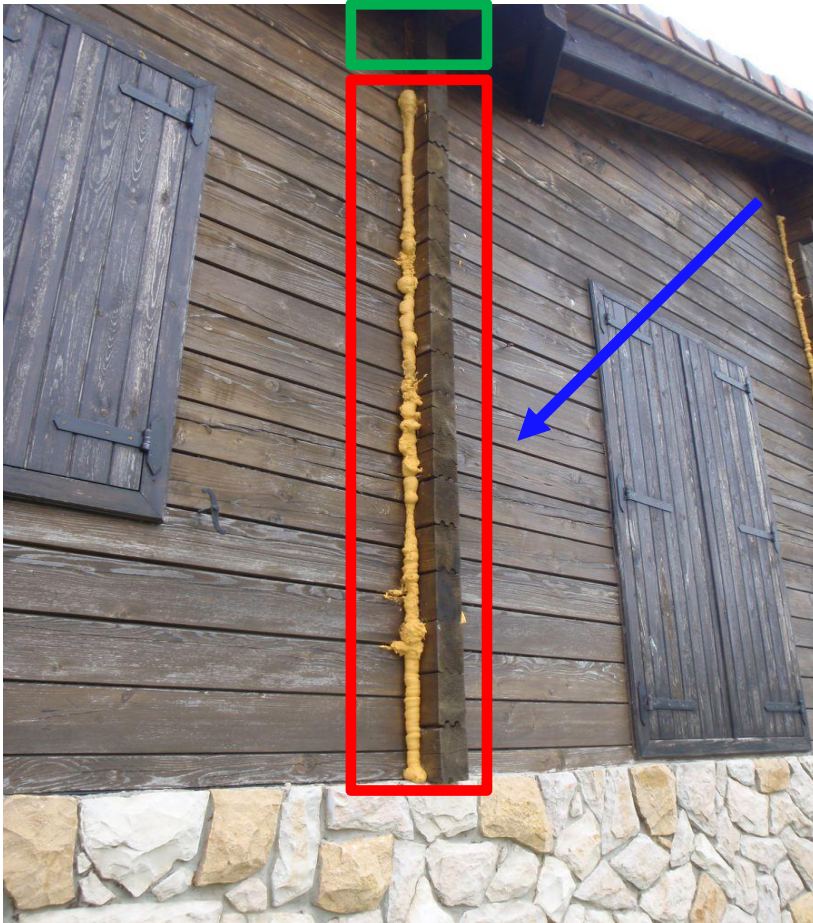
HOUSE 1

- Water traps (M.C>20%) driven rain in timber walls

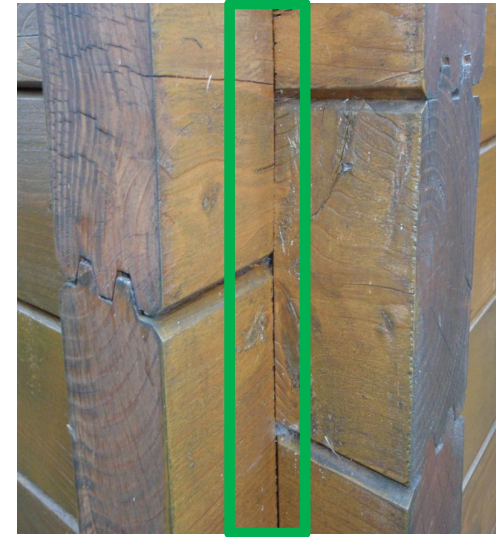
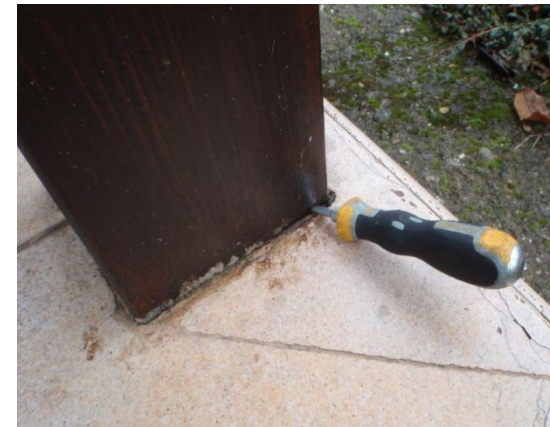
HOUSE 2

- Water traps (M.C<20%) no driven rain in timber walls (porch)

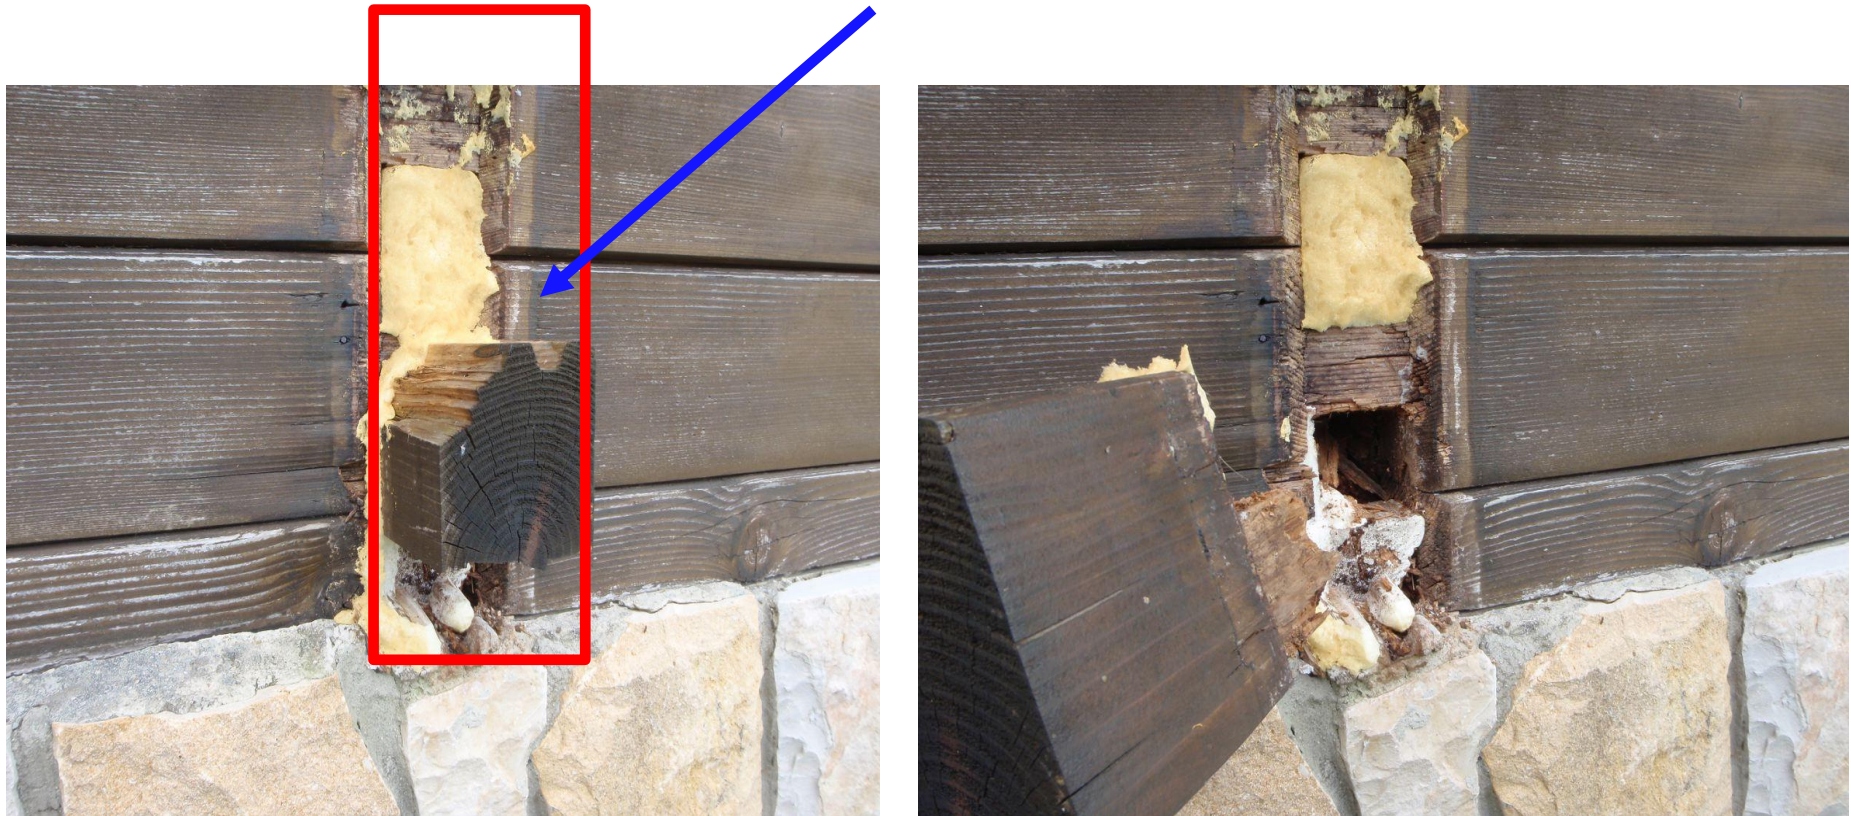
**HOUSE 1**

**Water traps (M.C>20%) driven rain in timber walls and early decays**  
**Important structural damages**

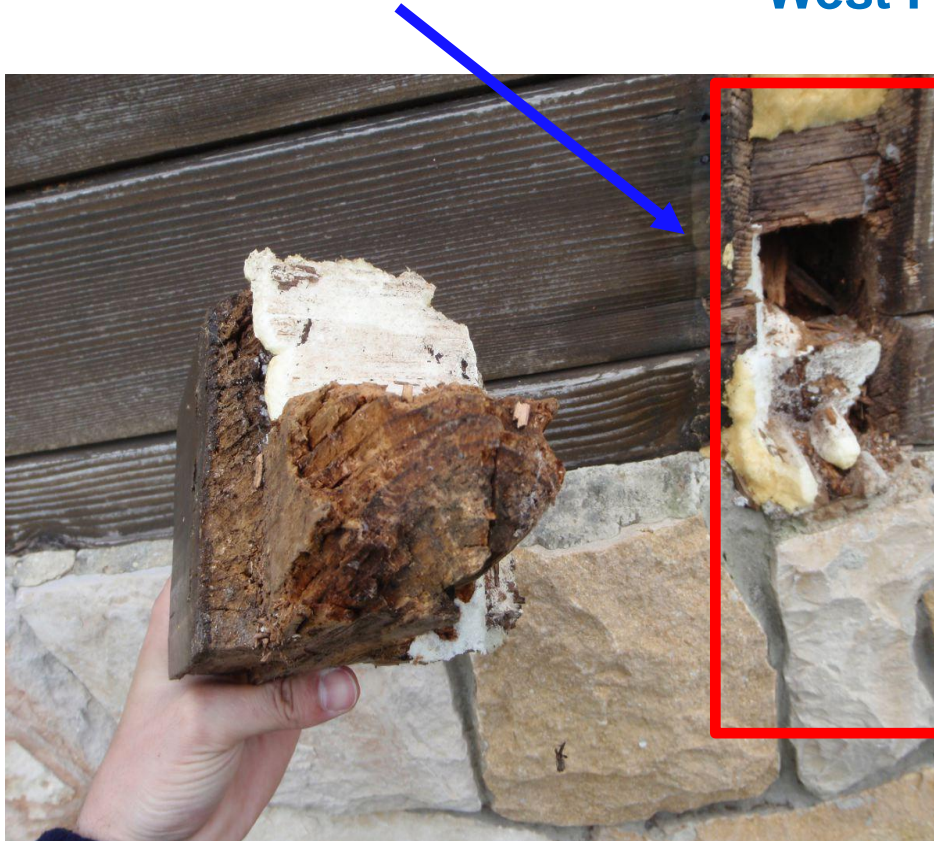
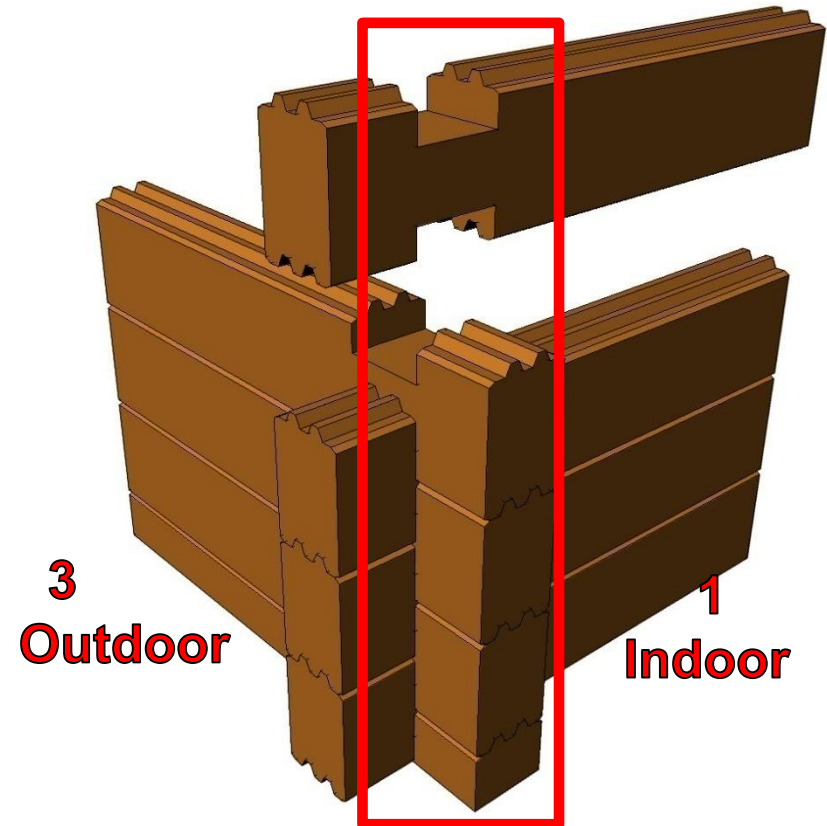
HOUSE 1

WEST TIMBER WALL HOUSE: IMPORTANT STRUCTURAL DAMAGES

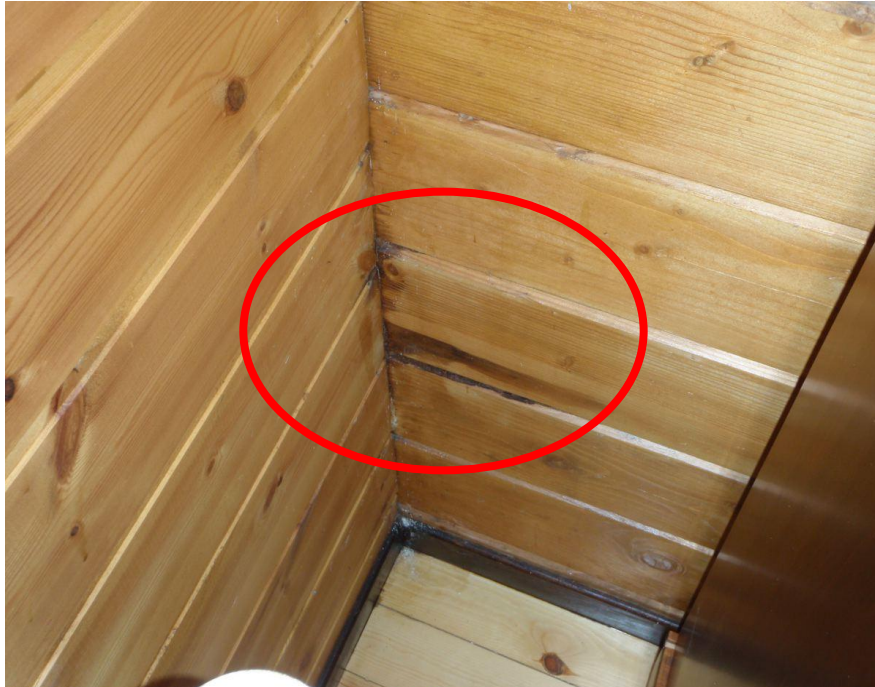
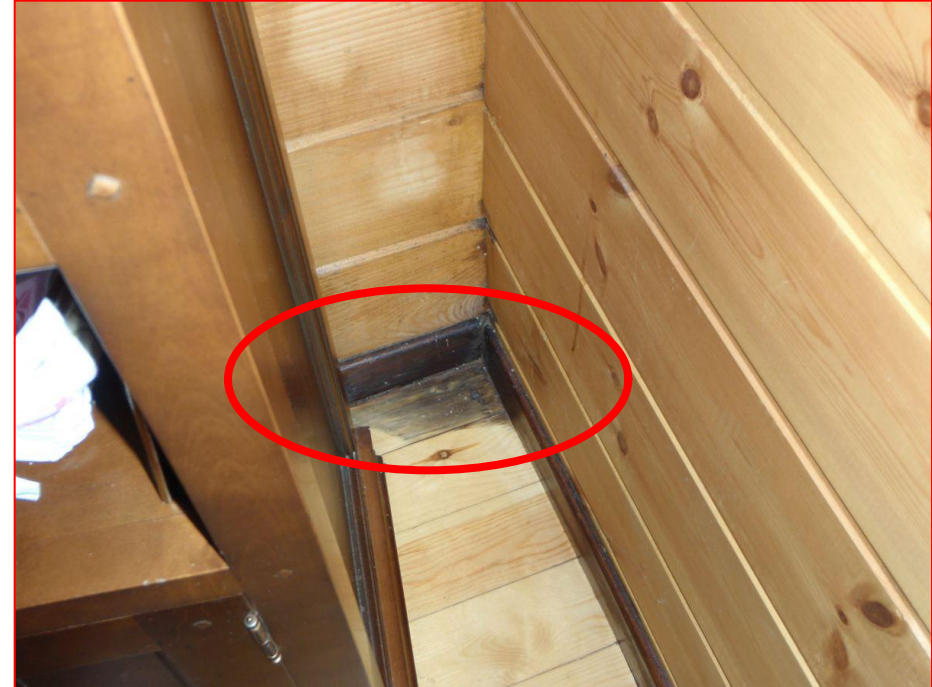
HOUSE 1

Interior timber house: stain and moisture problems and early decays in timber walls

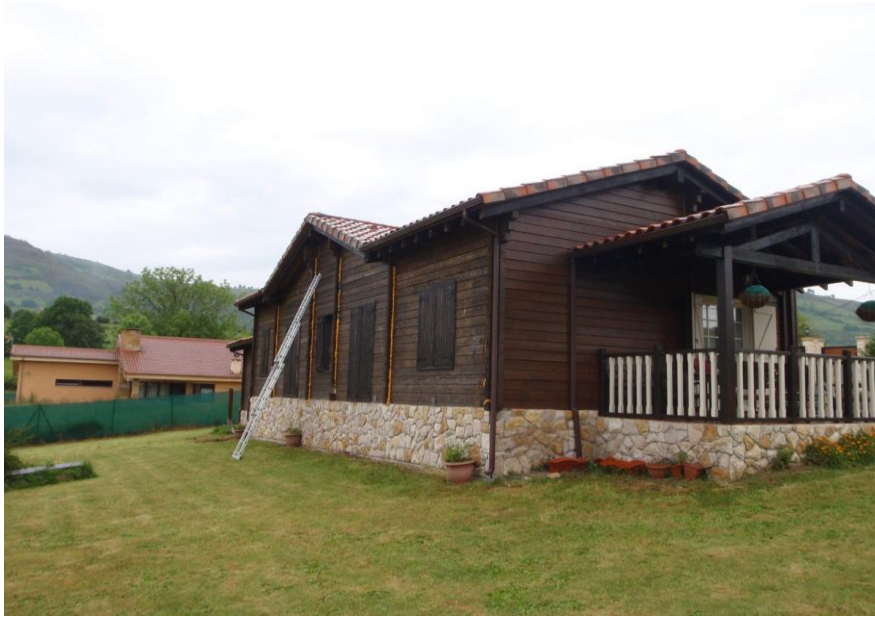
HOUSE 1

- *Abies alba* (fir)
- “Treated wood”
- Without maintenance (Coating)
- 8 years
- West facade: **Early and several decays.** Design details protection insufficient (exposed facade) **WATER TRAPS** (C.U: 3.2).
- Other facades: **Good performance.**

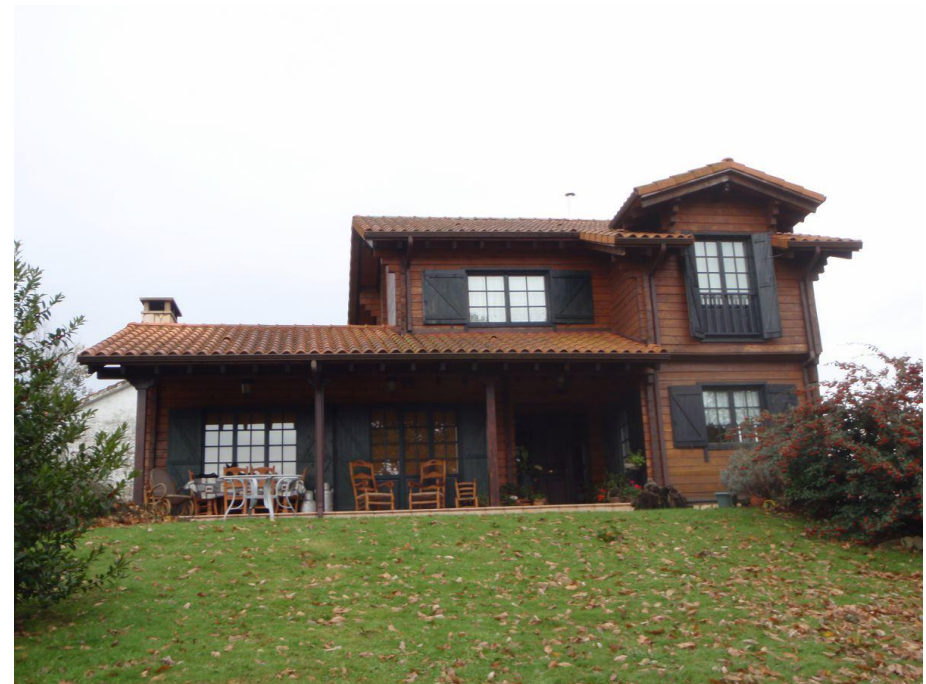
HOUSE 2

- *Picea abies* (Spruce)
- “Treated wood”
- With maintenance (Coating)
- 8 years
- West facade: **Early decays in base pillars.** Design details protection (Porch) **NO WATER TRAPS** (C.U: 2 and 3.1)
- Other facades: **Good performance.**
