Performance of a noise barrier with different wood materials – results from a service trial after 20 years' exposure

Jöran Jermer

SP Technical Research Institute of Sweden
(now RISE Research Institutes of Sweden)

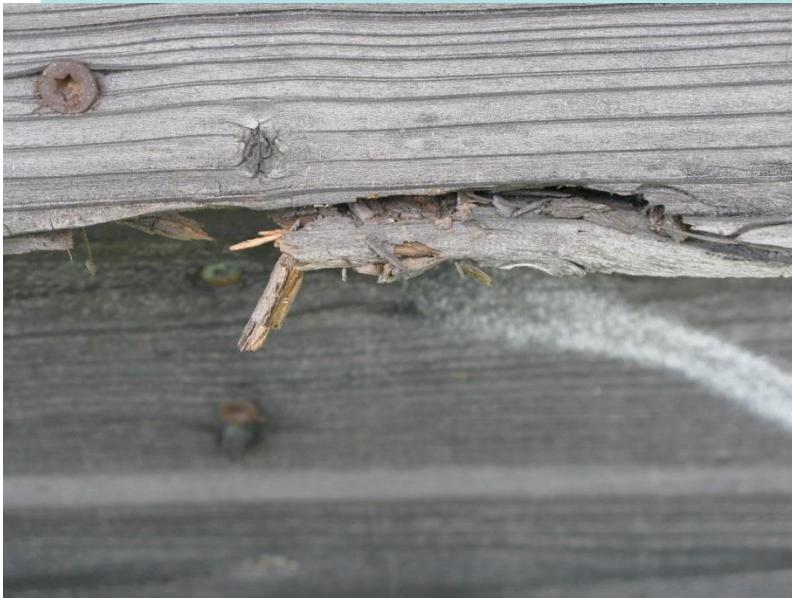
Example: Spot of slight decay

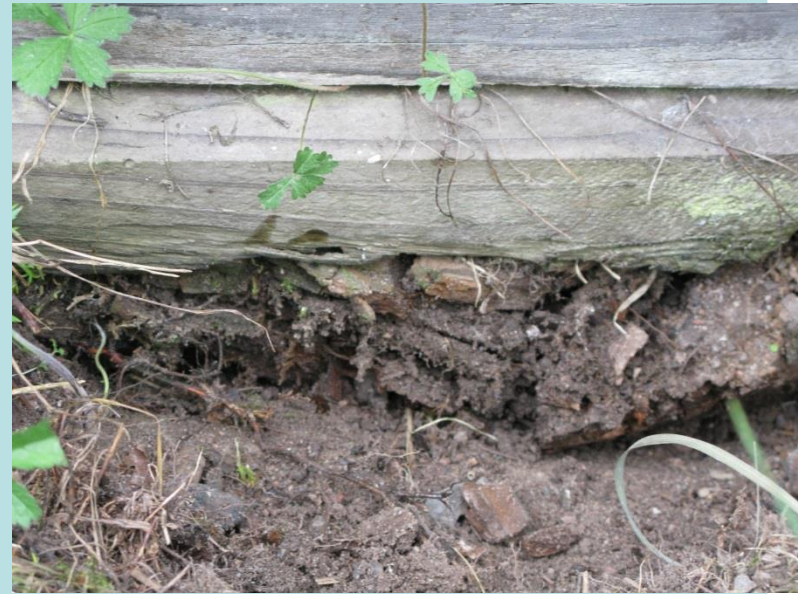
Example: Failure
