COST FP 1303 Cooperative Performance Test – Results after two years outdoor exposure

COST FP1303 meeting - Sofia, 28.2.-1.3.2017

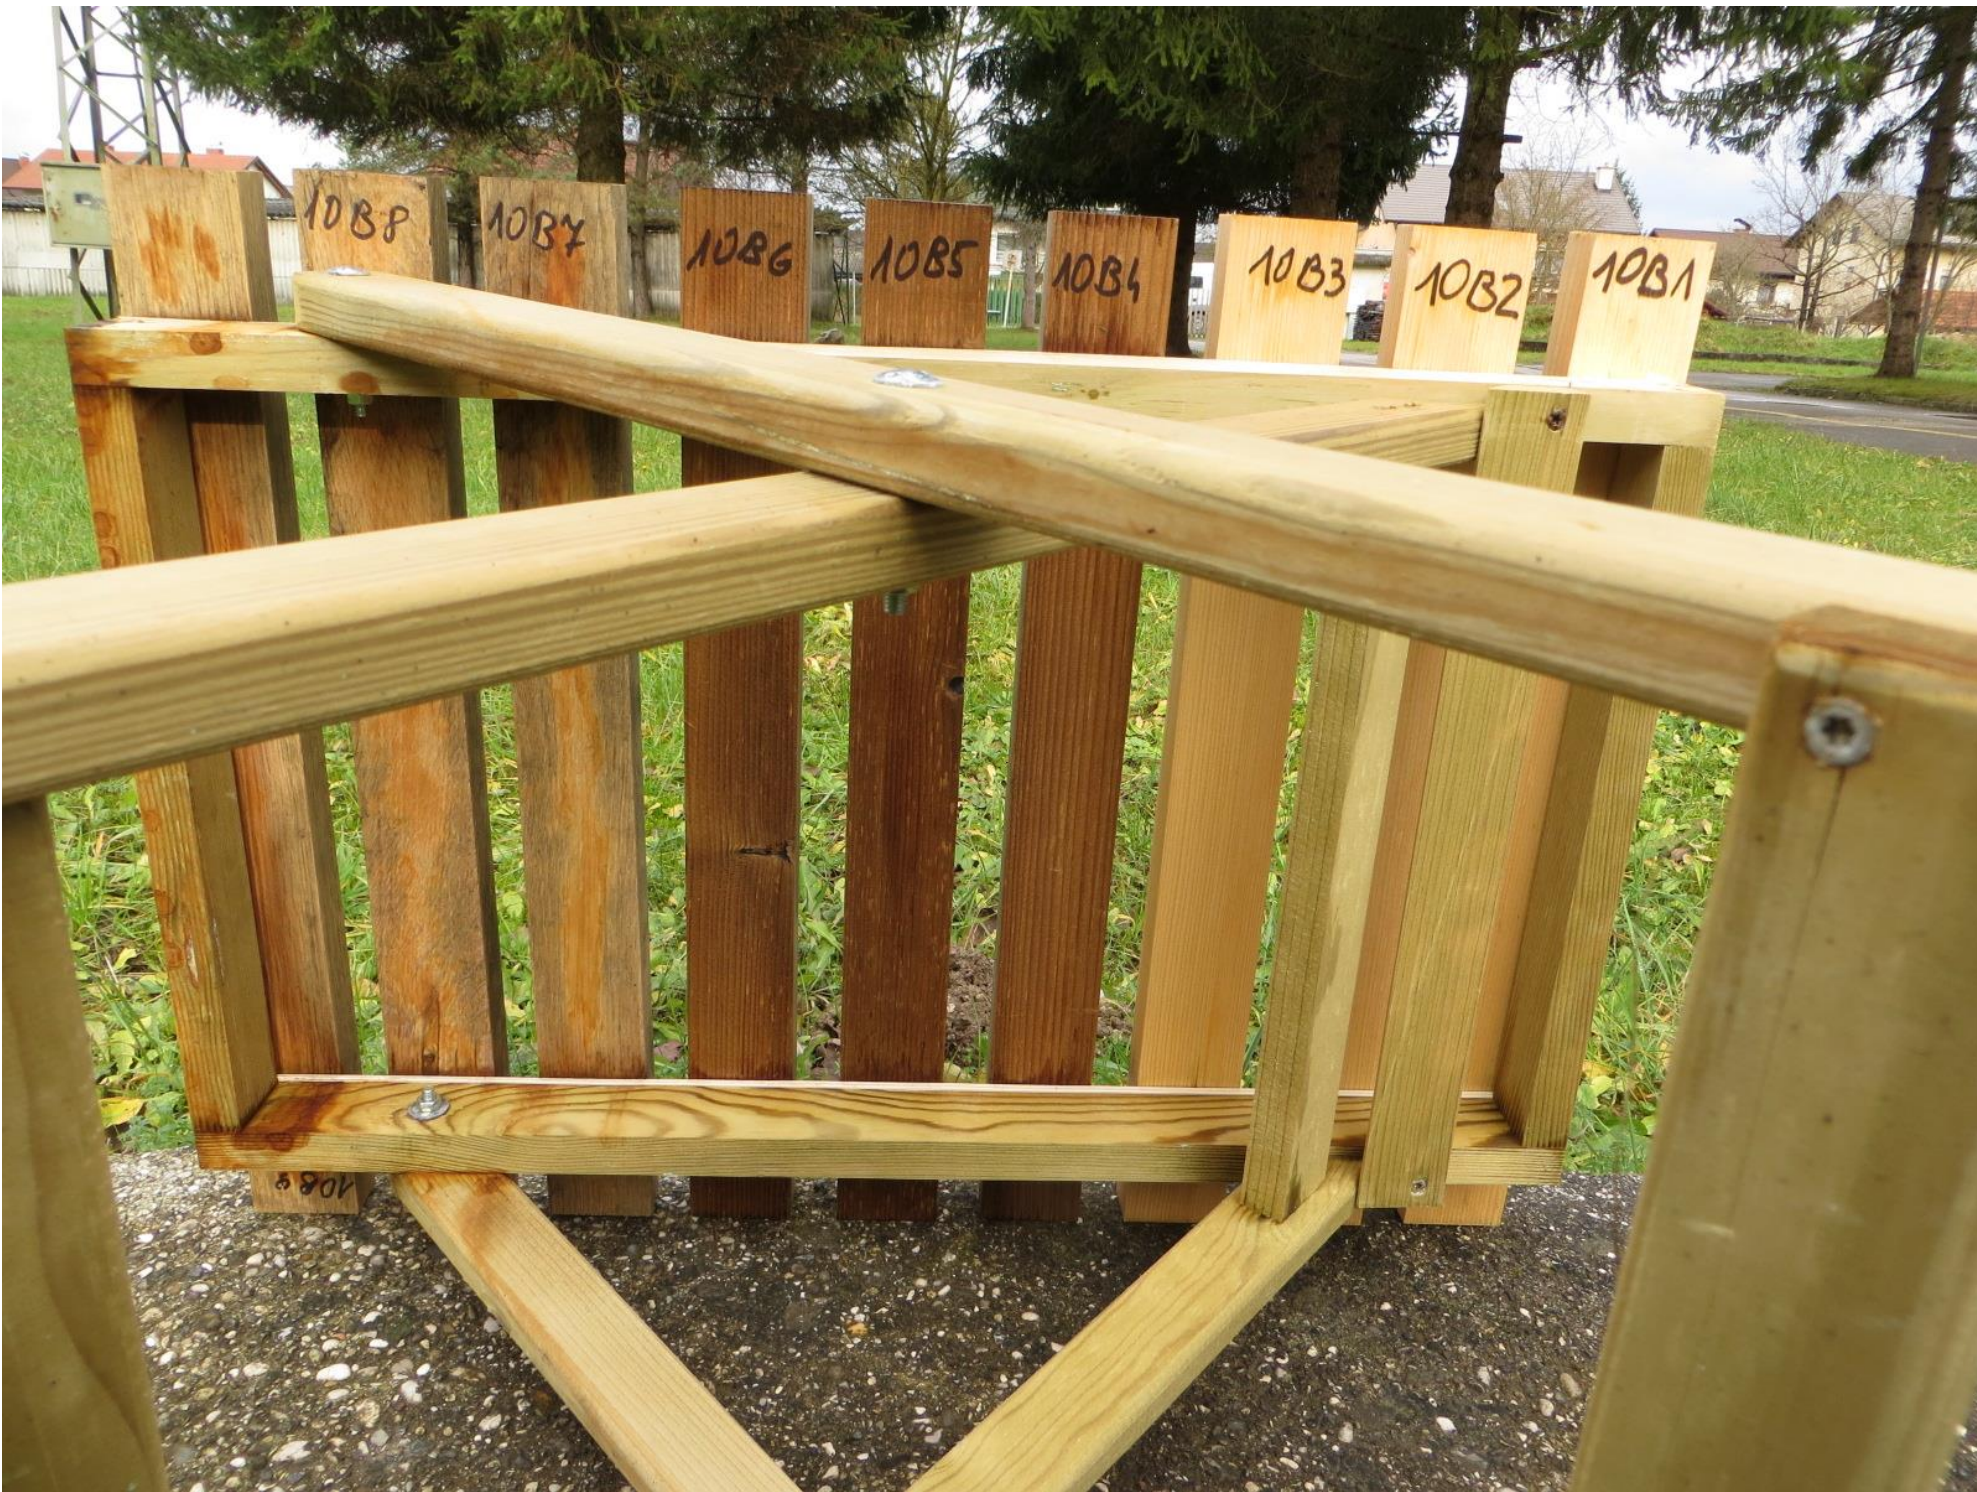
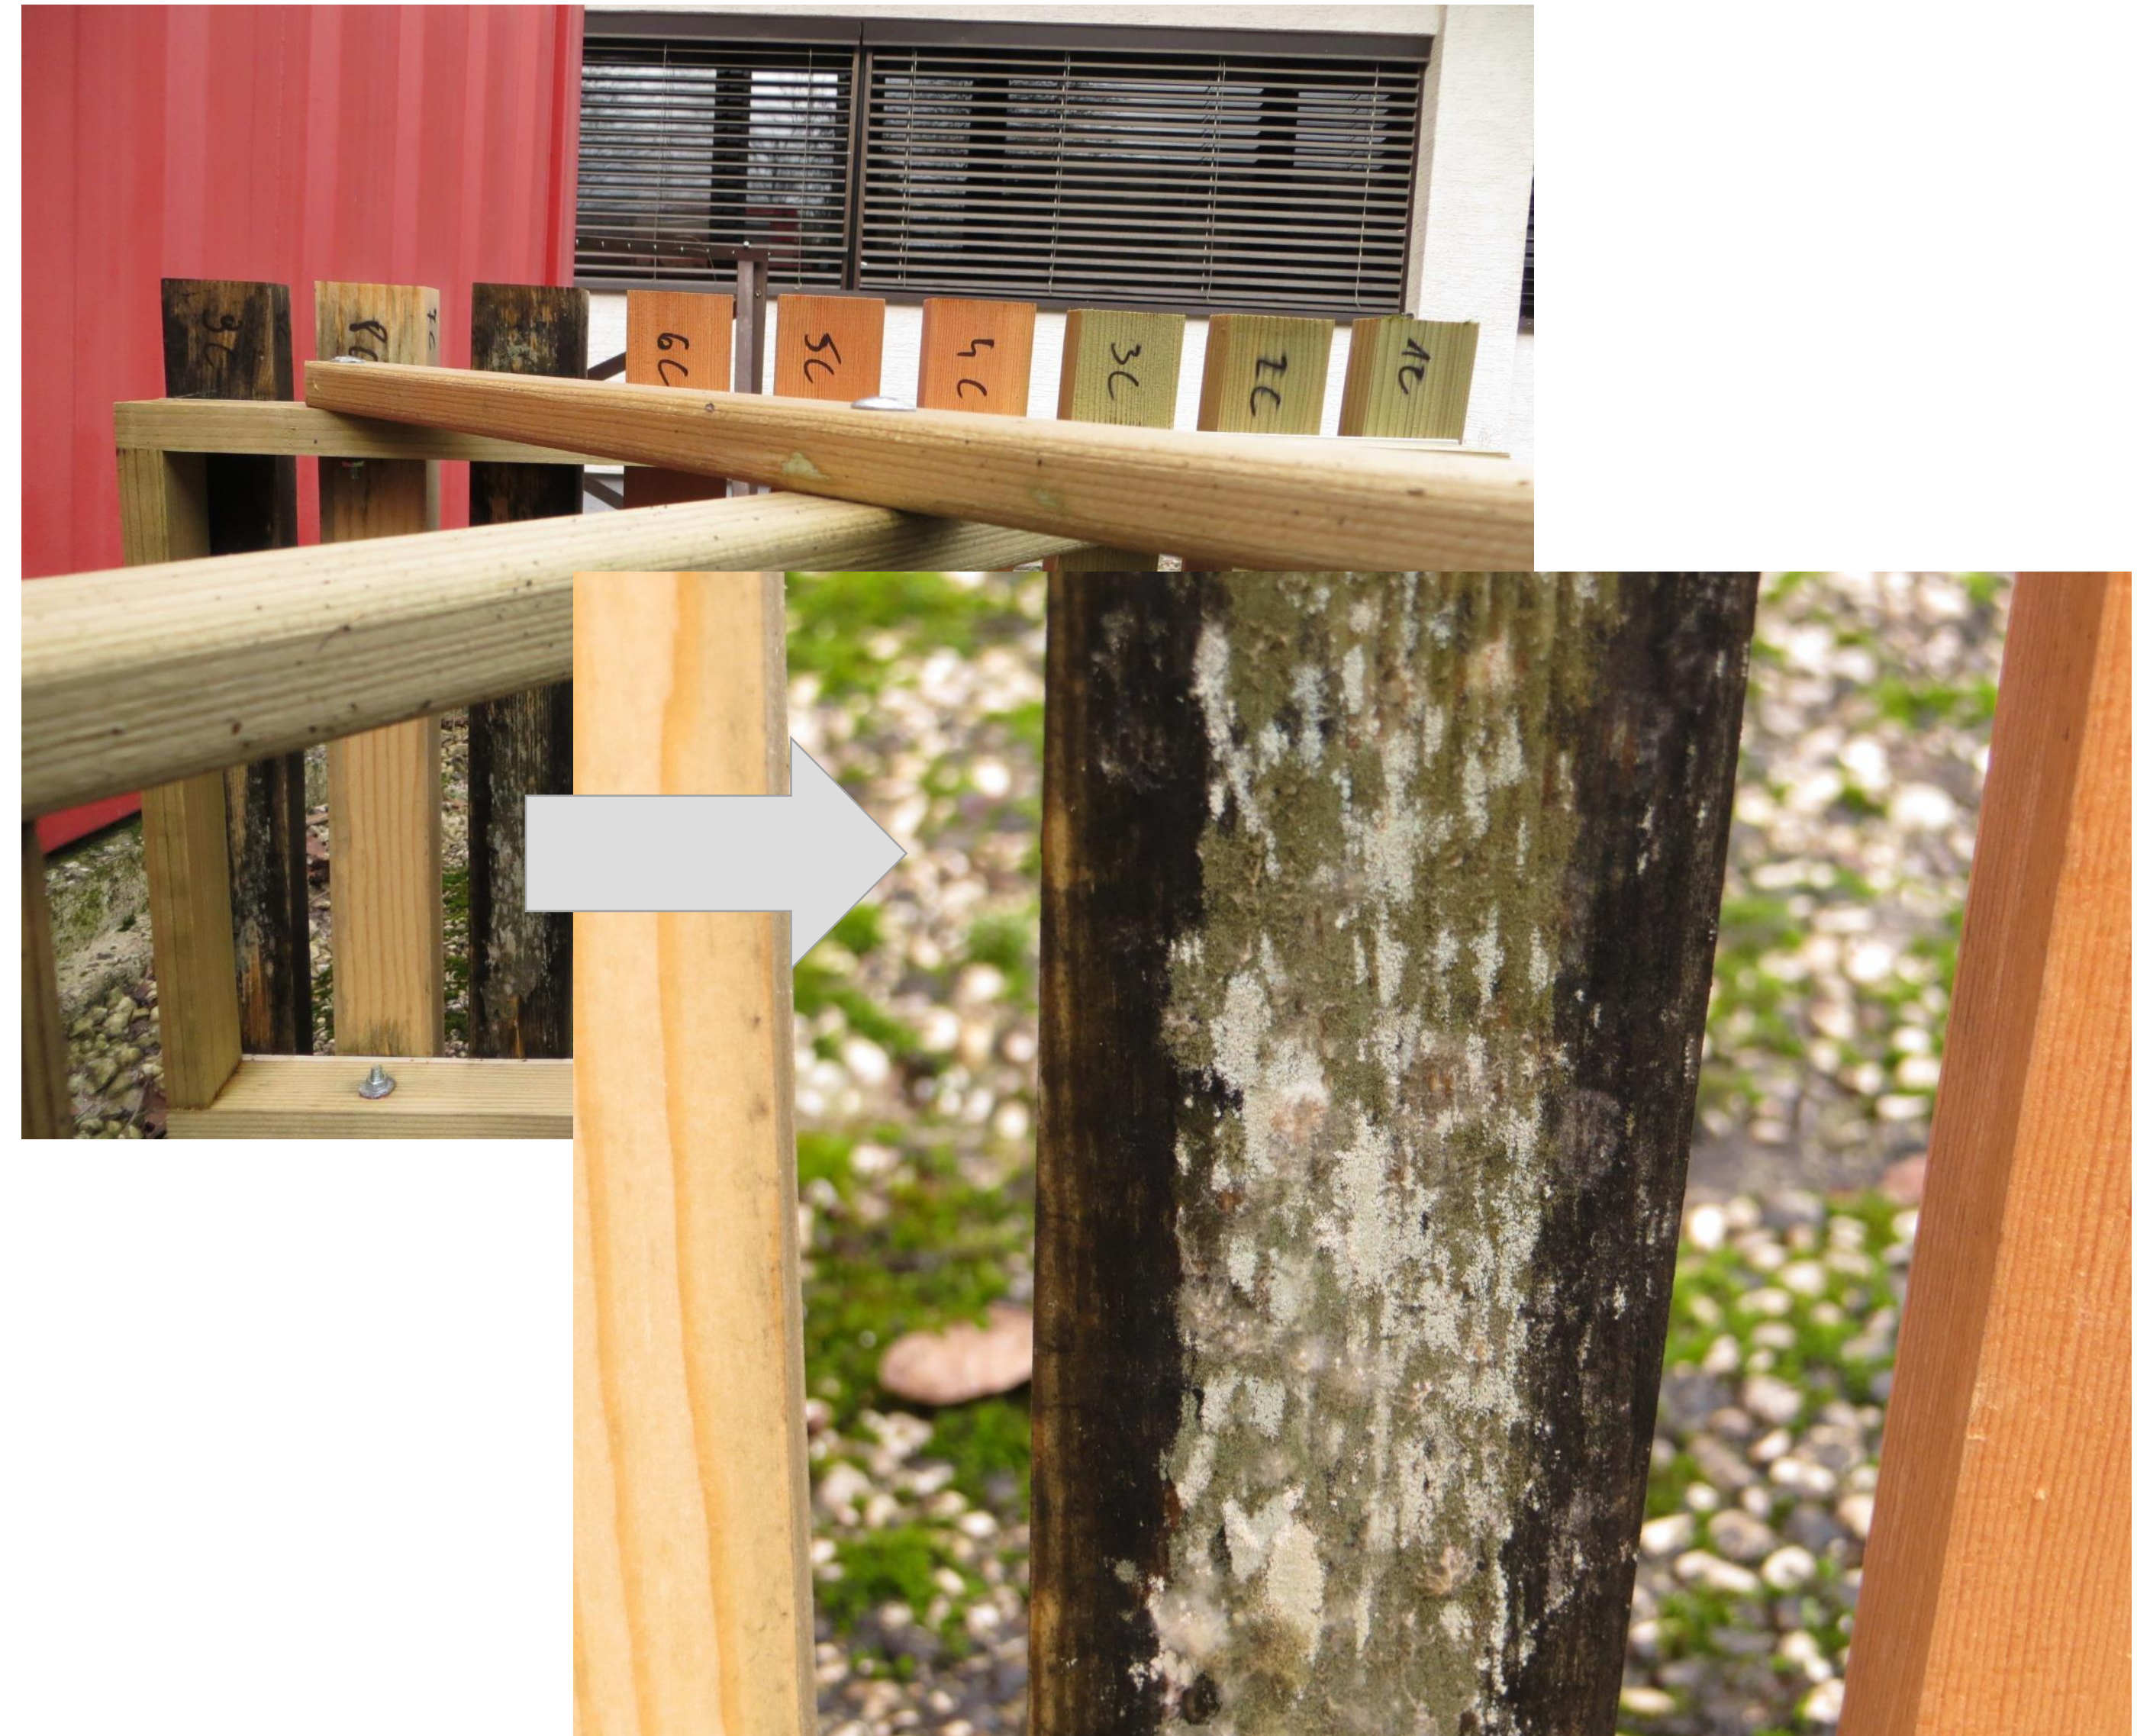
Surface disfigurement due to mould and staining fungi – Boothom surface after 3 months exposure

Oak, TMT NS , NS

Pine, Larch, Cu terated wood

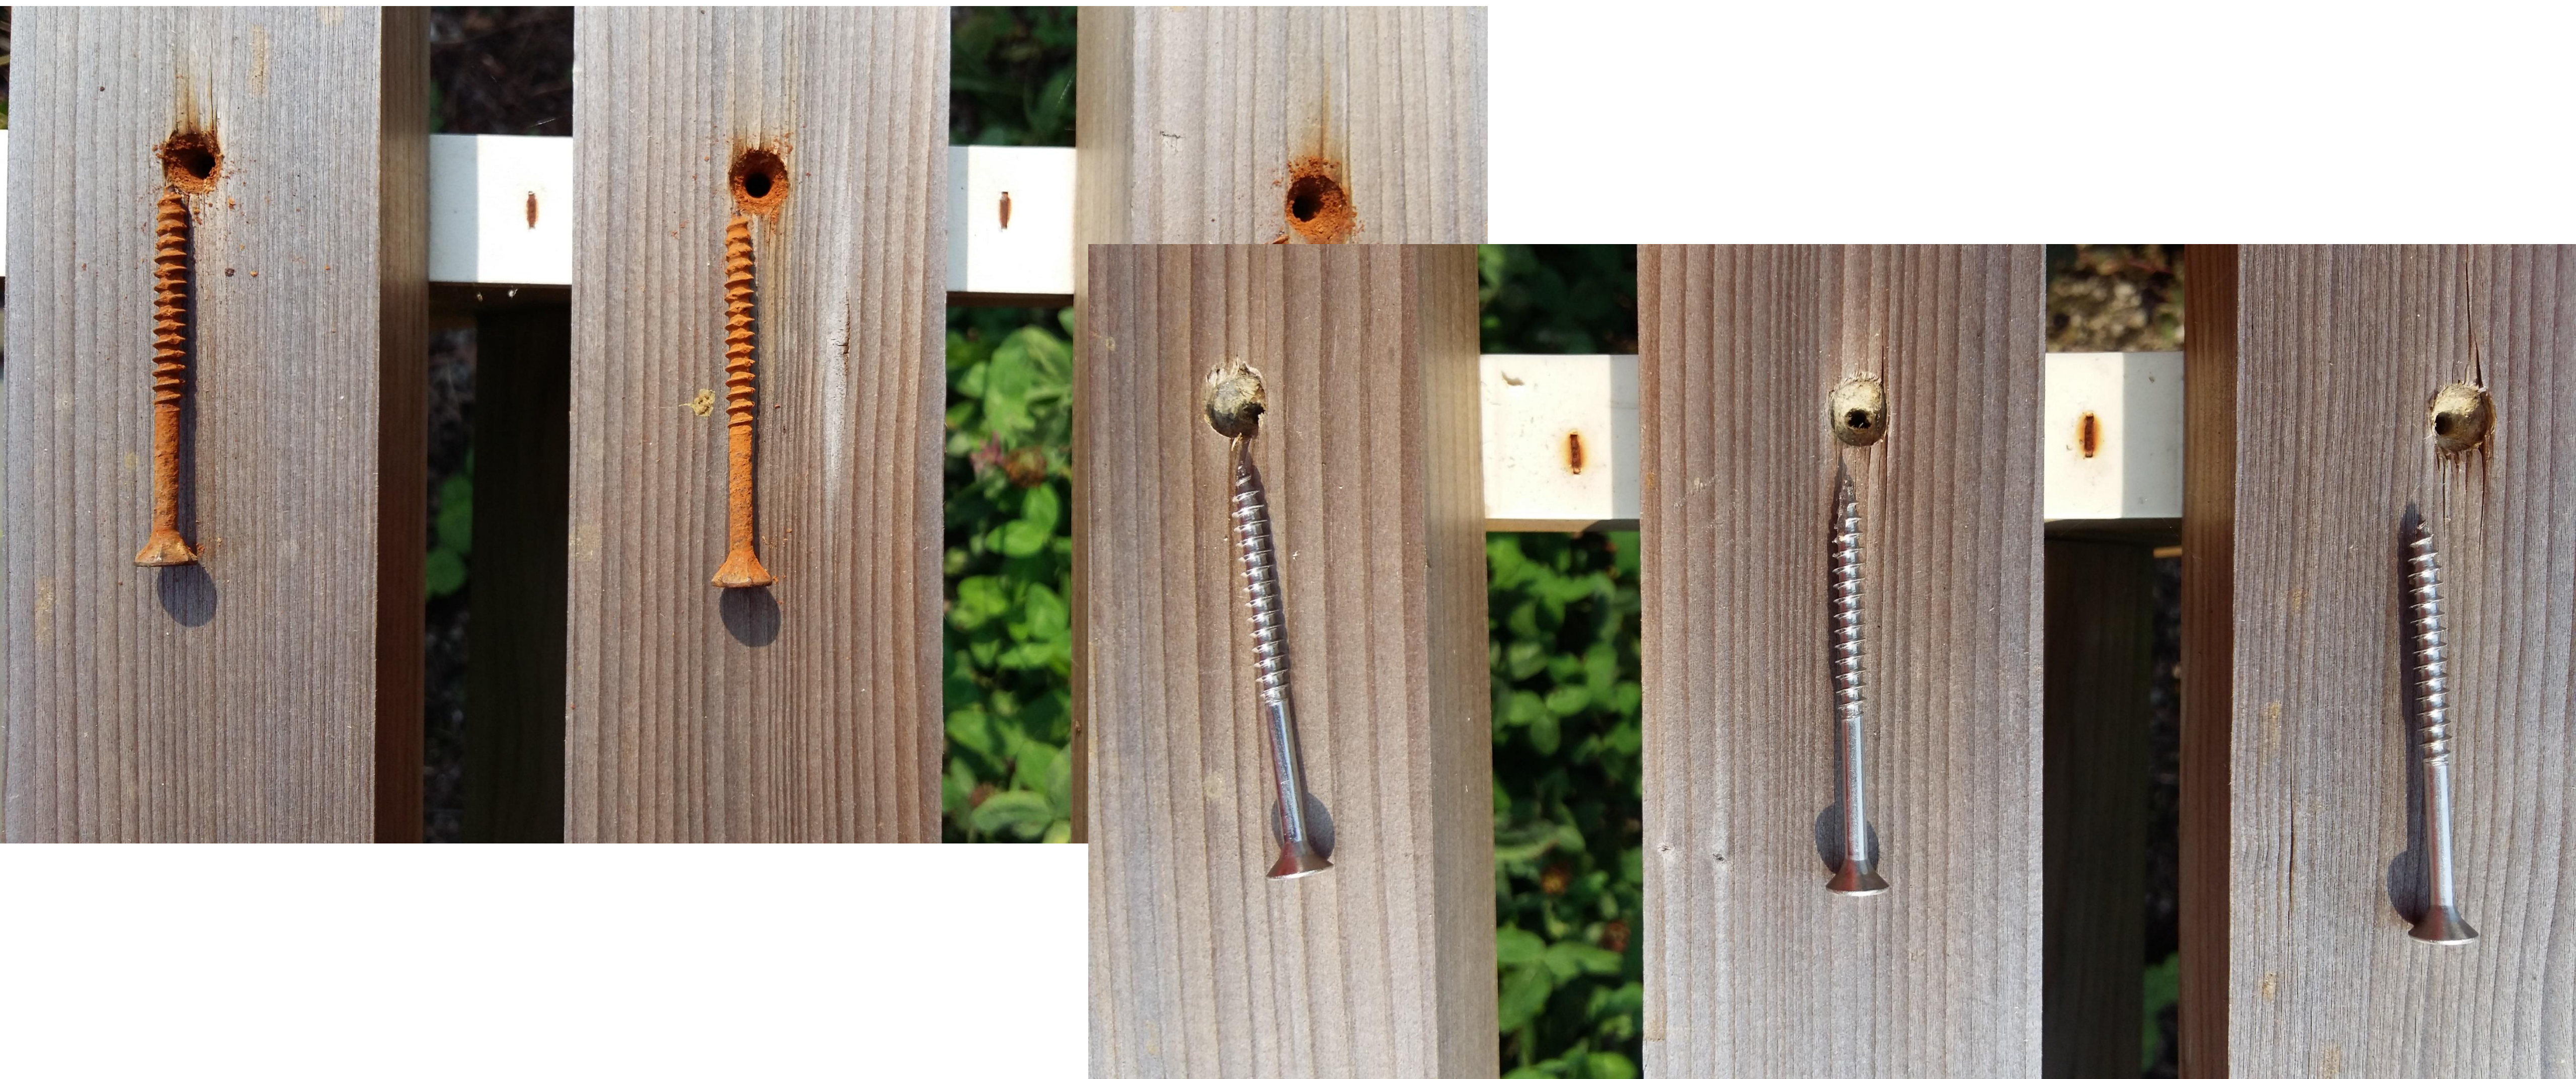
Results – Corrosion Galvanized vs. Stainless screws – Ljubljana, version C

Cooper treated Norway spruce

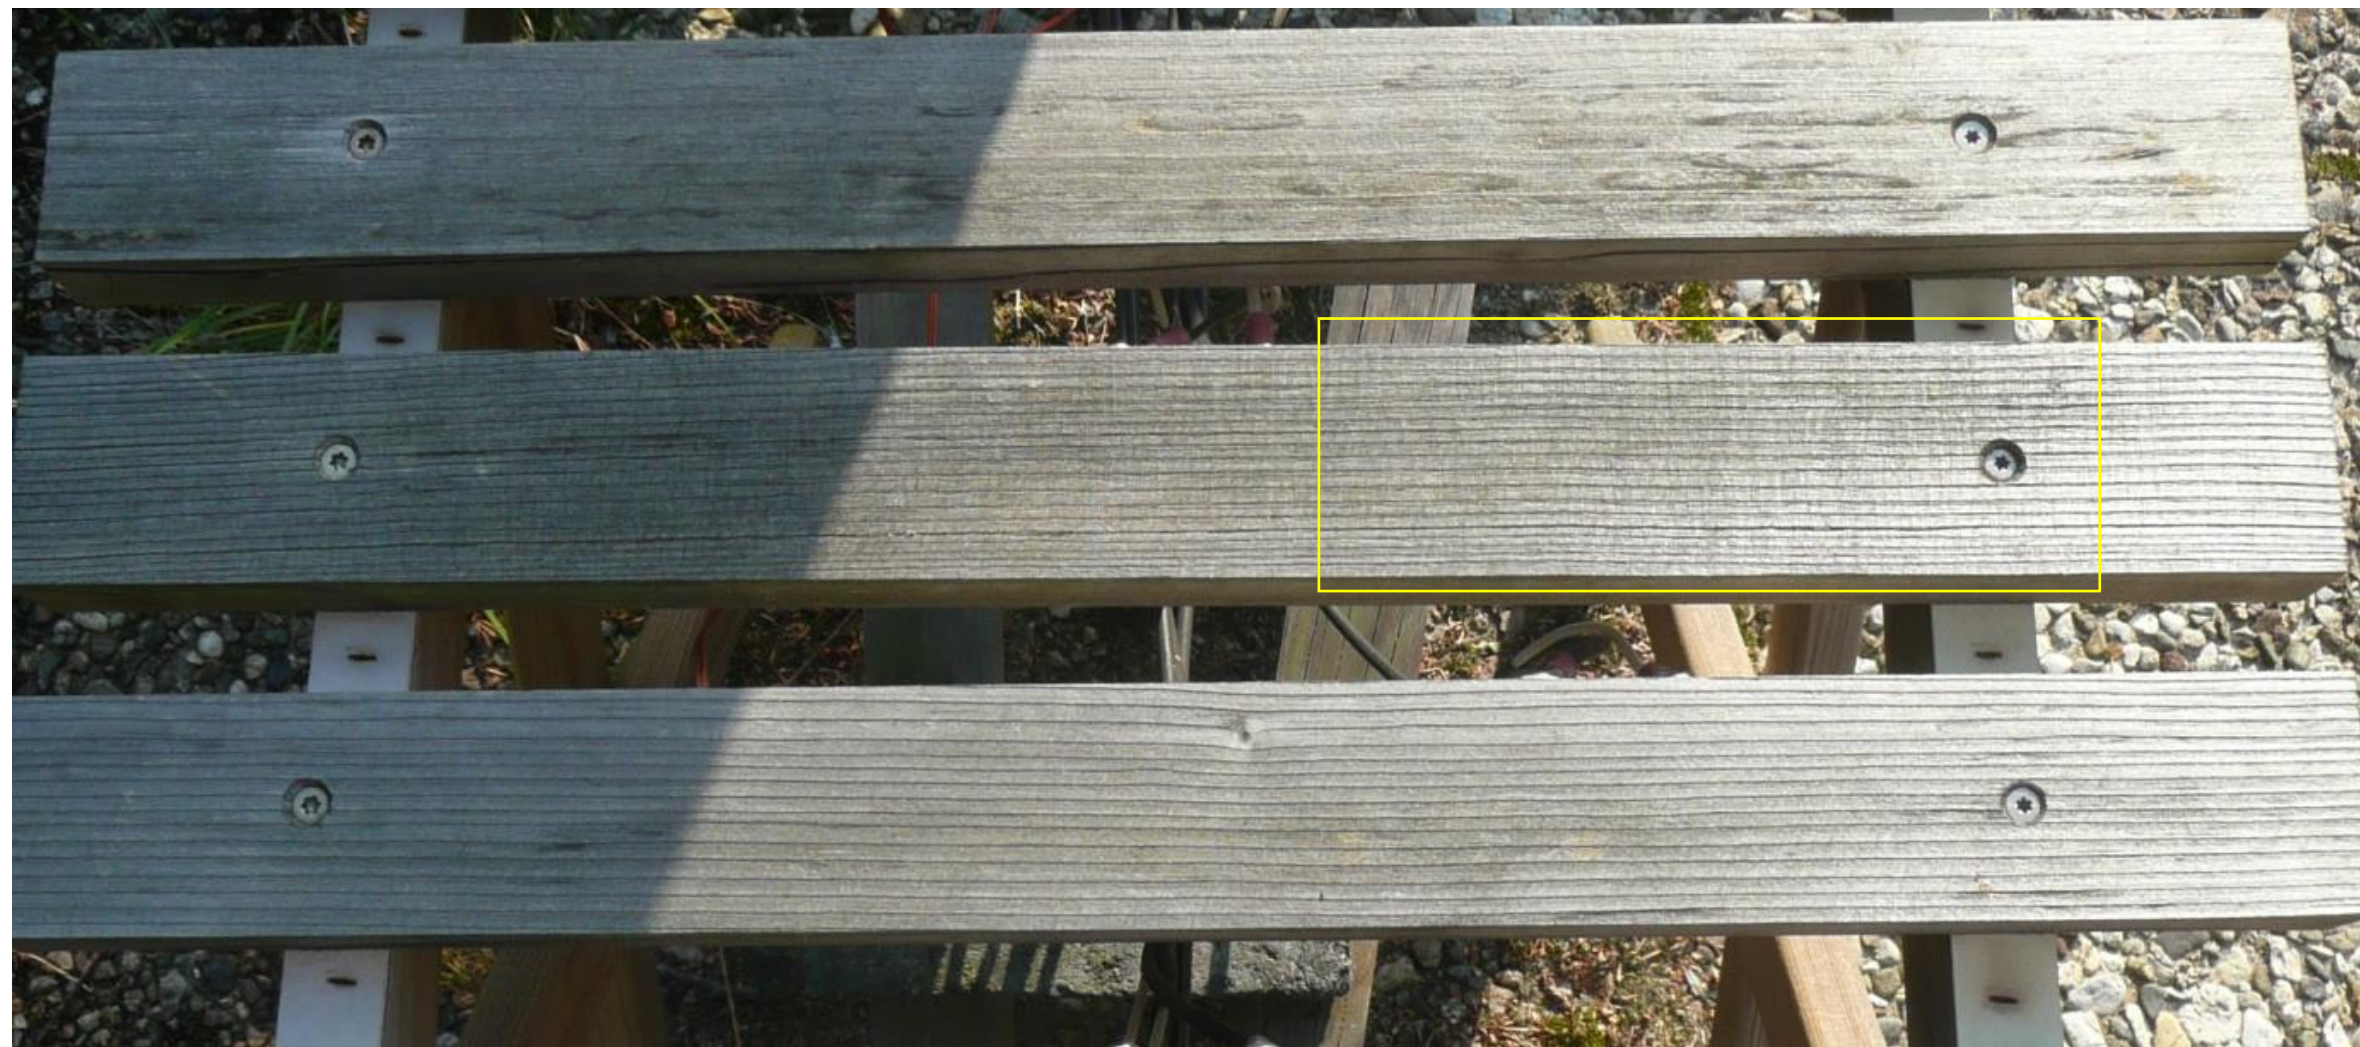
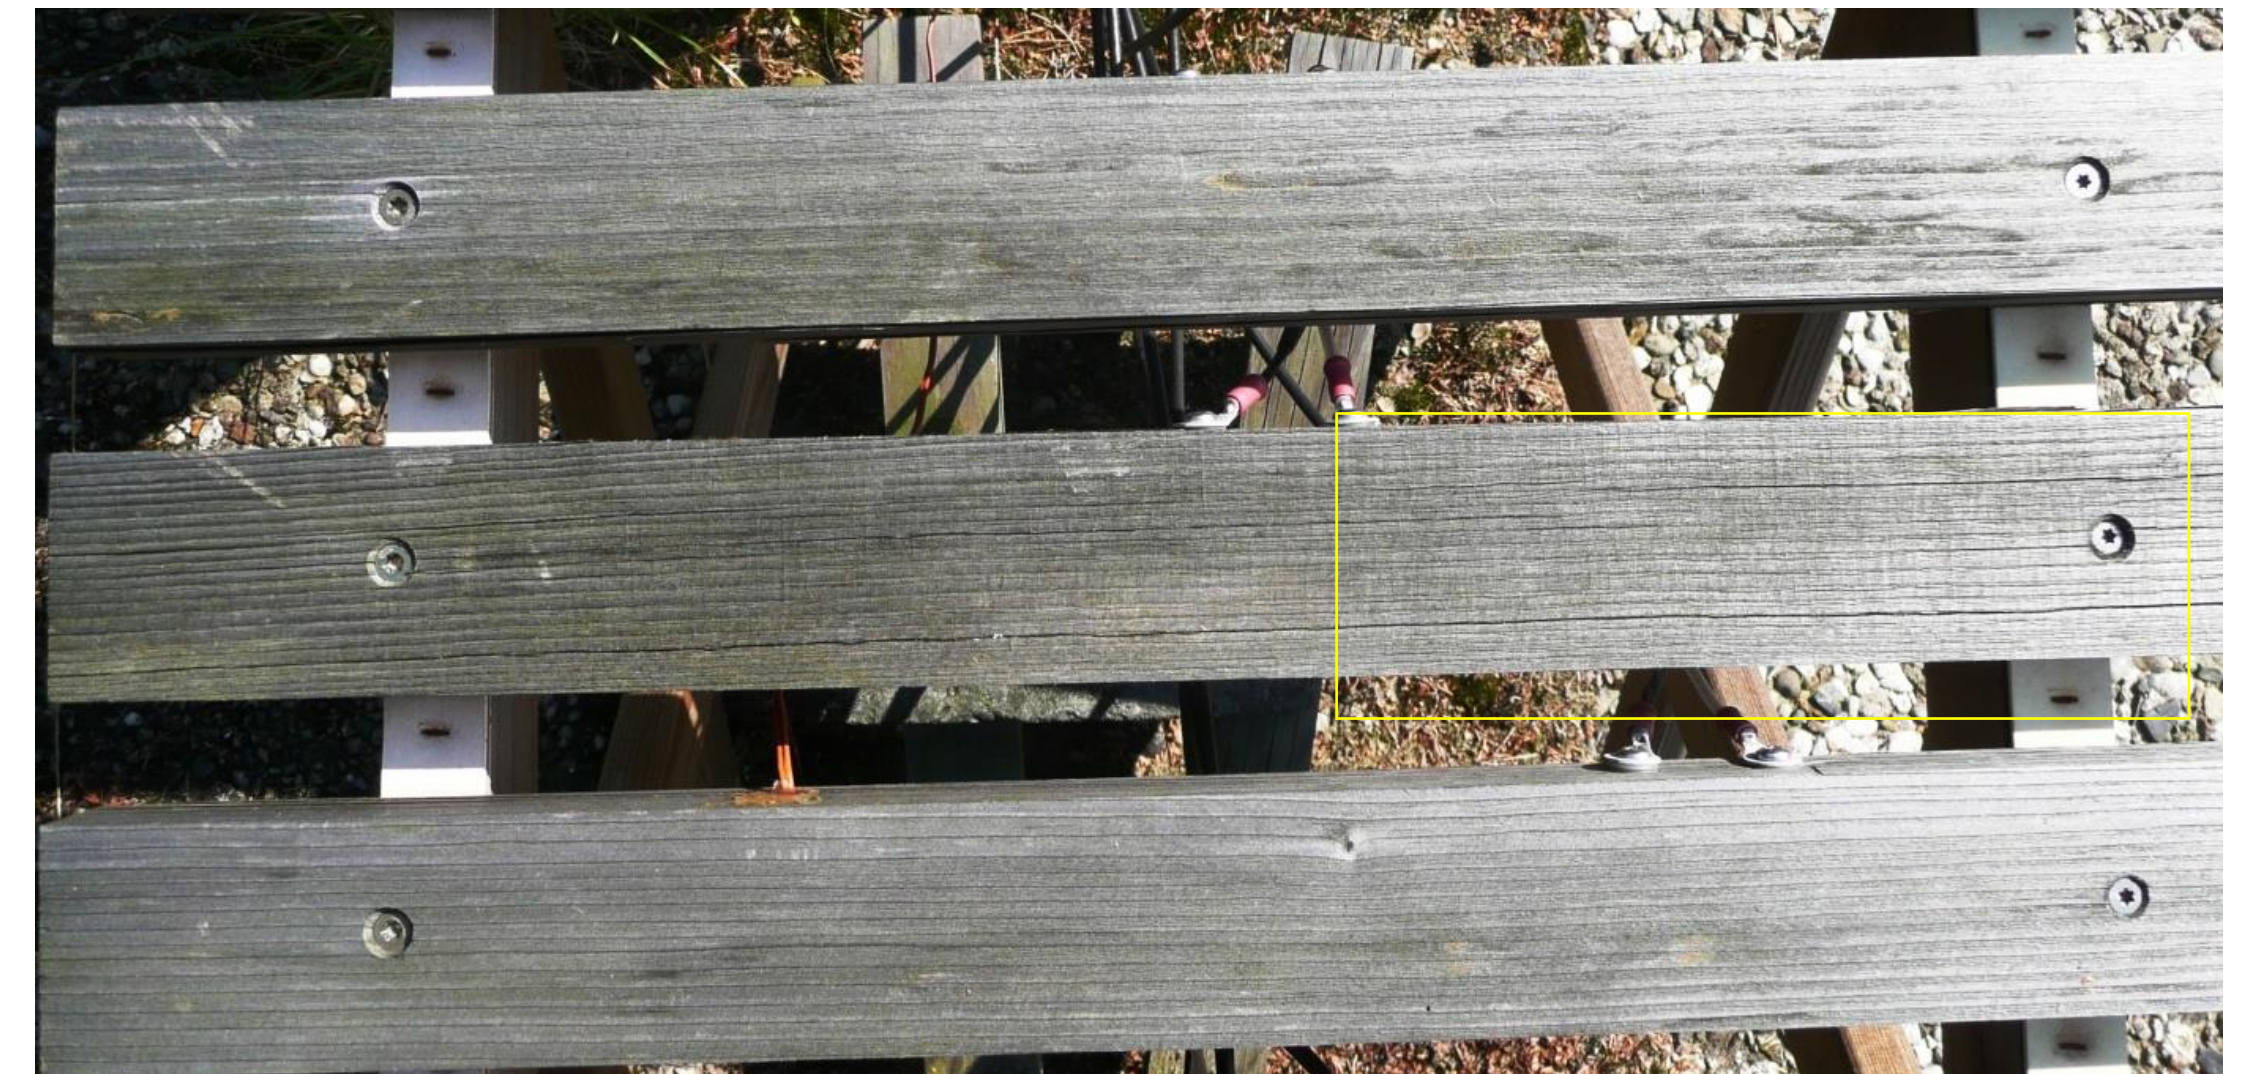
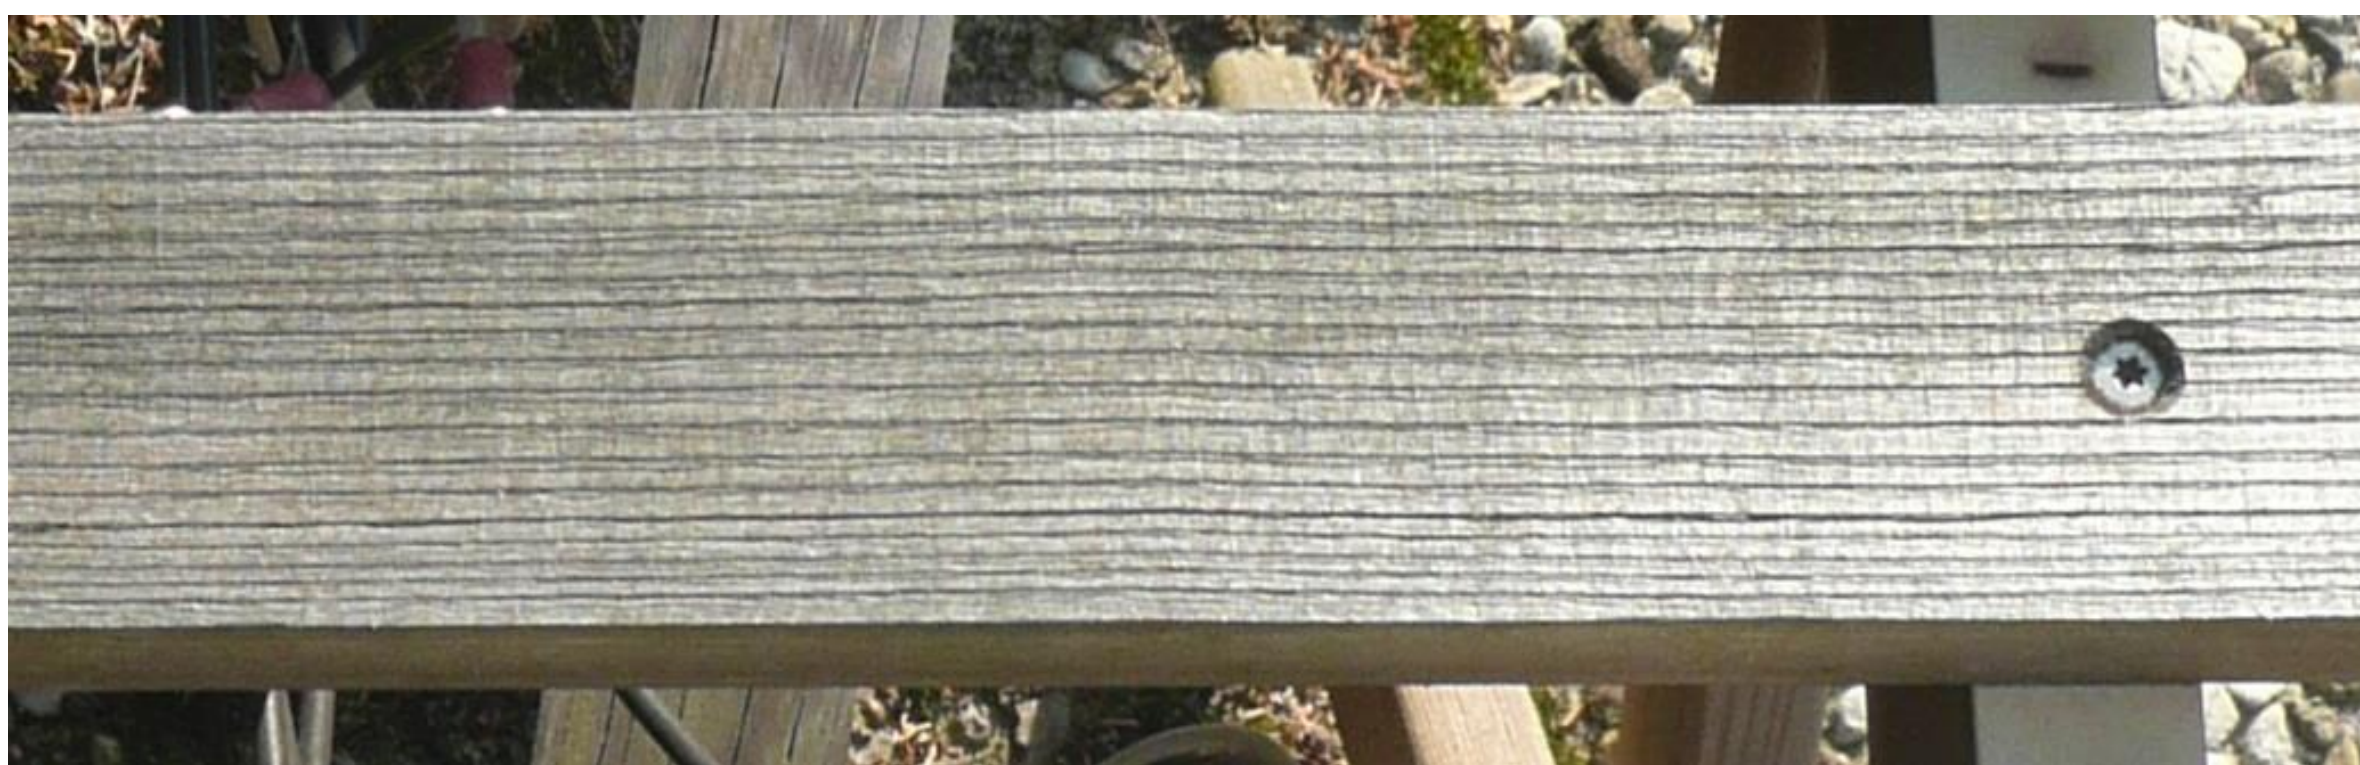
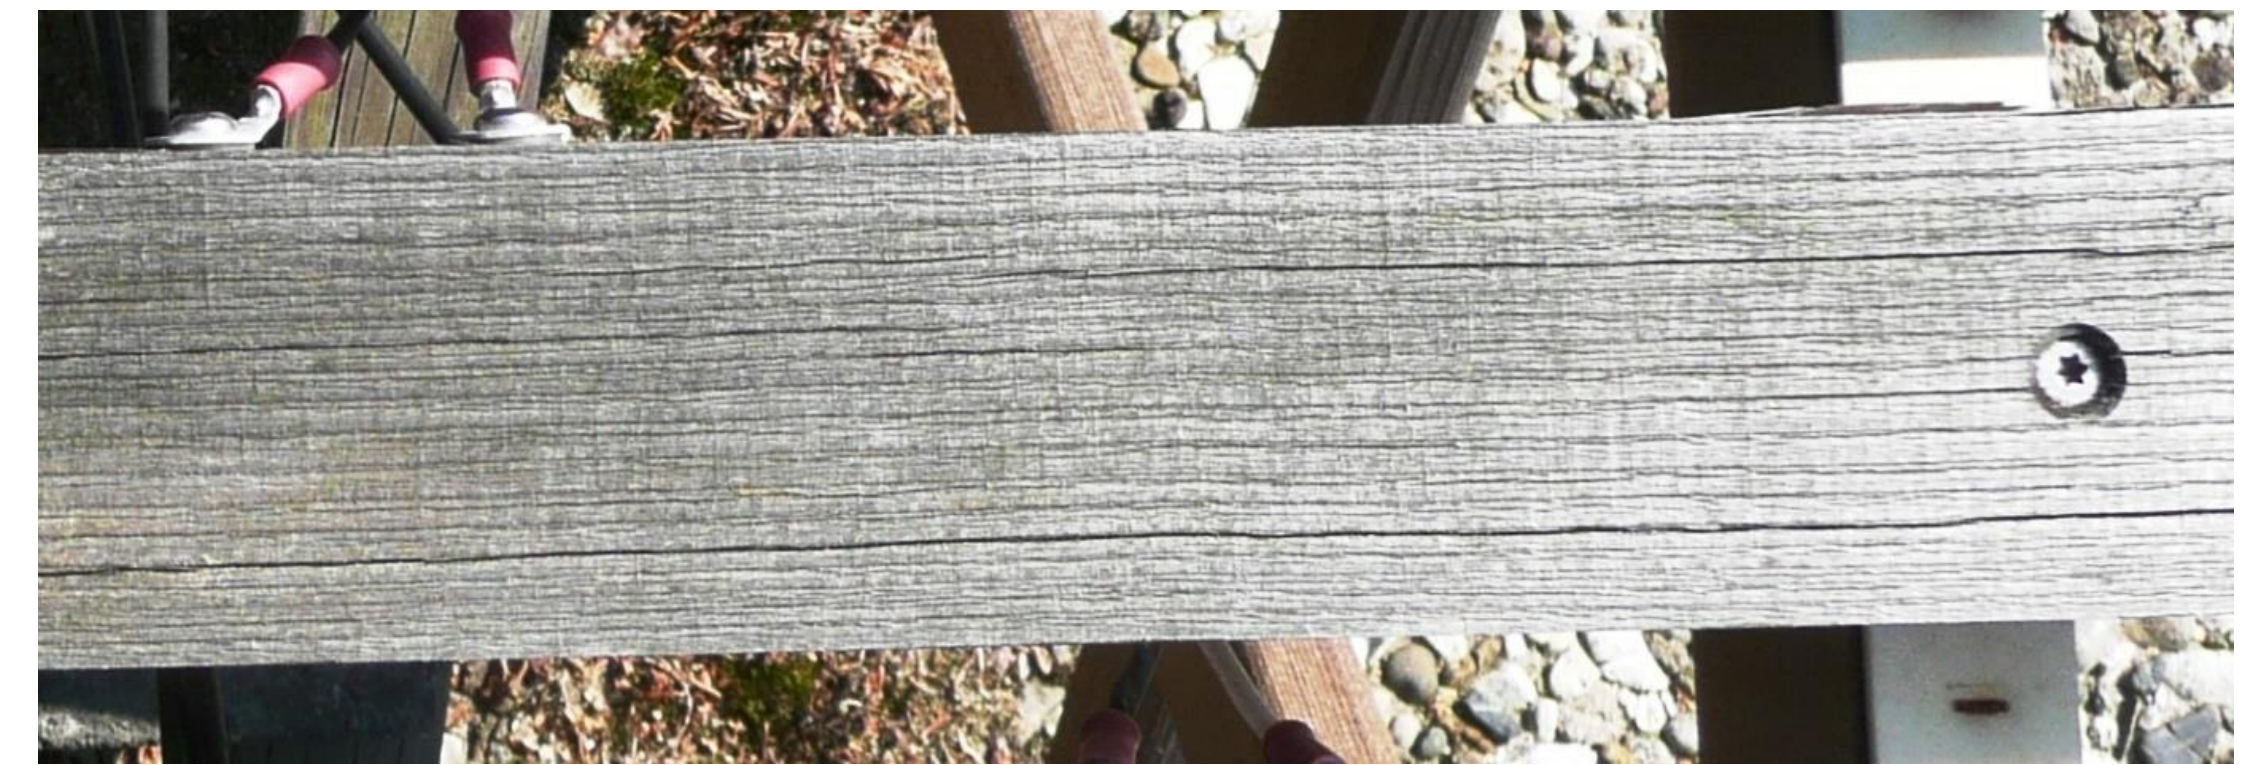
Results - Crack formation vs. time - Hamburg

TMT specimens at **11:30 am; 8th of September 2016**
