COST FP 1303 Cooperative Performance Test – Results after two years outdoor exposure

COST FP1303 meeting - Sofia, 28.2.-1.3.2017

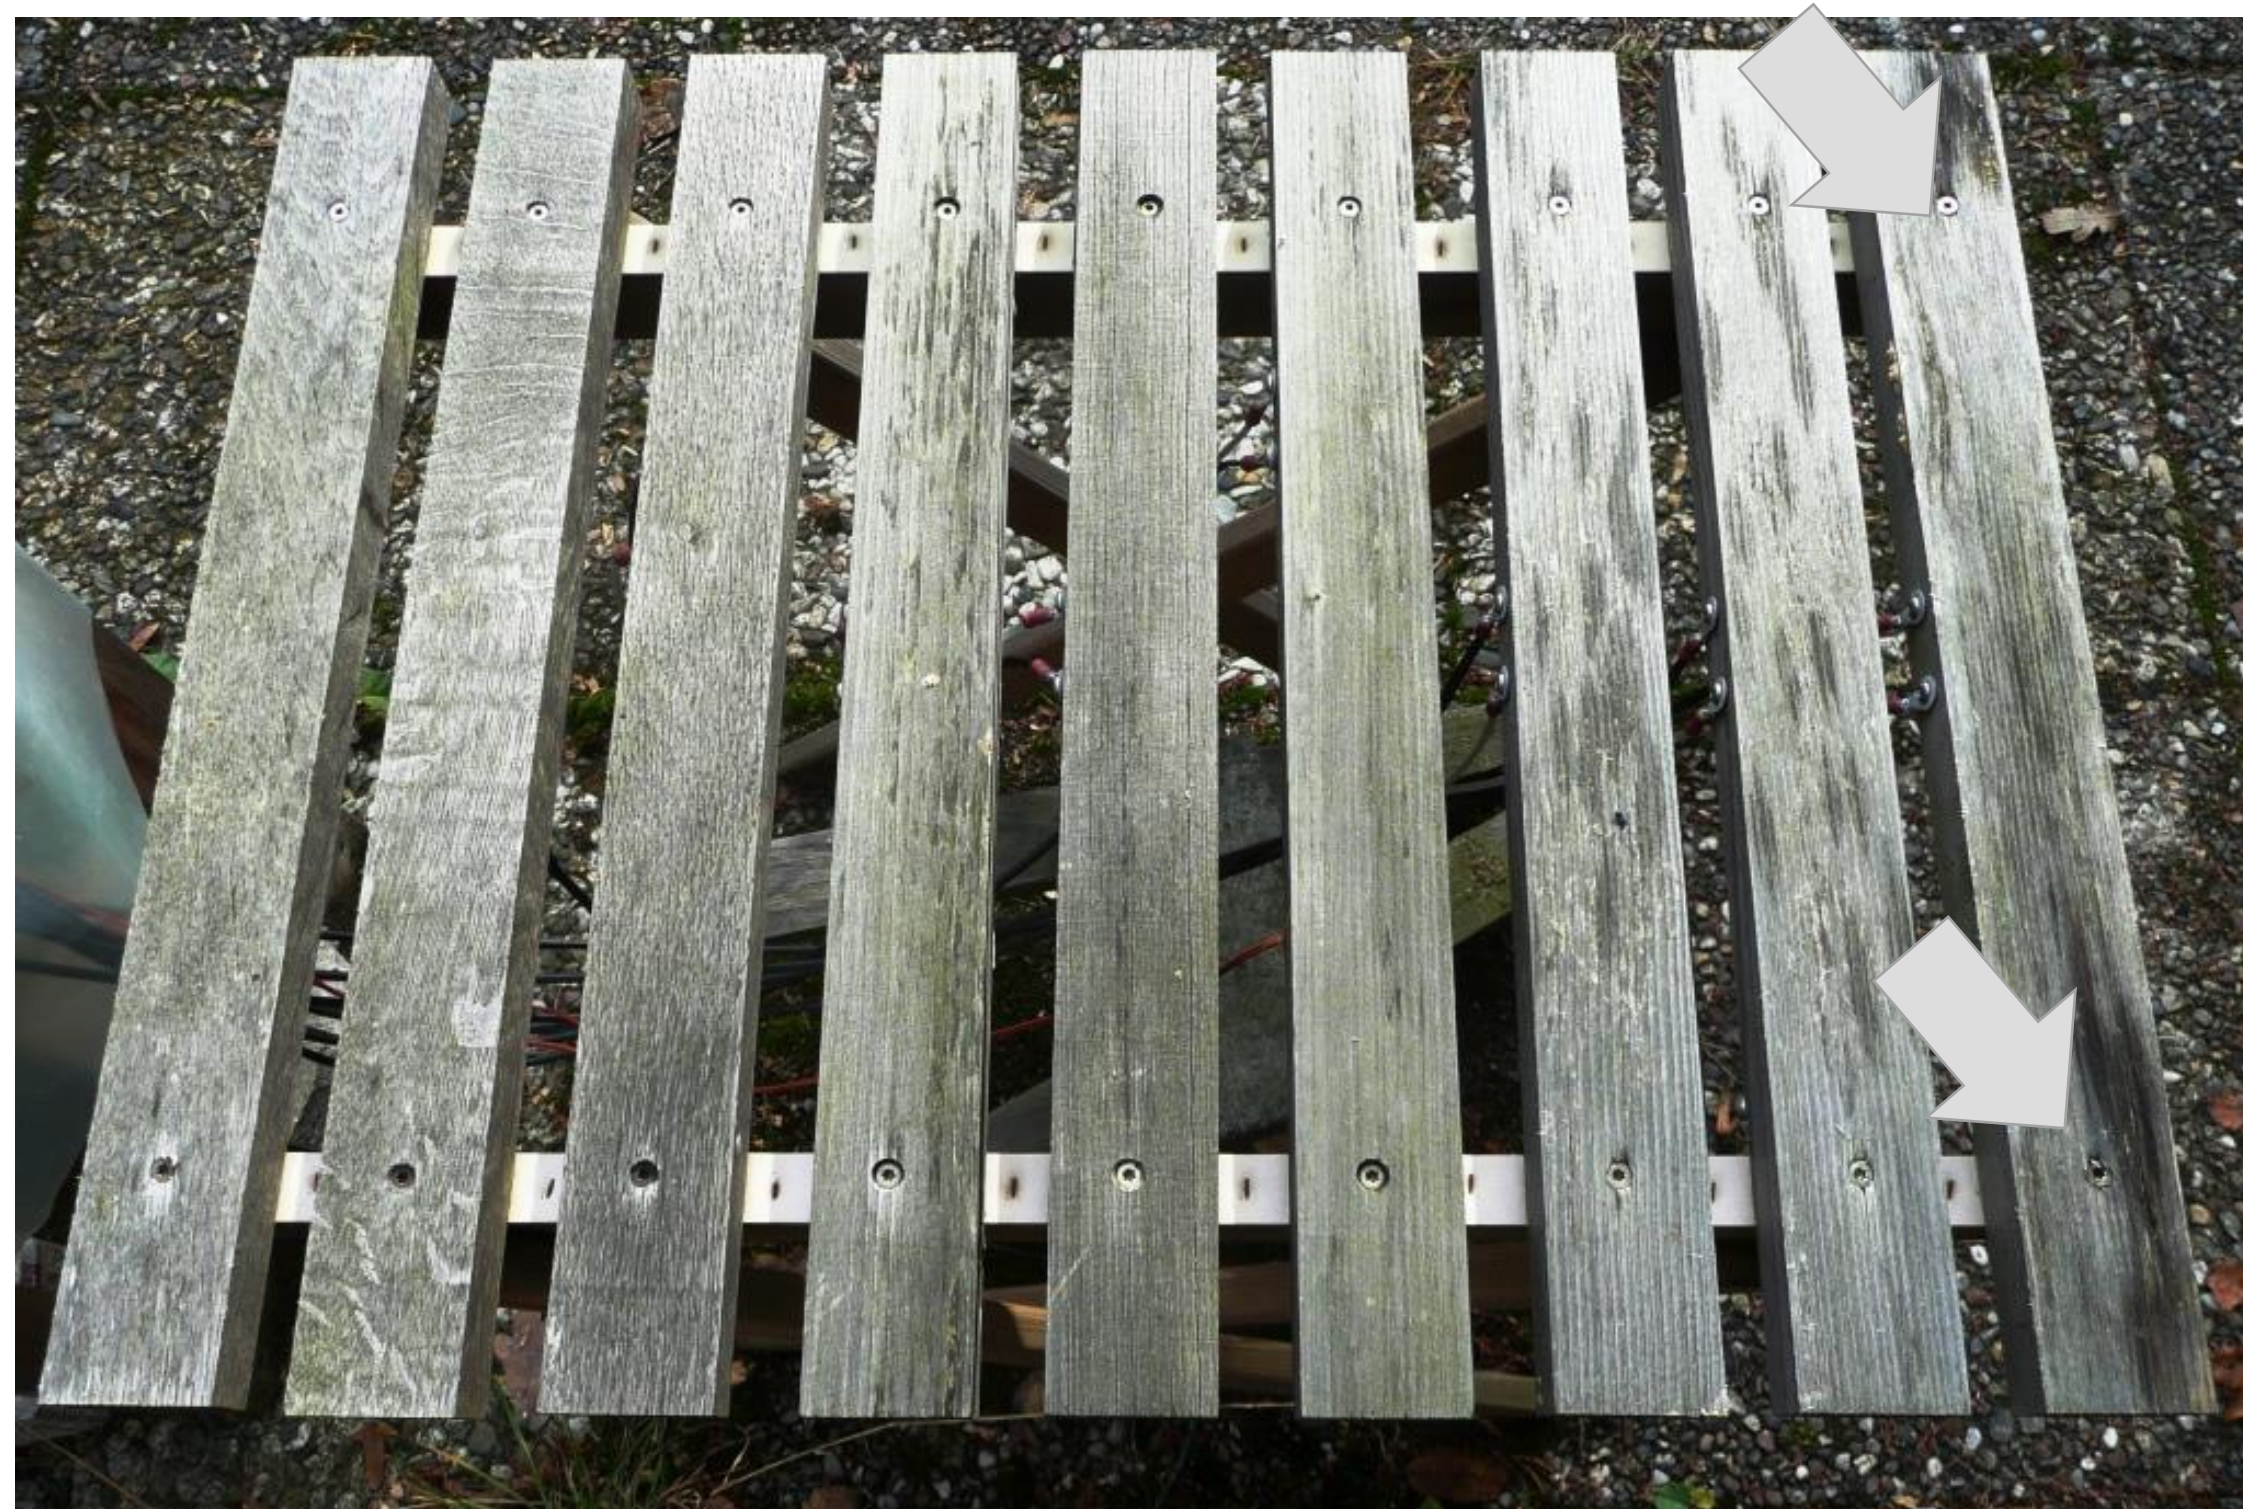
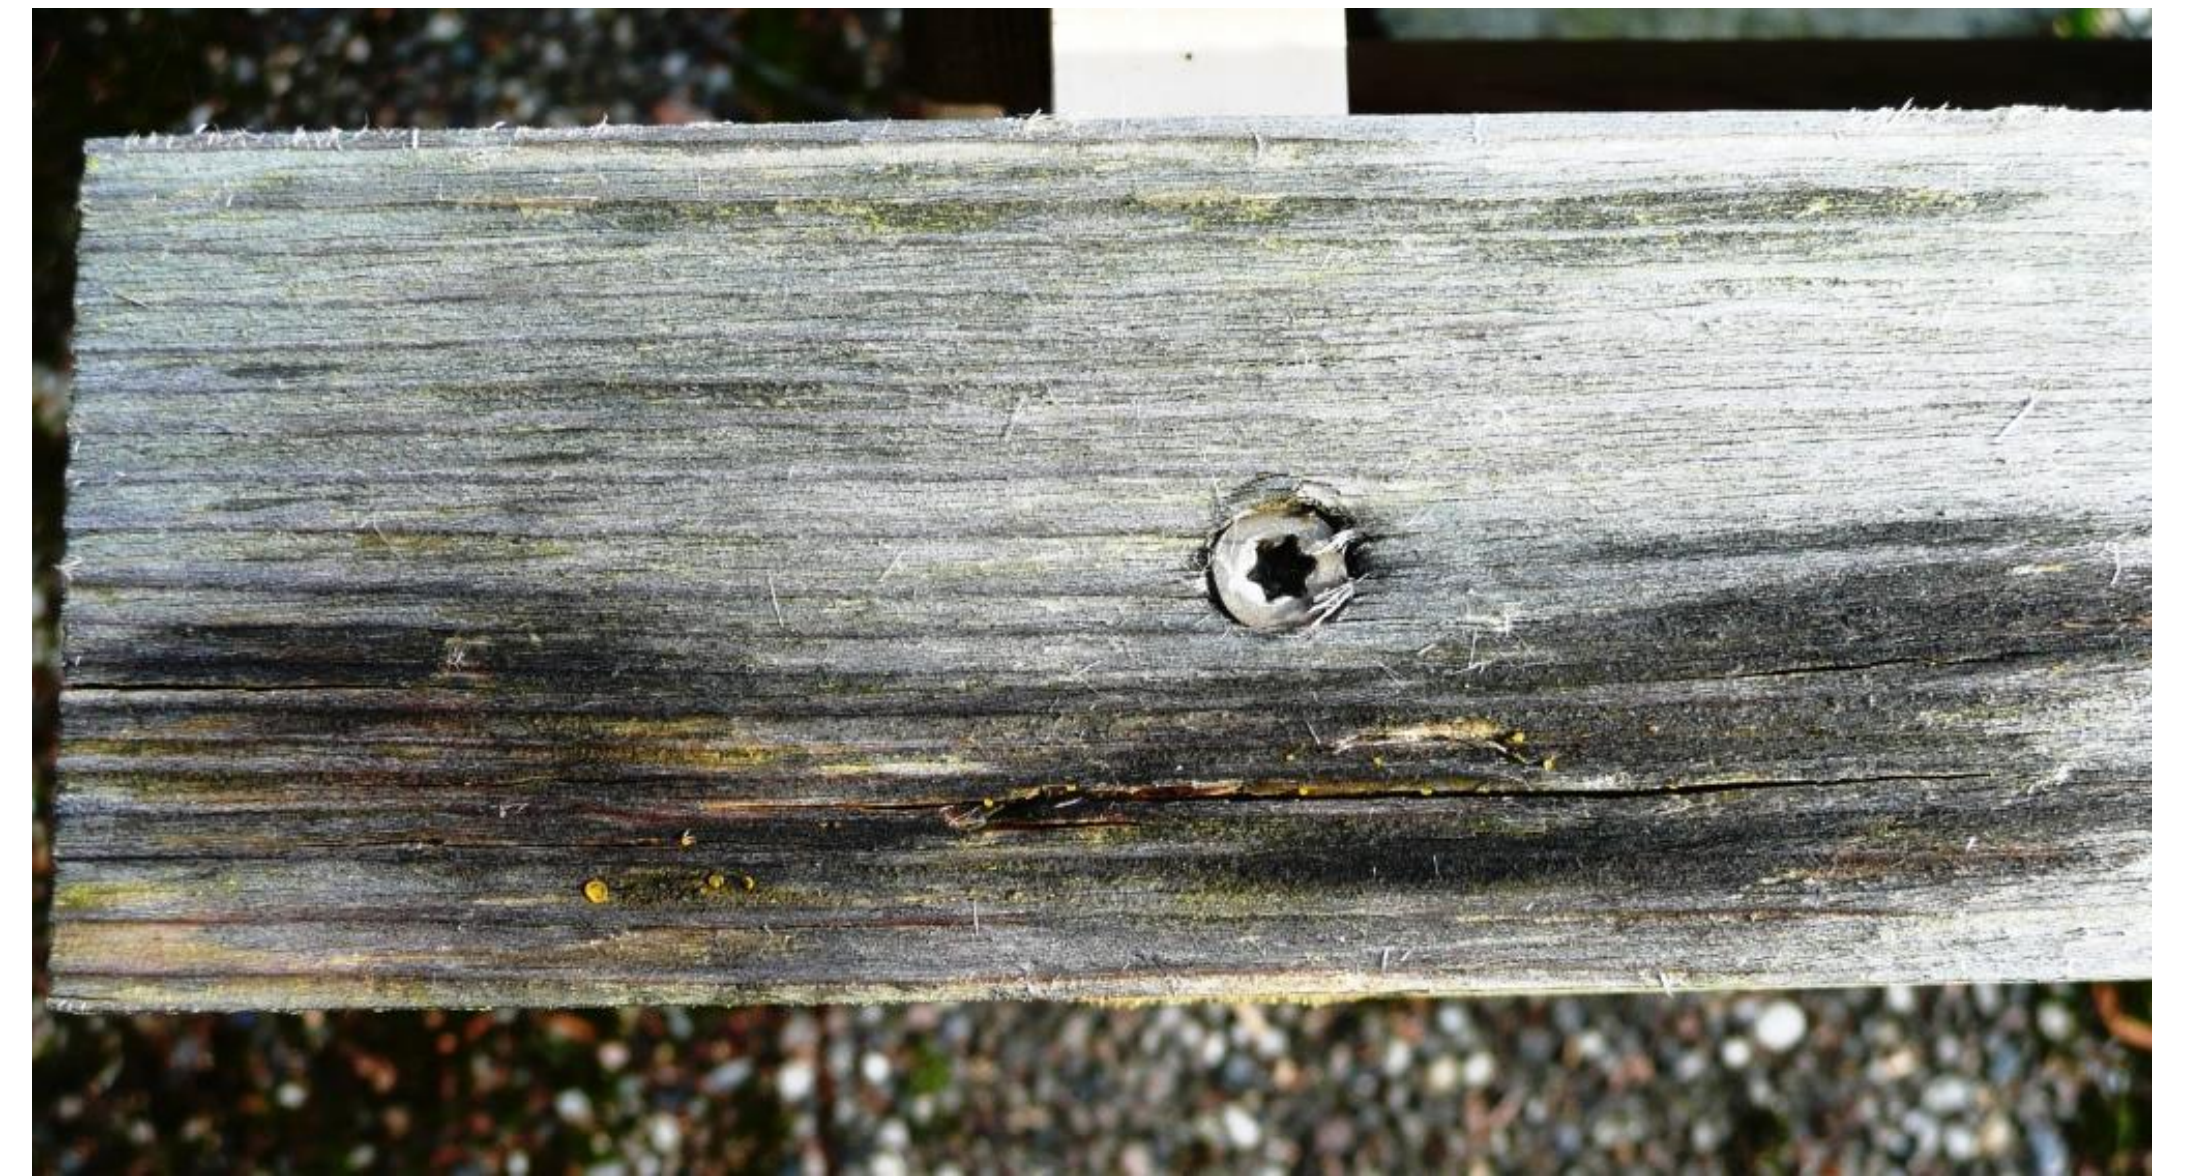
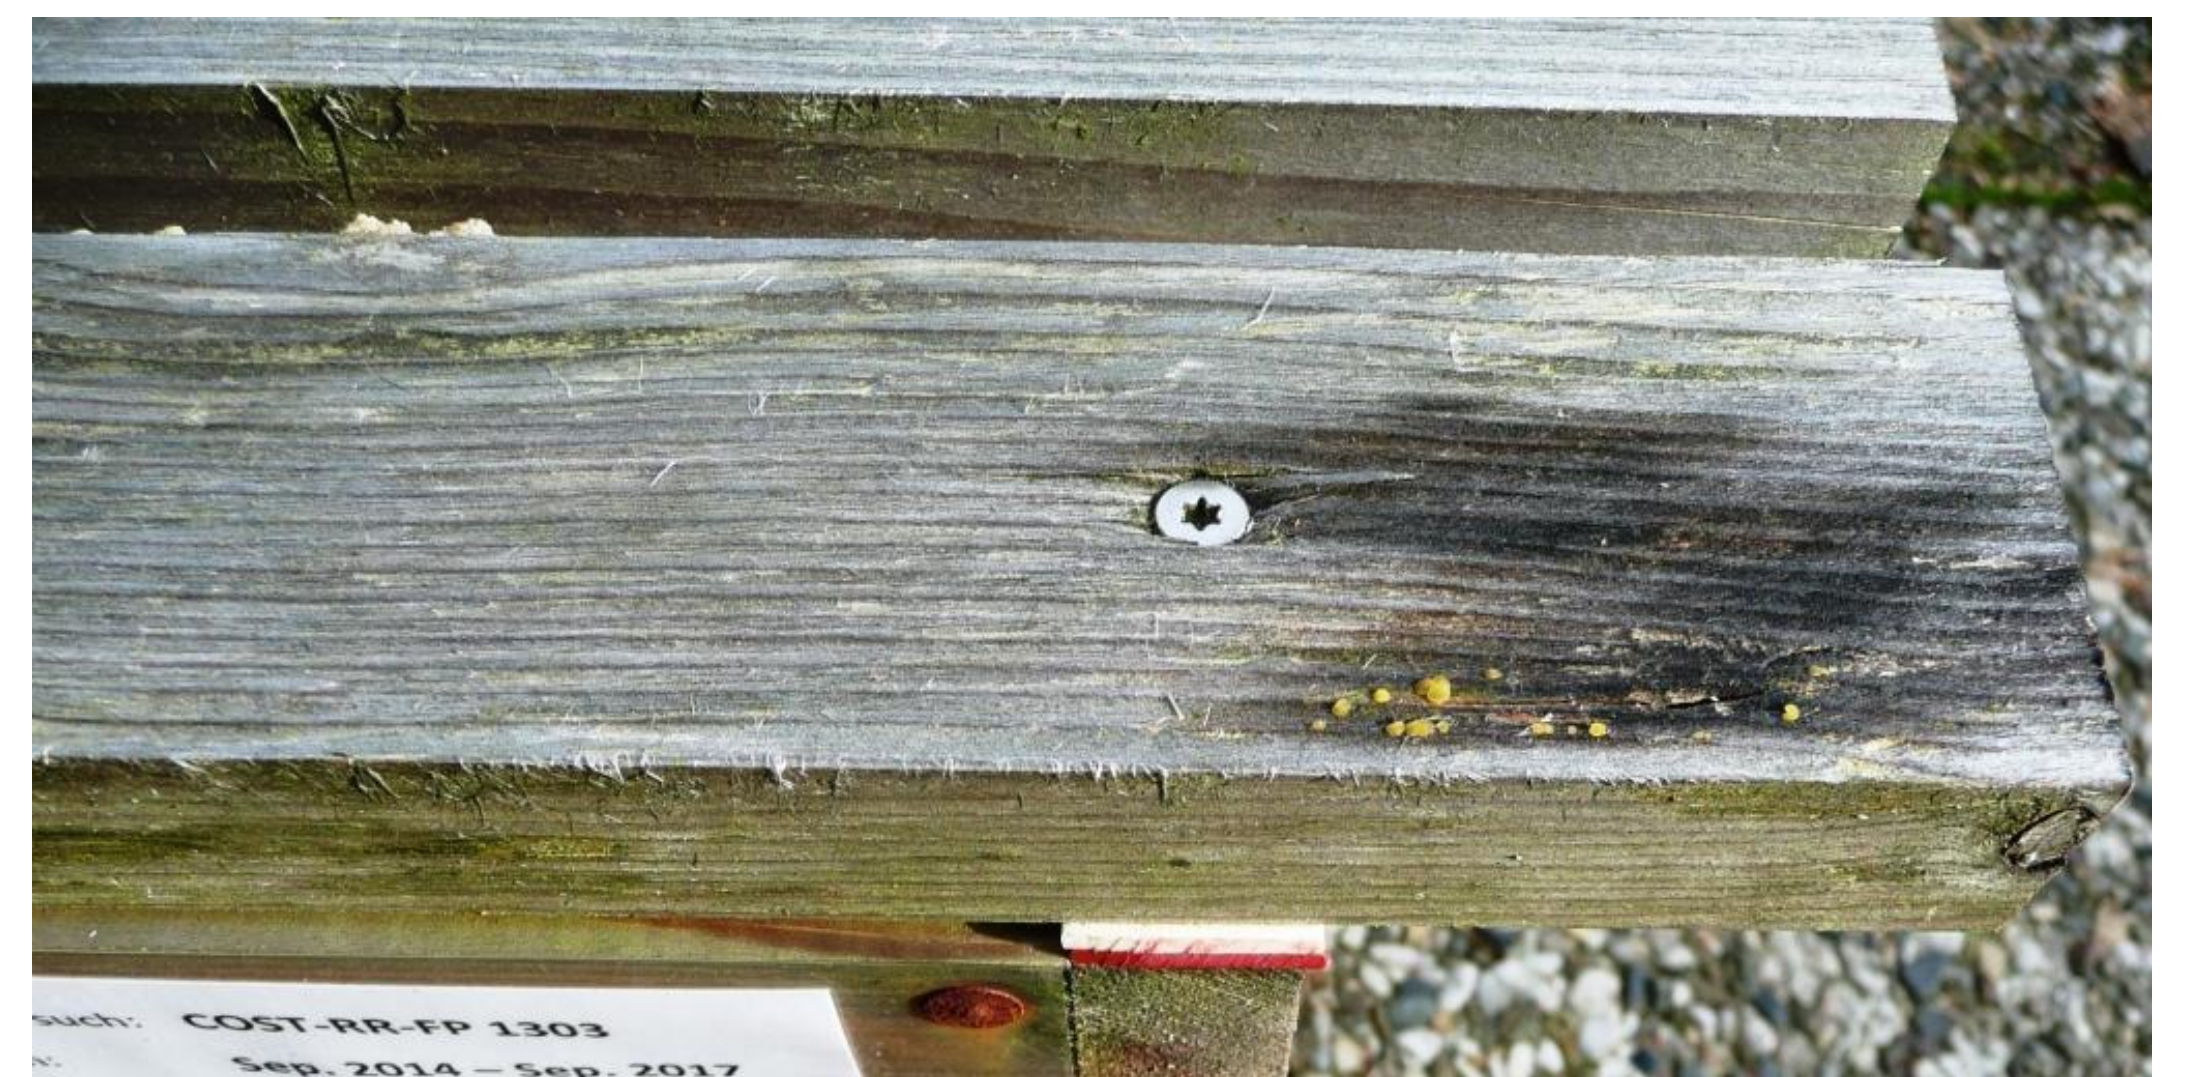
Results - decay Norway spruce in Hamburg

- Only in Hamburg (Photos from novembre 2016)
- Norway spruce and fir specimens

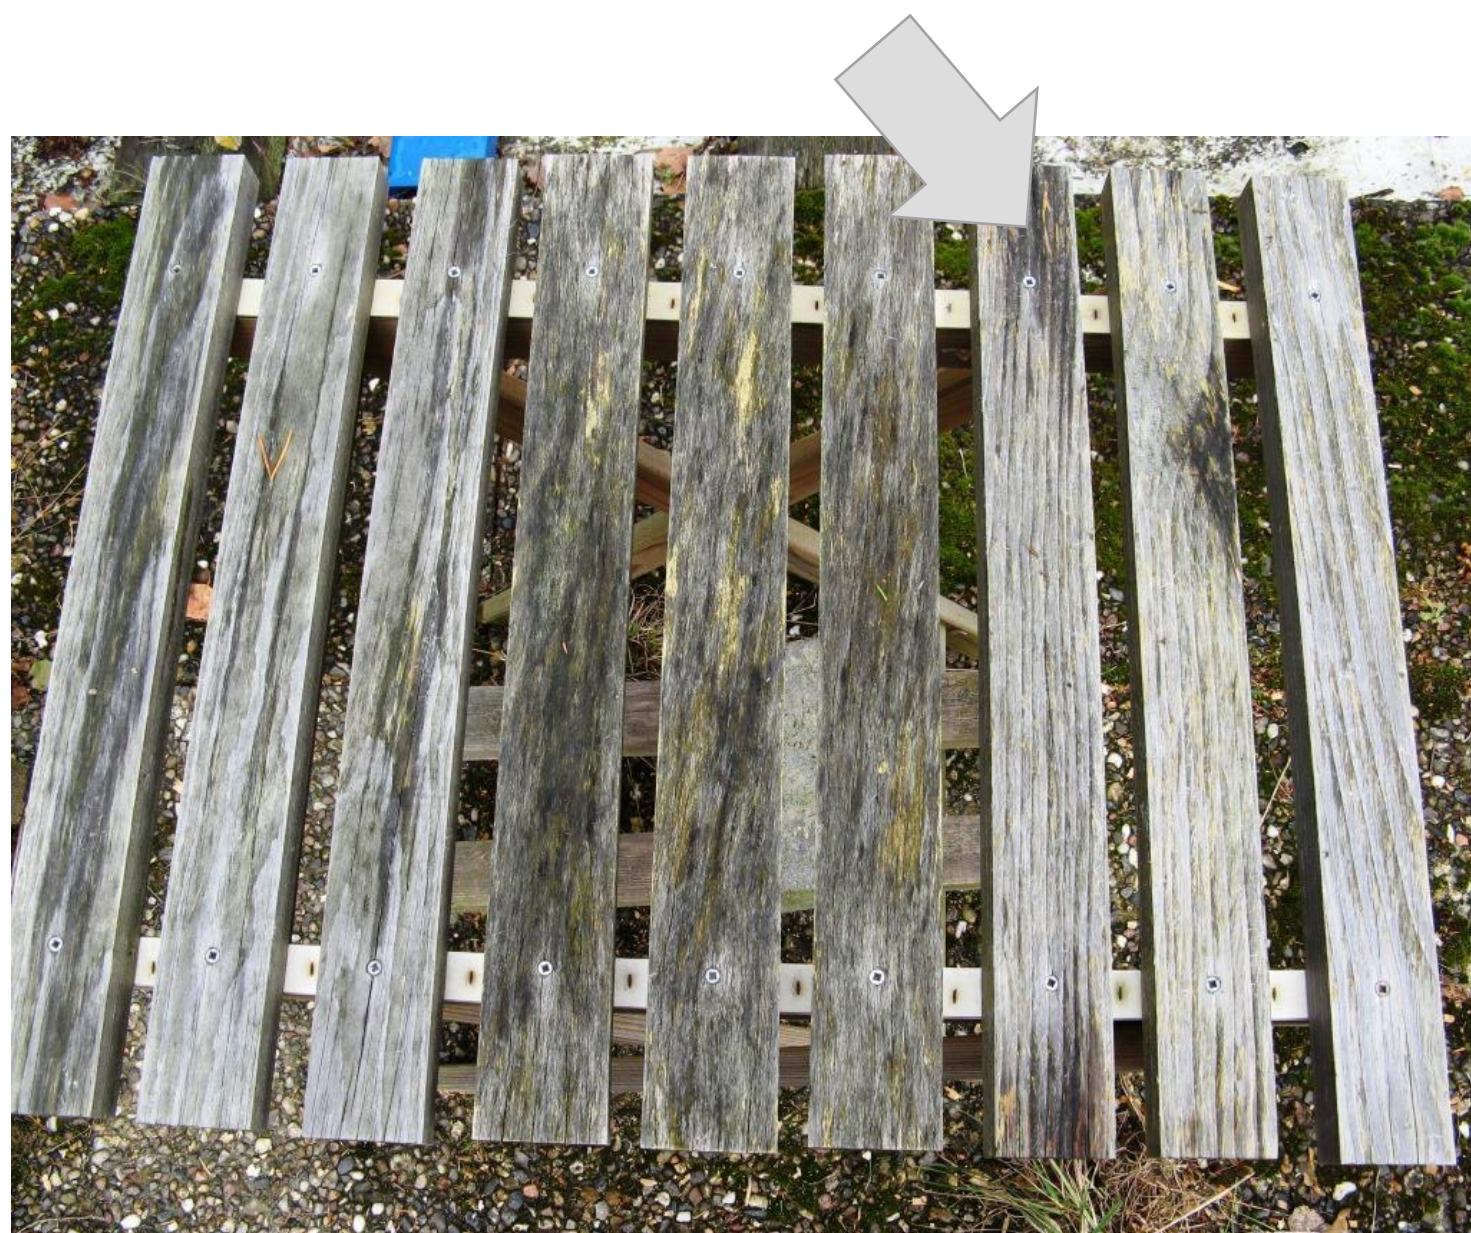
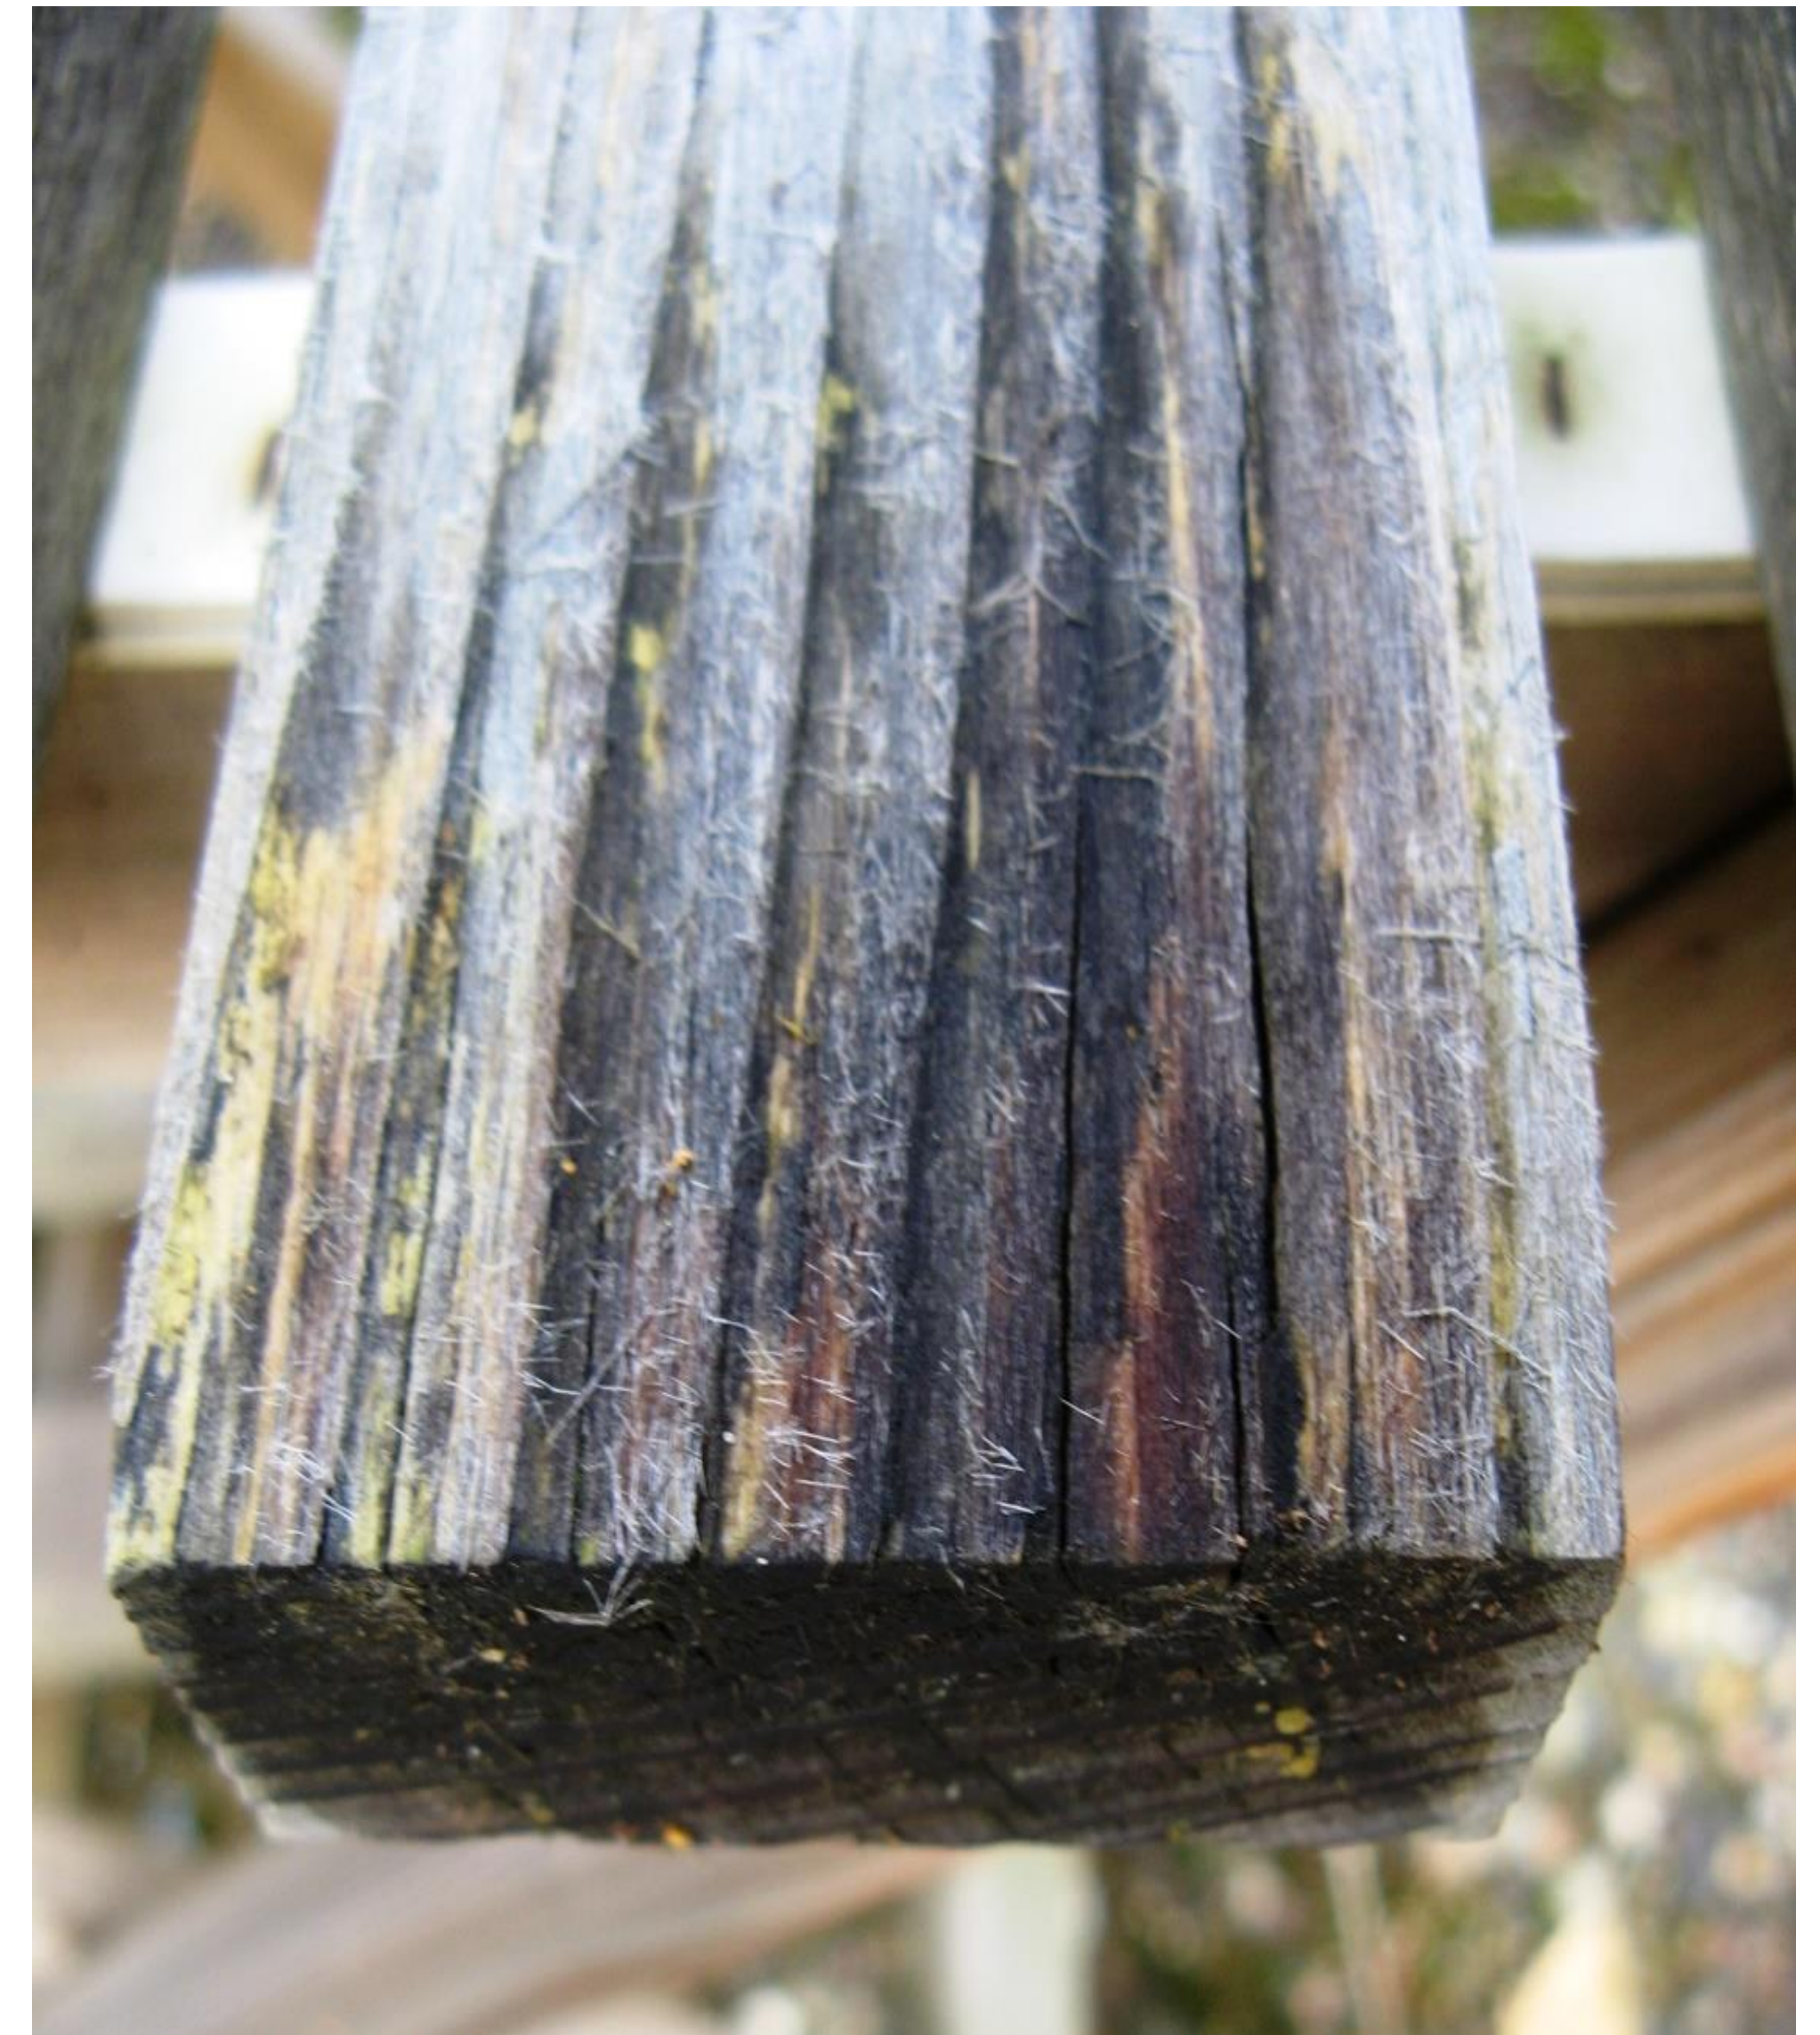
Results – decay of Fir in Hamburg

- Only in Hamburg (Photos from novembre 2016)
- Fir hardwood specimen with fruit bodies of *Dacrymyces* spp. s
