Deterioration of thatched roofs – moisture and temperature monitoring in a cold roof museum

C. Brischke, T. Bornemann, A.O. Rapp

Leibniz University Hannover

*COST FP 1303 Workshop
Tallinn [Estonia]
04-05 March 2015*

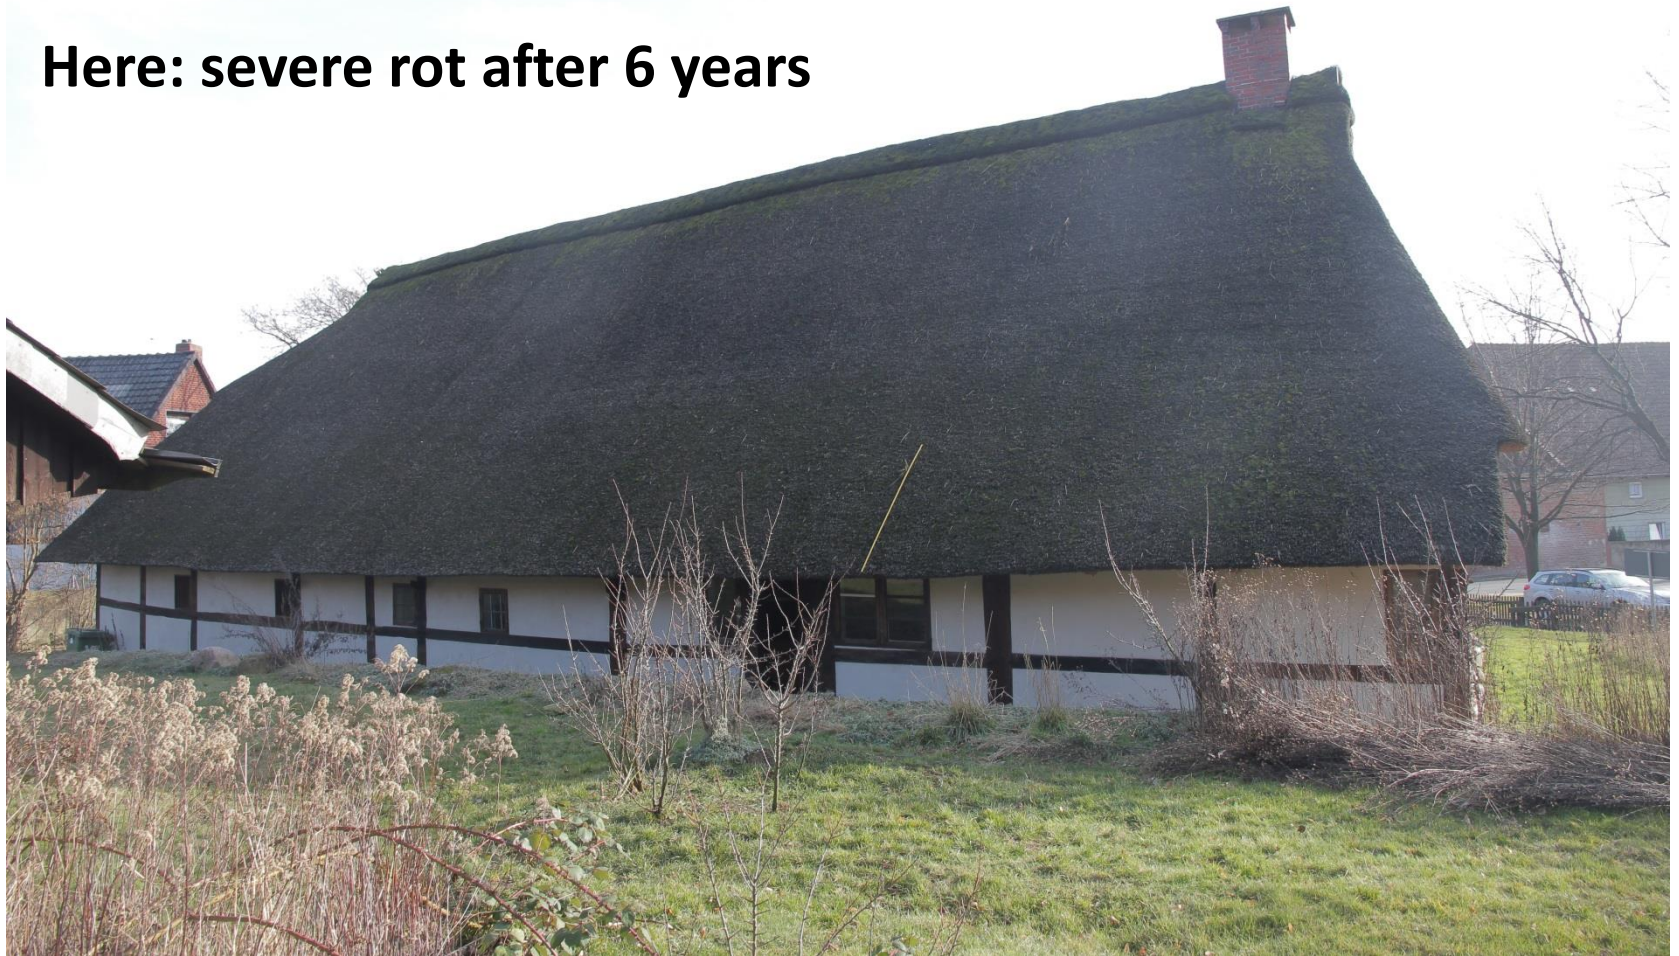
Premature failure

Desired/Expected service life = 30-40 years

Here: severe rot after 6 years

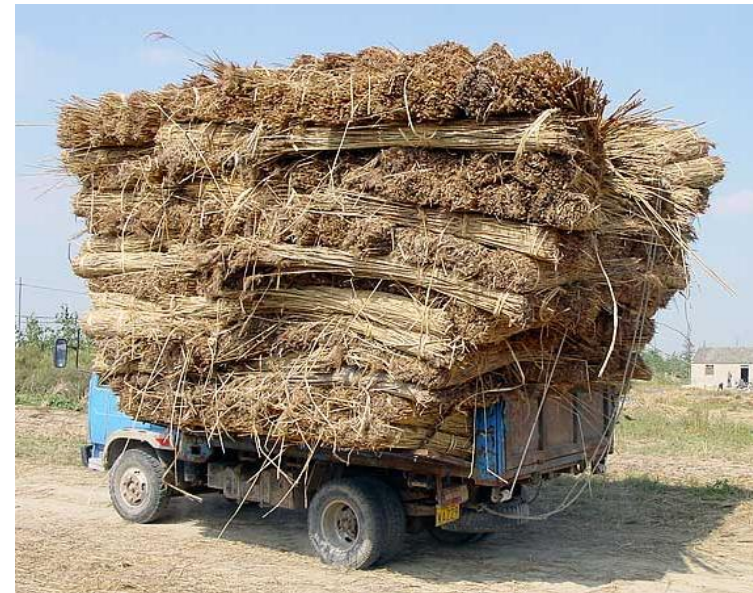
Potential reasons

- Increased amount of imported reed (low quality)
- Newly introduced pests
- Disadvantageous conditions of harvest and storage
- Increased number of warm roofs (insulated attics)
- Emissions from cattle-breeding farms

→ most likely a complex!

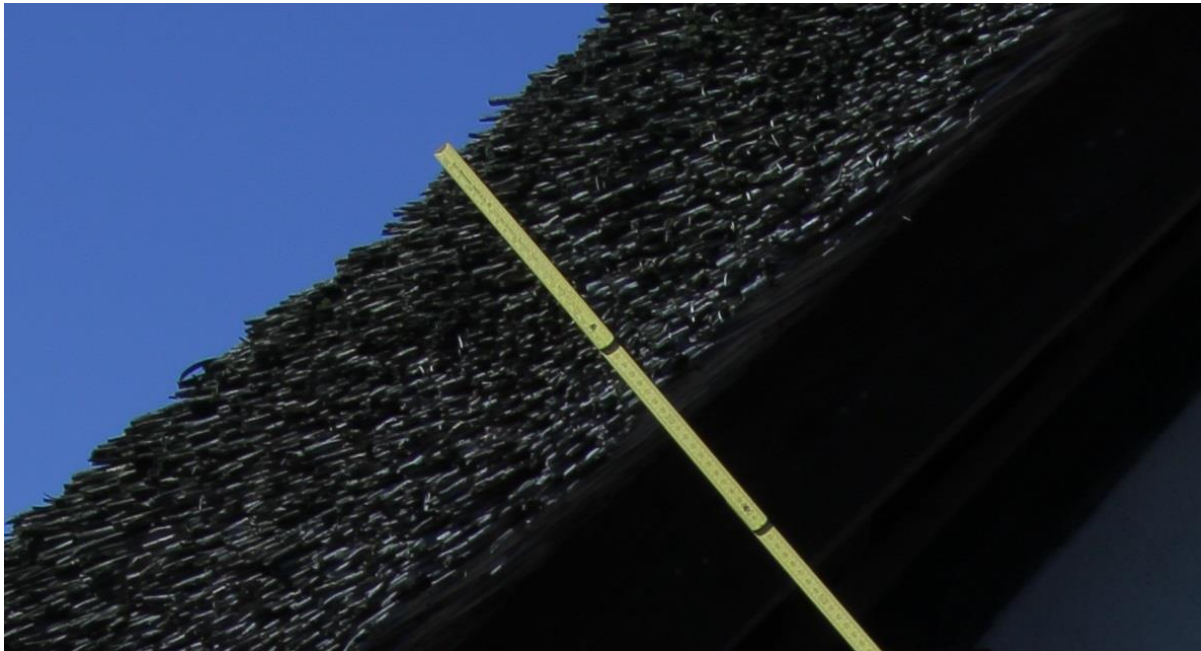
- Reed layer: 290 mm thickness
- Moisture monitoring at different depths
 - 35, 70, 105, 140, 175, 210 mm

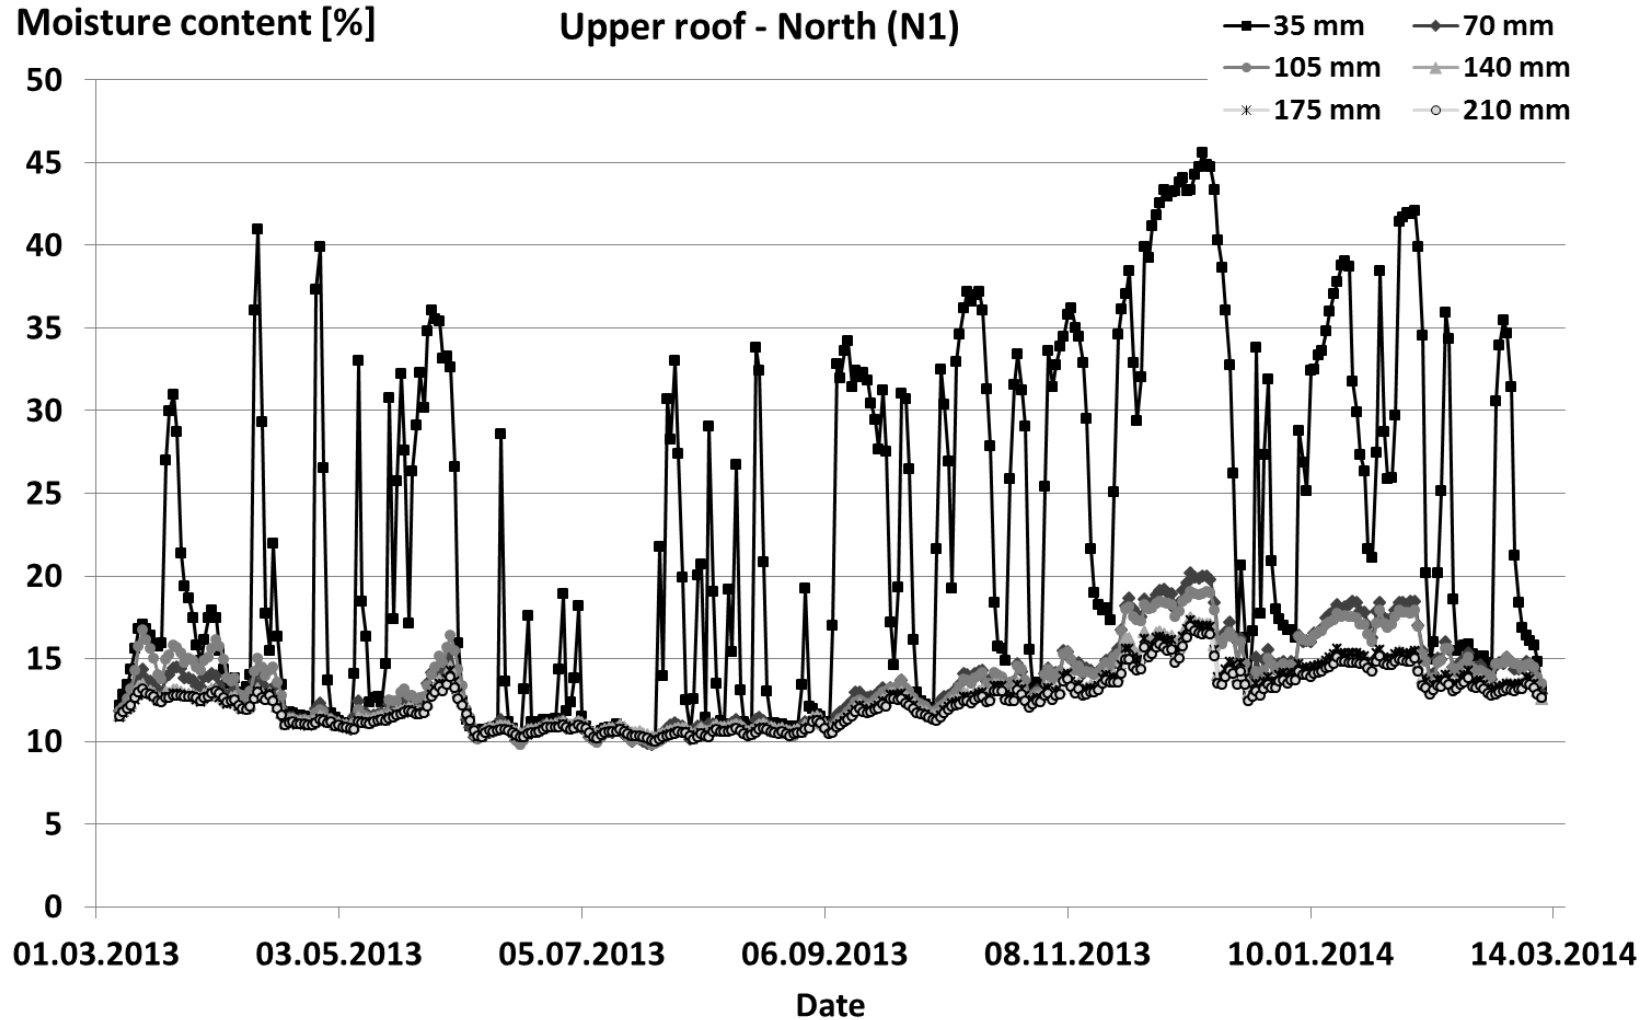
Results – Moisture monitoring

- Highest moisture loads on outer layers of North roof
 - plus severe rot, and superficial growth
- Algae and mosses:
 - Cause or consequence of high MC?
- High MC where roof pitch turned from steep to flat
- Reason for premature failure not clearly identified
 - Further analysis needed!
 - Initial reed quality?
 - Storage conditions?
 - Pests? Preinfection?
