Performance of thermally modified timber in use class 3.2

Dipl.-Ing. (BA) Philipp Flade

Institut für Holztechnologie Dresden gemeinnützige GmbH (IHD)

1st COST FP1303 Conference 23.-24.10.2014

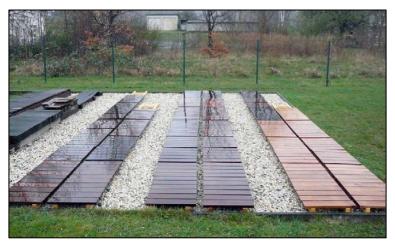
outdoor test field of IHD

- exposure: use class 3.2
 - orientated to south
- artificial + natural weathering
- monitoring of crack formation

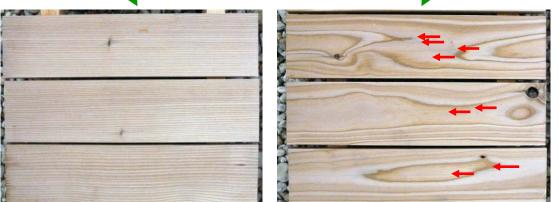
more radial surface cracks

spruce TMT, lying rings

spruce TMT, standing rings

annual ring arrangement (example: spruce TMT)
