COST FP1303

February 24-25.
Madrid, Spain

Comparison of a new and a 40 years old robinia glued-laminated
load bearing element

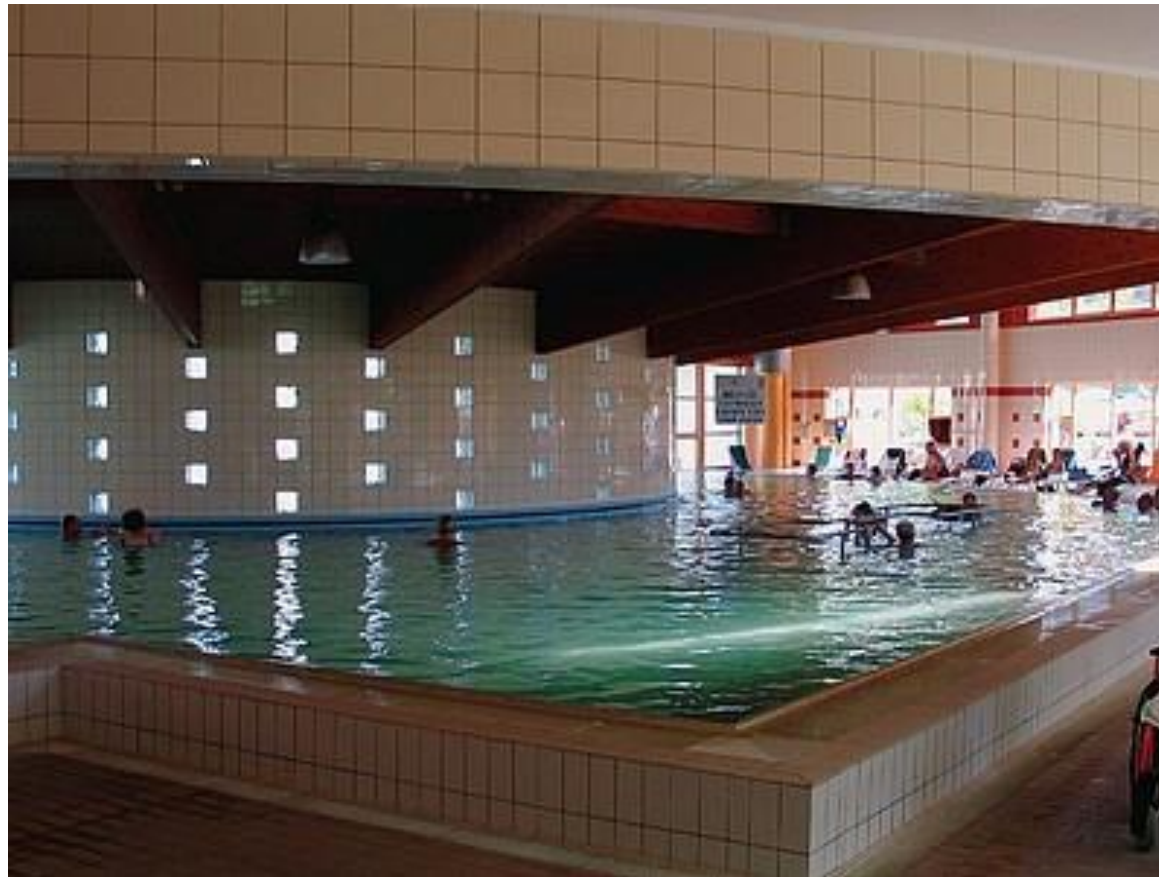
Robinia glulam elements in the spa of Harkány (Hungary)

- The topic of this research was the comparison of the delamination and mechanical properties of a new and a 40 years old robinia glued-laminated load bearing element.
- The old element was manufactured in 1974 by the firma Agrokomplex and it was used in the spa in Harkány (Hungary) until 2014.
- The exposure during the utilization of the old element was quite high, as it was working under highly moist conditions. It was exposed in this environment also to dissolved salts in the thermal water.

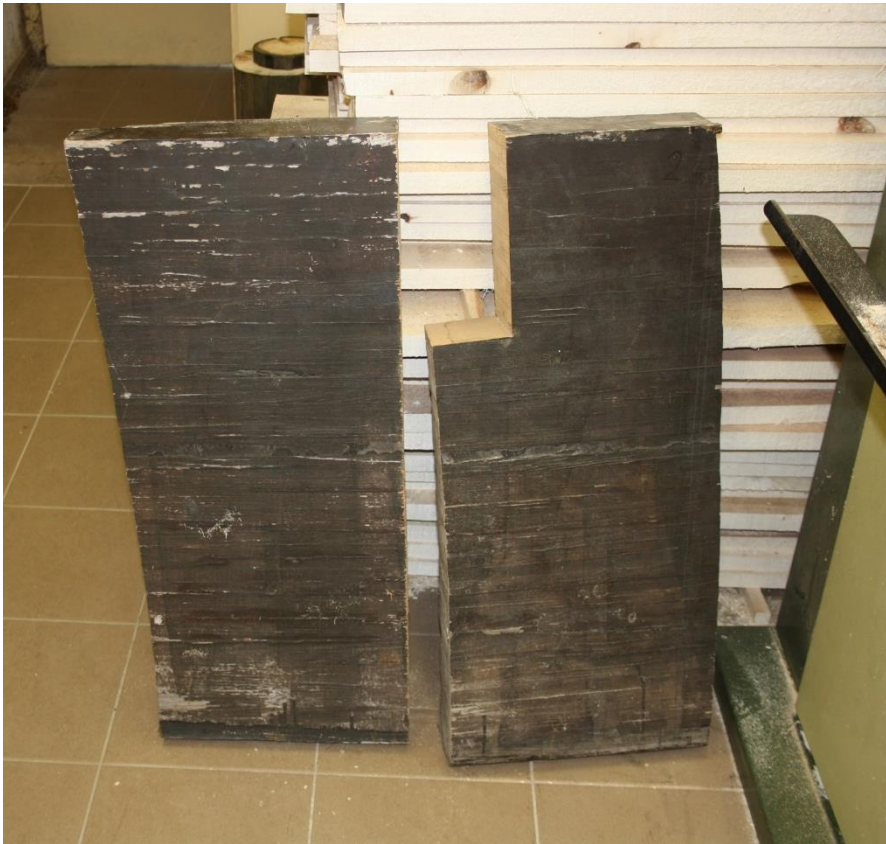
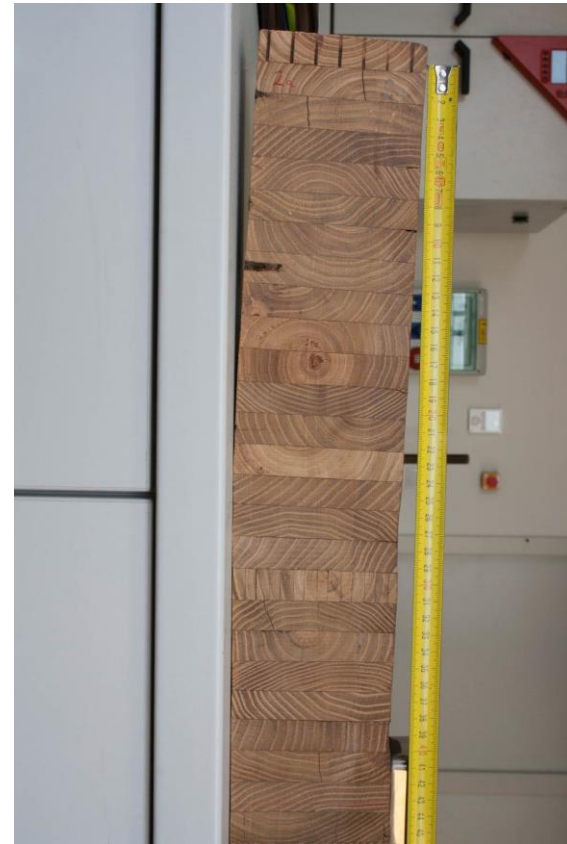
Piece of the 40 years old element

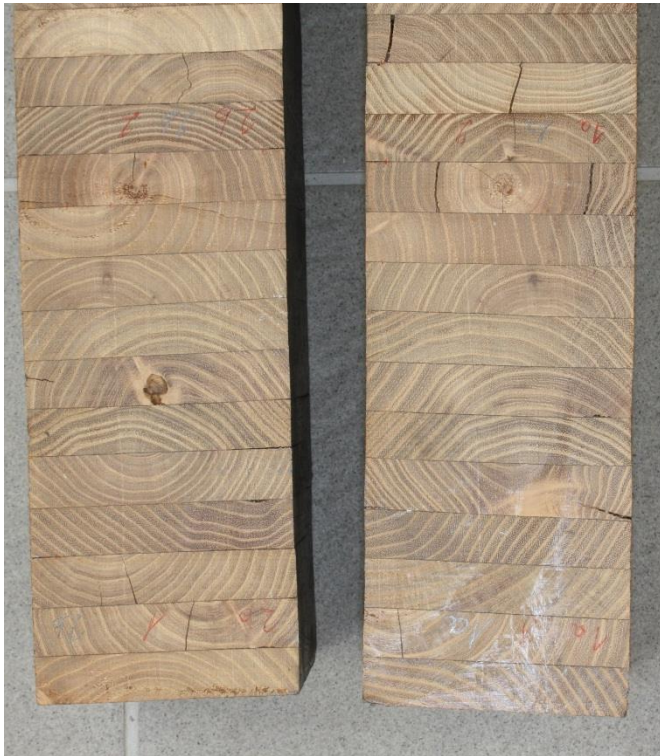
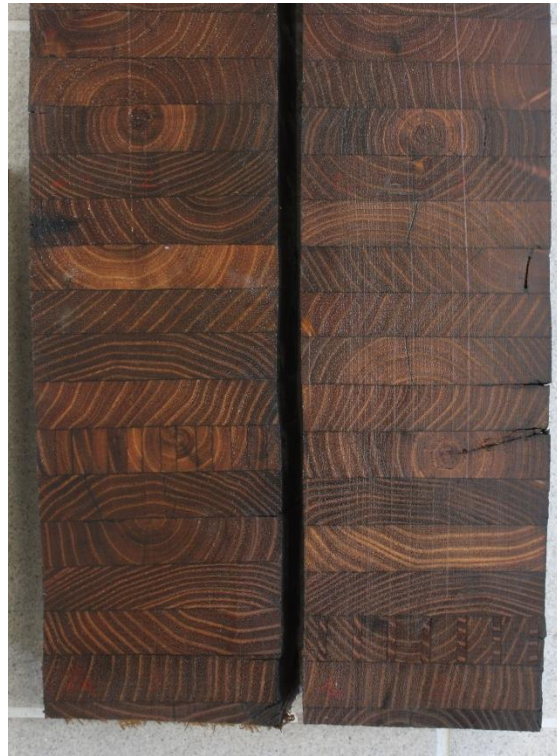
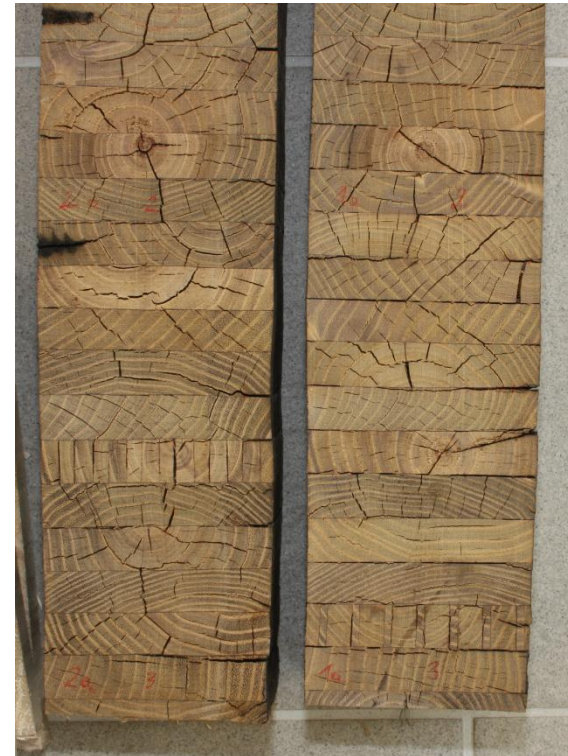
Old element before – during – and after delamination test

- The old element showed that some glue layers were delaminated exceeding the limit defined by the standard.
- In case of the new element the delamination occurred even before the delamination test. The main question about this result is that is the used glue suitable for the gluing of robinia.
- The exposure during the utilization of the old element was quite high, as it was working in a spa under highly moist conditions. This was well explained by the low value and high variance of the bonding strength (shear strength).
- However, the material of the old element would fit in the GL 24h bending strength category according to the standard EN 1194, but the bonding quality is below the regulations of the standard EN 314.
- These results confirm the replacement of the elements after the 40 years of usage.
