Formation of cracks in wooden elements – design, moisture and durability aspects

COST FP 1303 4th Conference
24th - 25th February 2016, Madrid, Spain

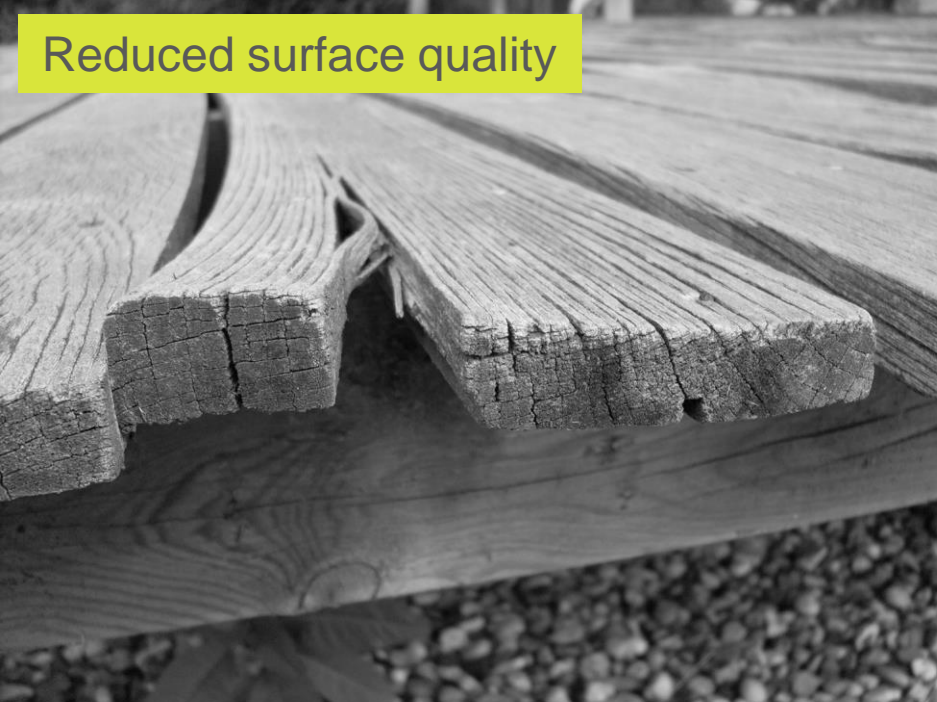
Reduced surface quality

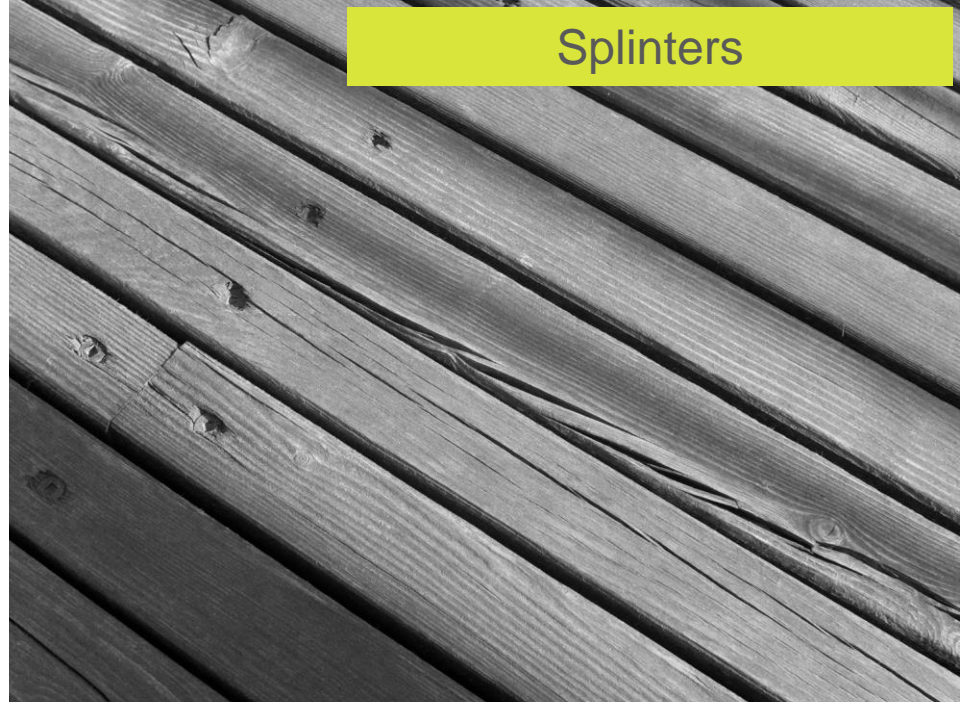
Splinters

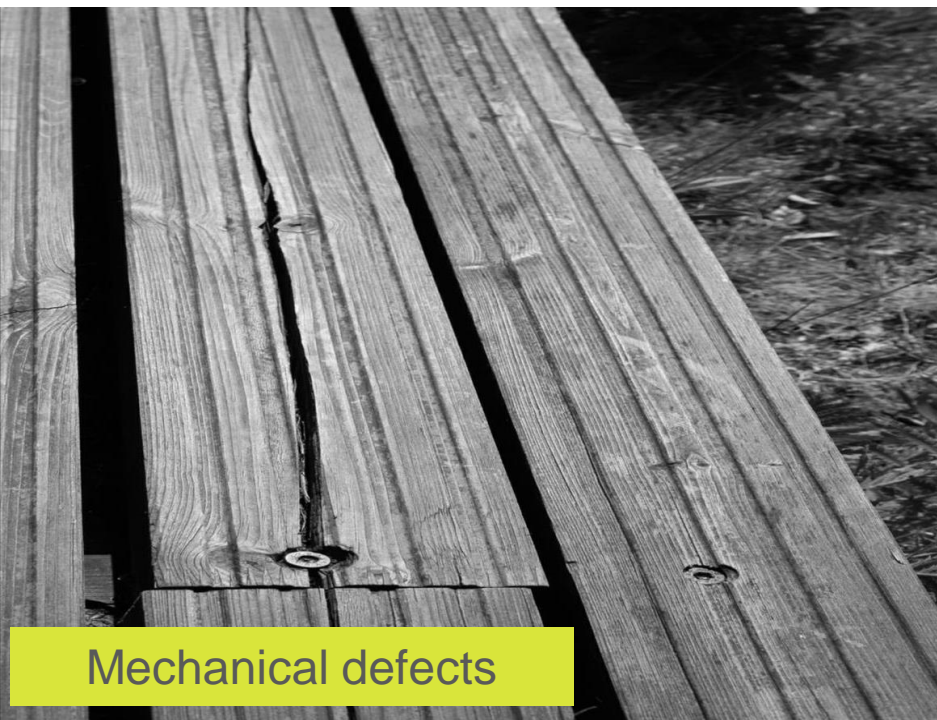
Mechanical defects

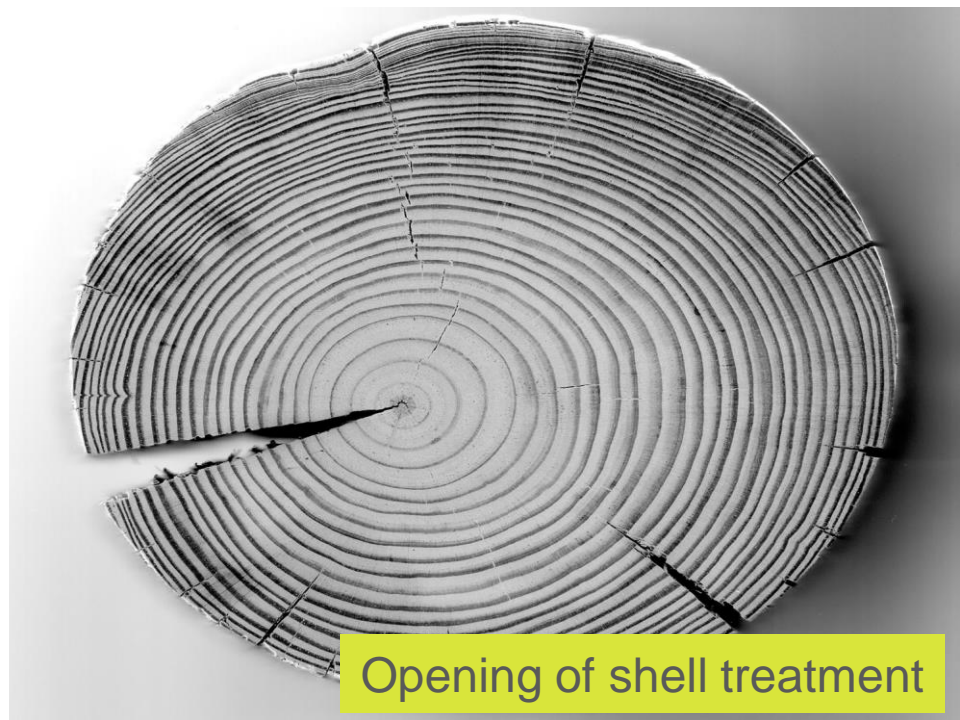
Opening of shell treatment

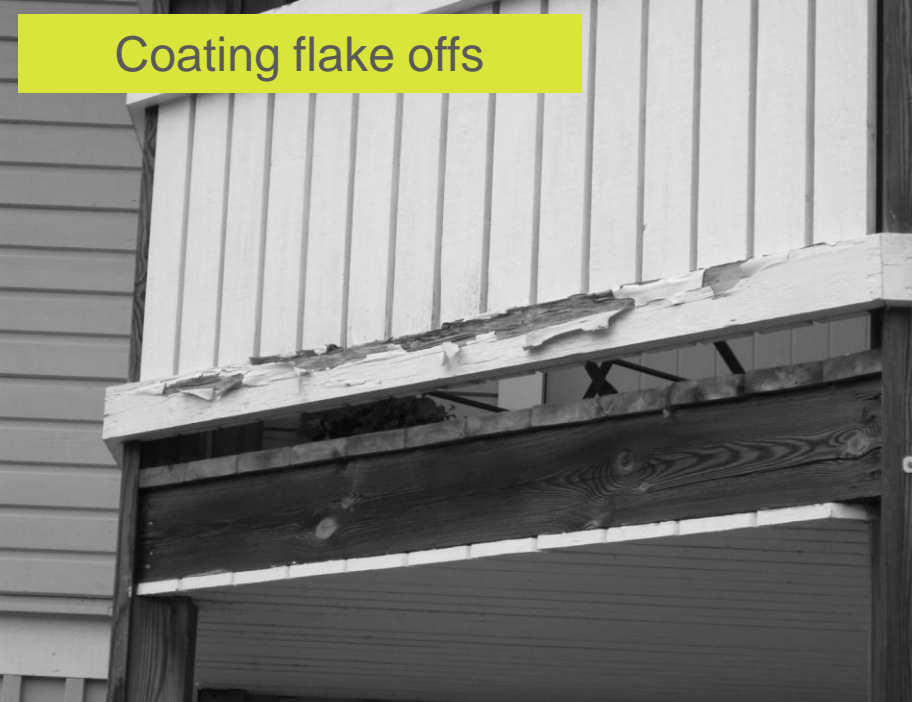
Coating flake offs

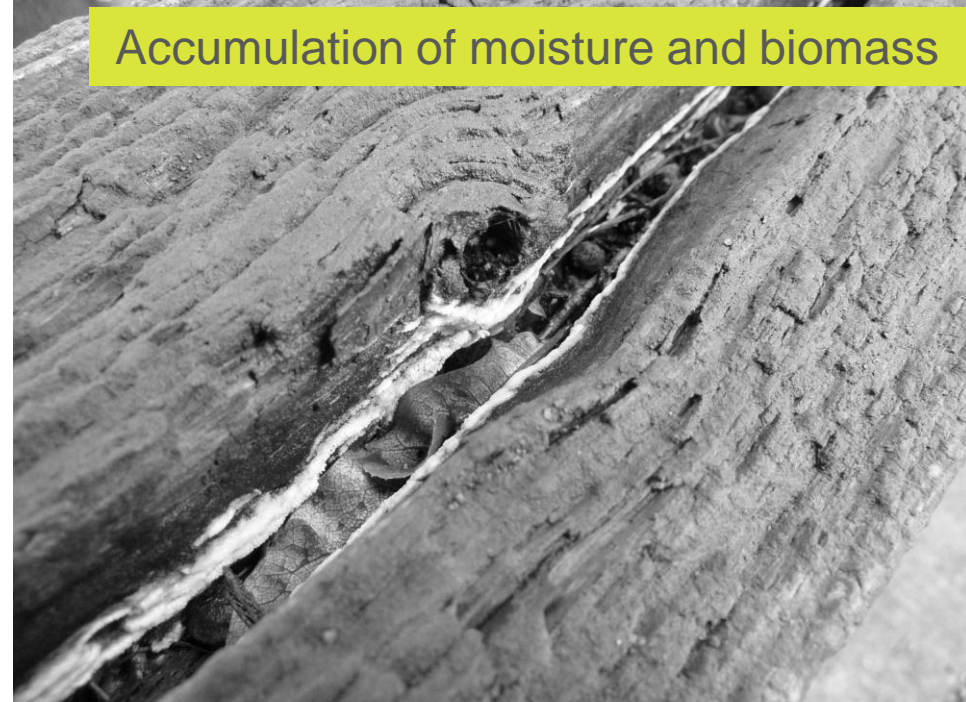
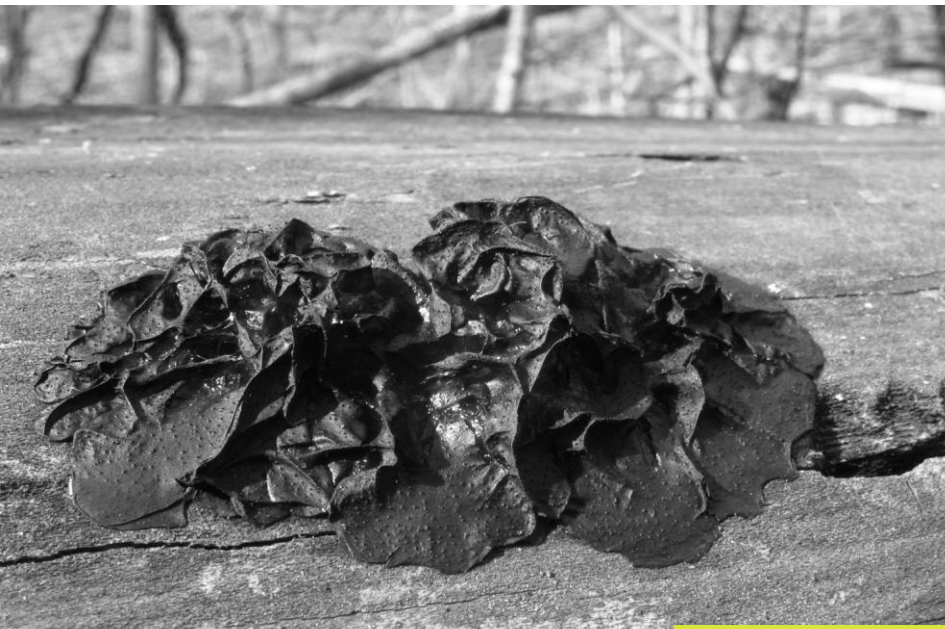
Accumulation of moisture and biomass

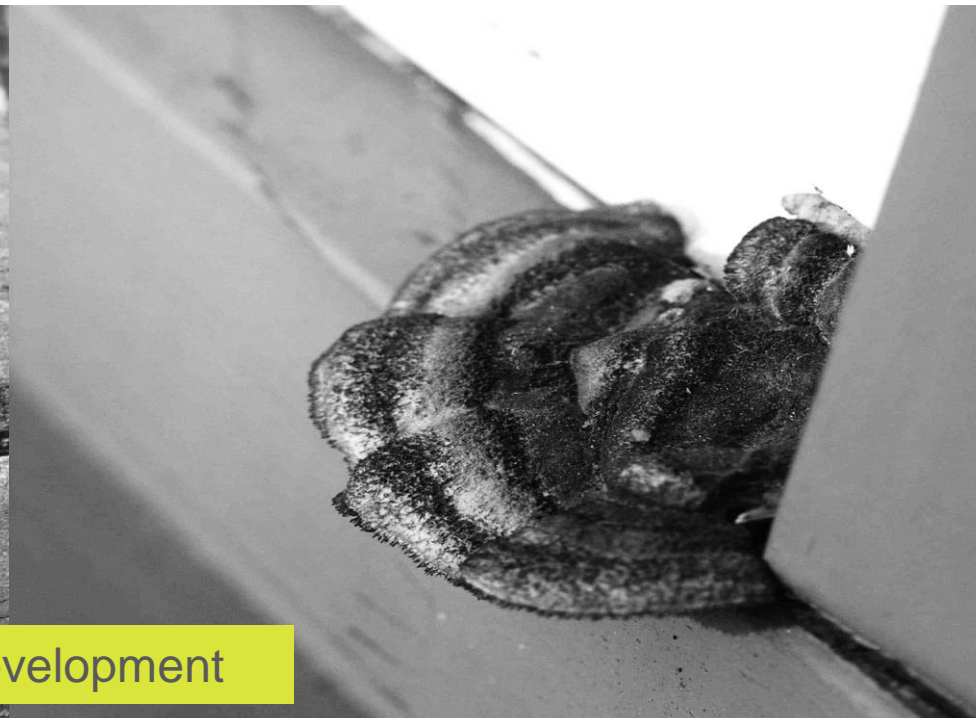
Decay development

- Cracks can be a starting point for rot
 - No clear effect of cracks on MC
(and resulting MC induced decay risk)
 - Formation of cracks differs a lot between materials
 - Most cracks on Scots pine, Norway spruce and Siberian larch
 - Drastic effect on optical appearance
- Future task: 1) Study cracks in bigger components
2) Monitor MC close to and remote from cracks

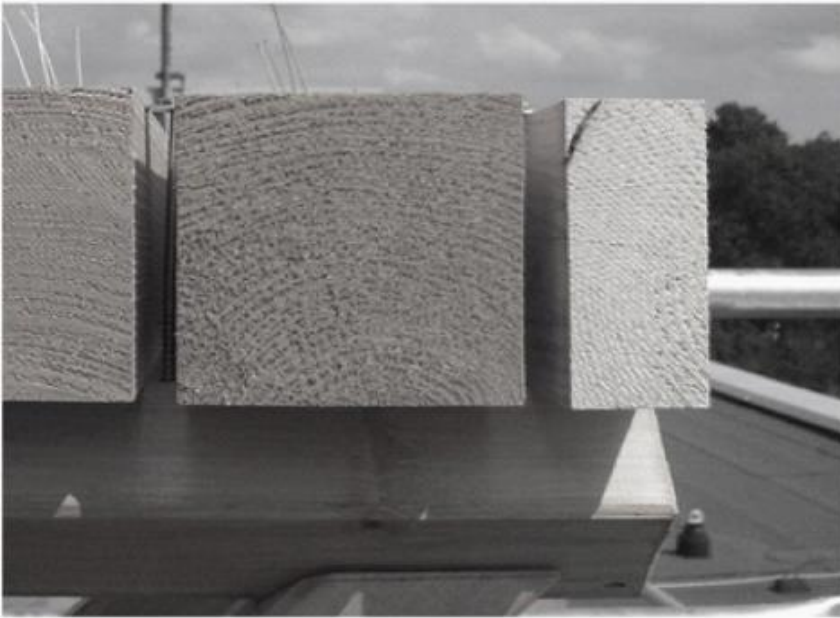
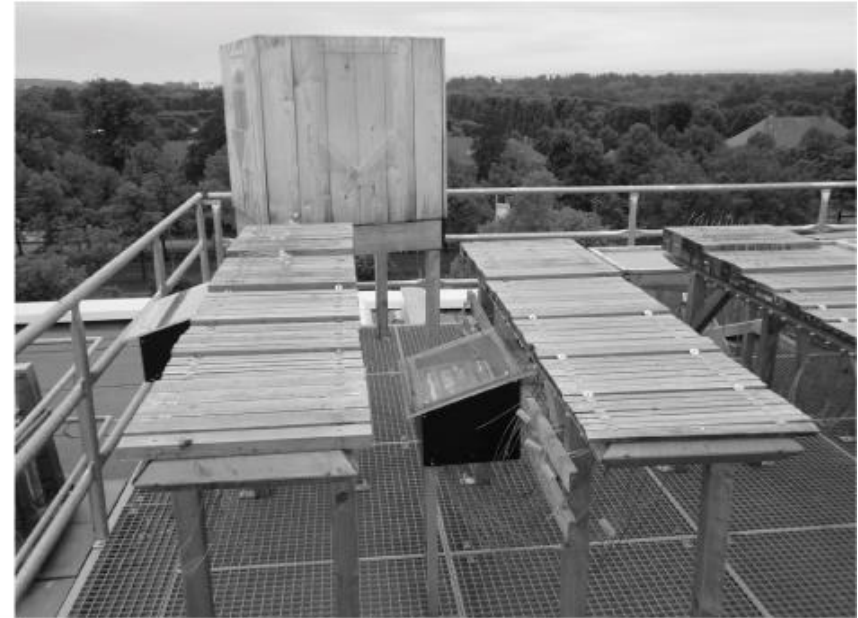
Dimension trial

- Exposed 2009-2014
- Single members with different cross sections
- Scots pine and Norway spruce

- **No clear effect of cross section on decay**
- **Weak points for decay development:**
 - **Cracks**
 - **Contact faces**
 - **BUT: Interior rot also occurs**
- **What about moisture?**

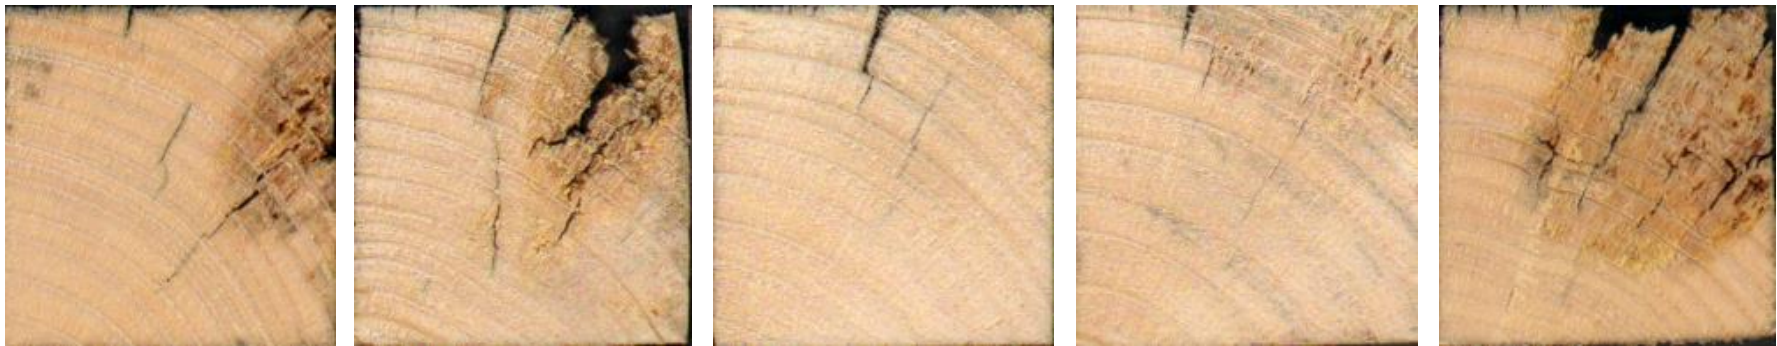
50 x 50 mm

Decay patterns

→ Norway spruce

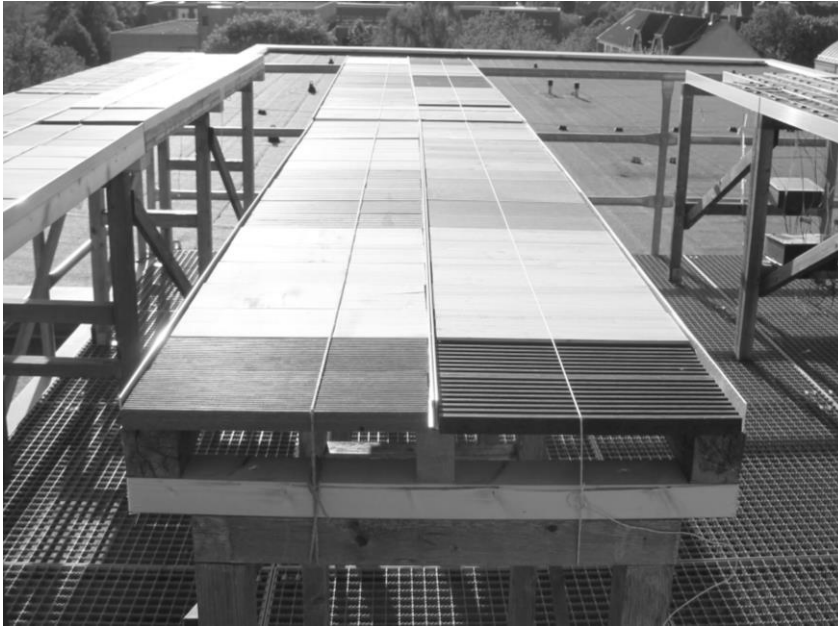
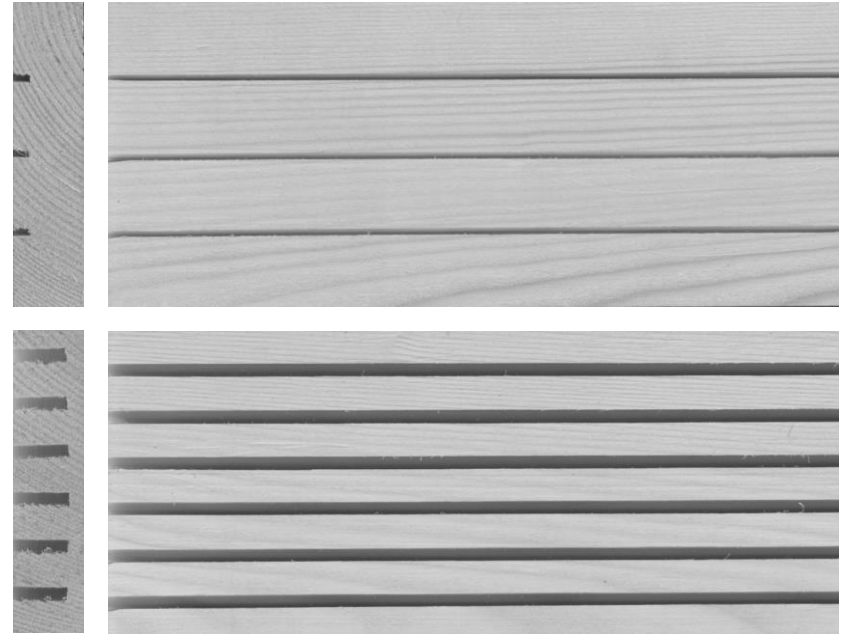
Crack study 1

- Exposed in 2015
- Norway spruce with artificial cracks
- Gravimetric MC measurements 05.2015 – 08.2015

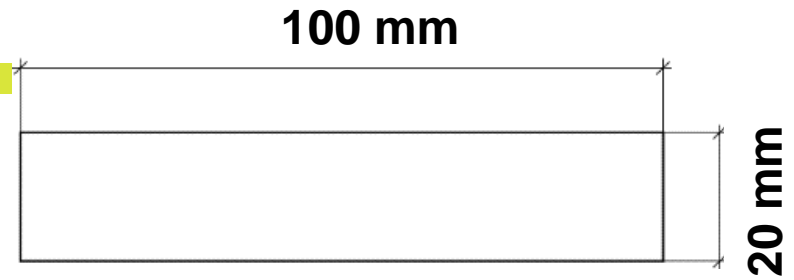
Crack study 1

- Norway spruce (100 x 20 x 300 mm³)
- Artificial cracks
- Varying in width (0 - 3 mm), depth (5 - 15 mm) and number

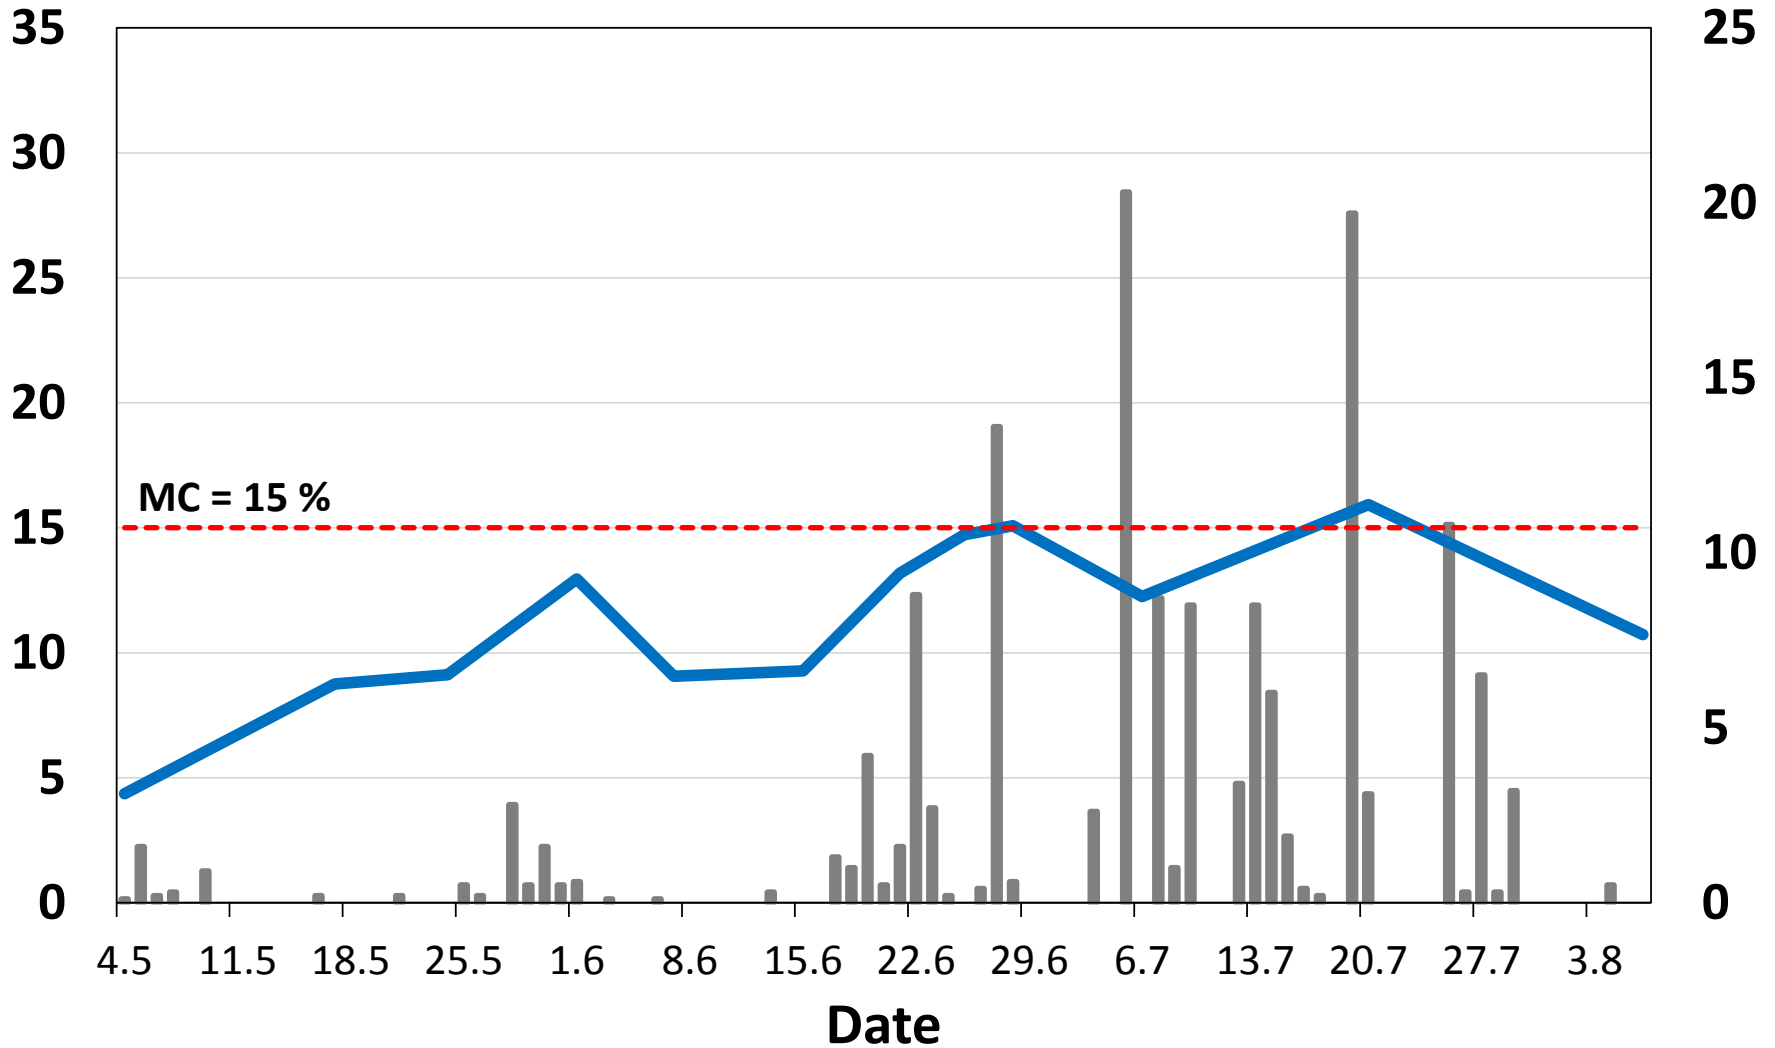
Spruce – no cracks

Moisture content [%]

Precipitation [mm]

- No significant effect of artificial cracks on MC
- Similar findings for naturally developed cracks
- Note: limited exposure time (3 months)
- What about cracking of different materials?

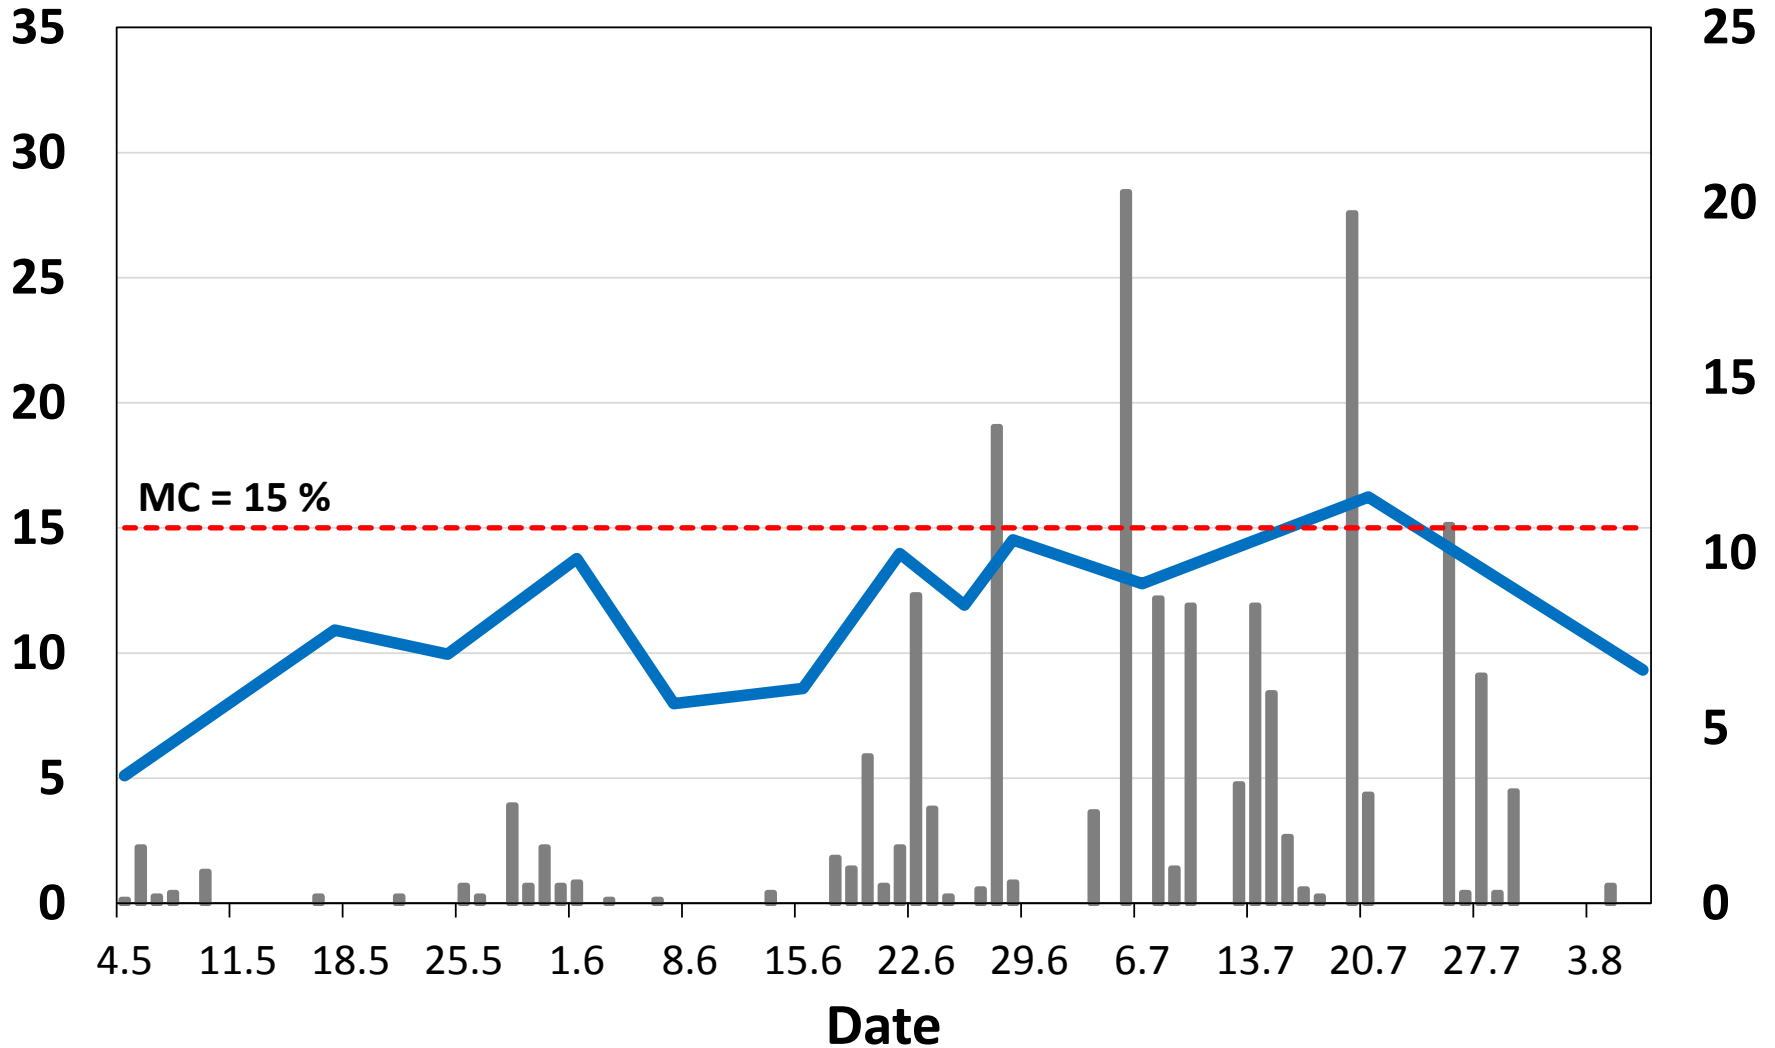
Spruce – extreme cracks

Moisture content [%]

Precipitation [mm]

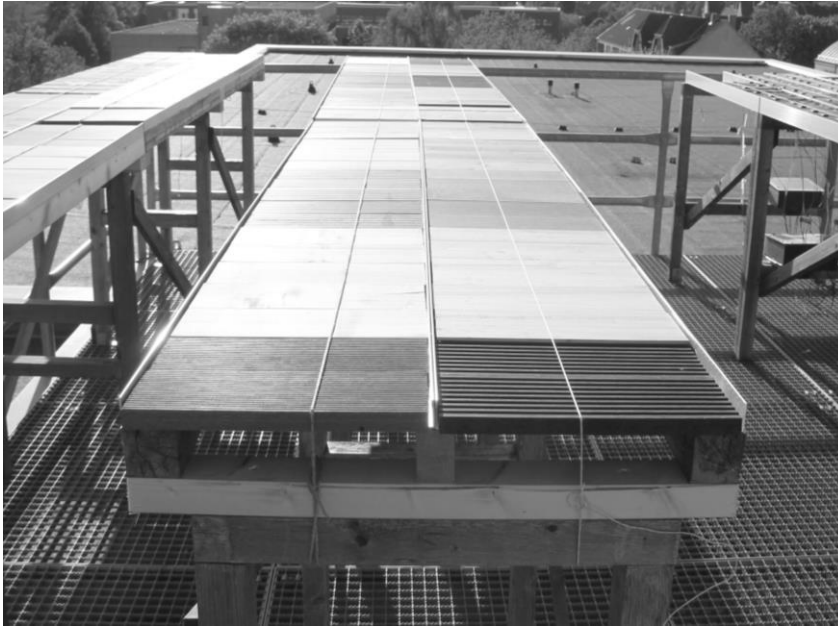
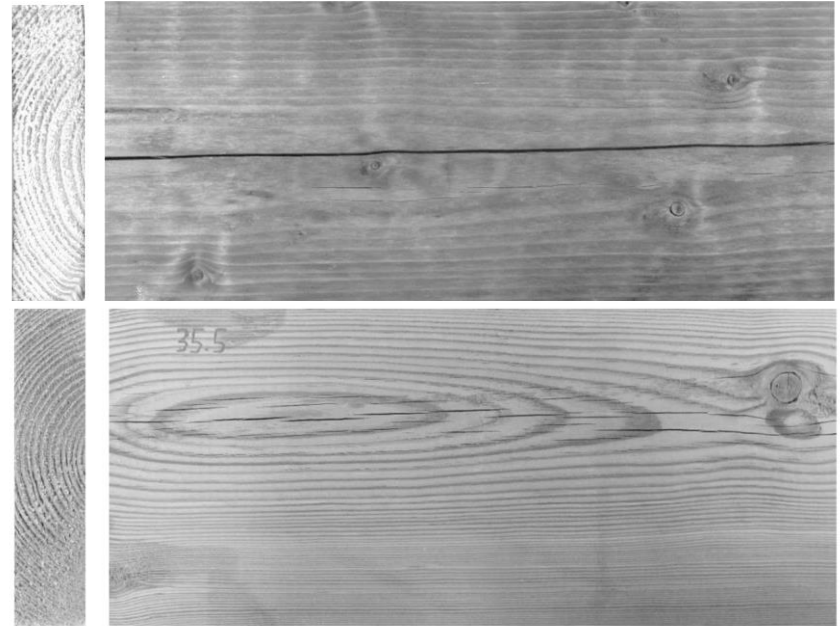
Crack study 2

- Exposed in 2015
- 45 wood materials
- Determination of crack length and MC

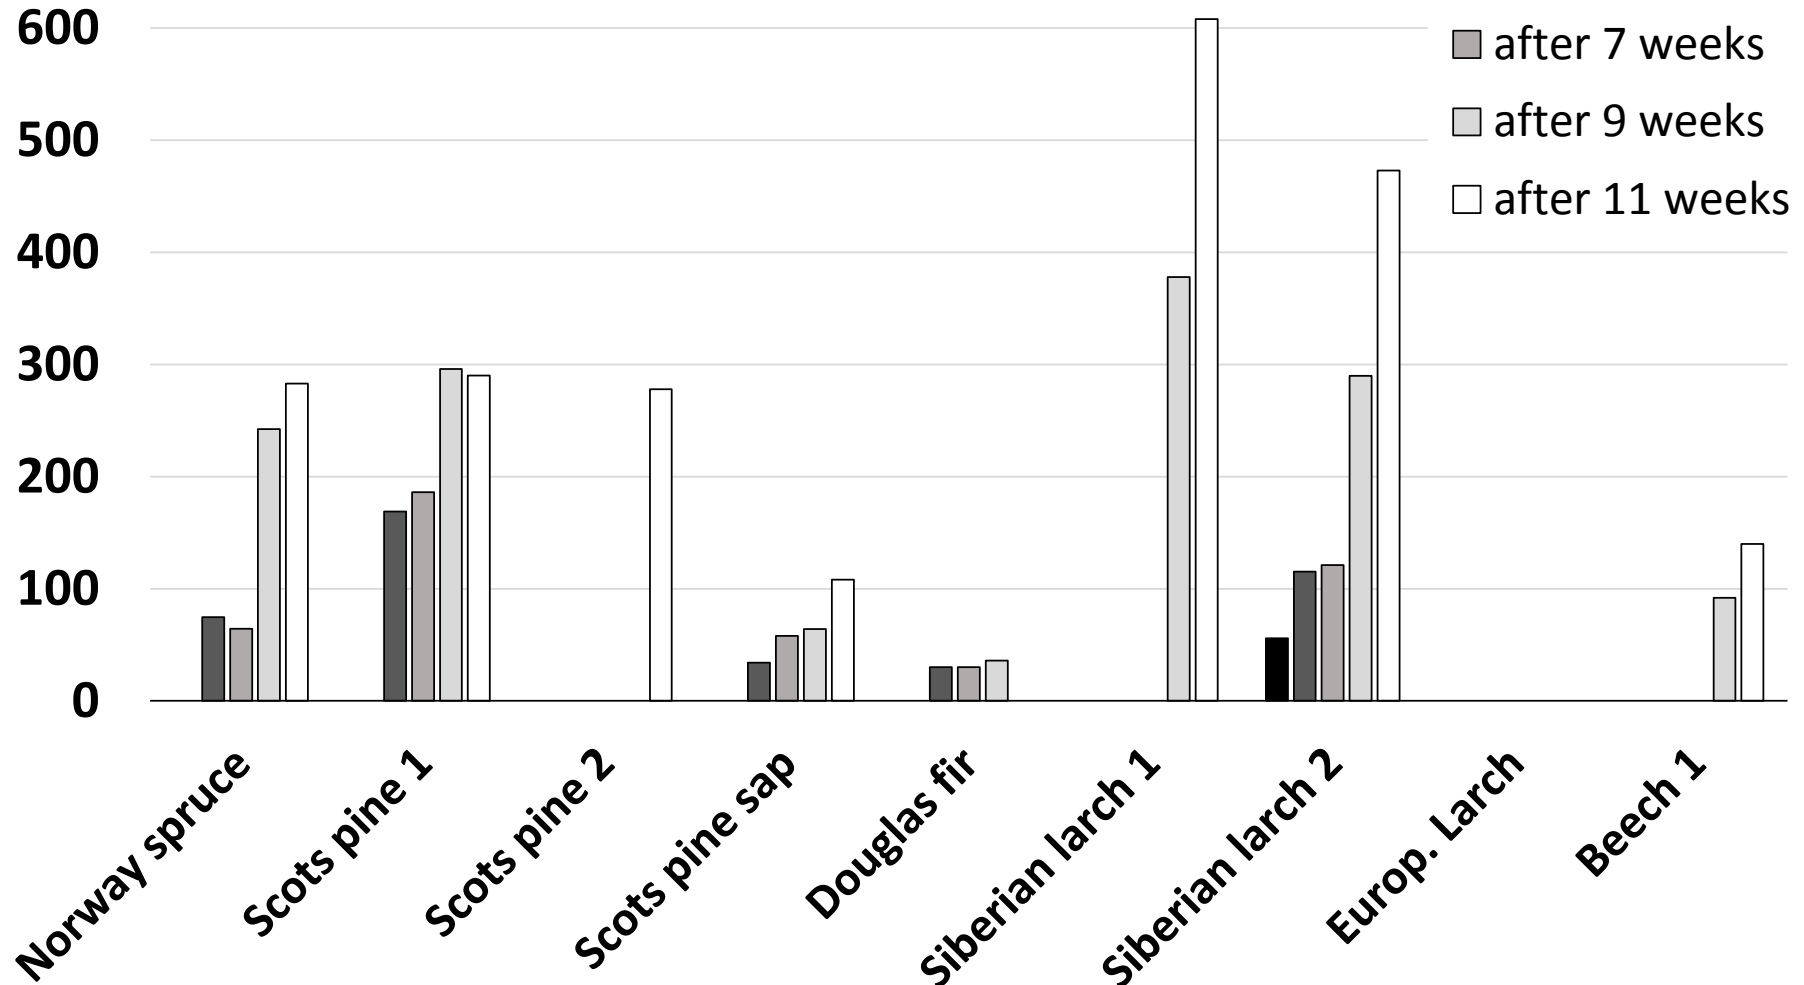
Untreated materials

Mean crack length sum [mm/specimen]

- **Significant differences in crack susceptibility between materials**
- **Time-dependent formation of cracks**
- **Again: No clear effect of cracks on MC, even within one wood species**

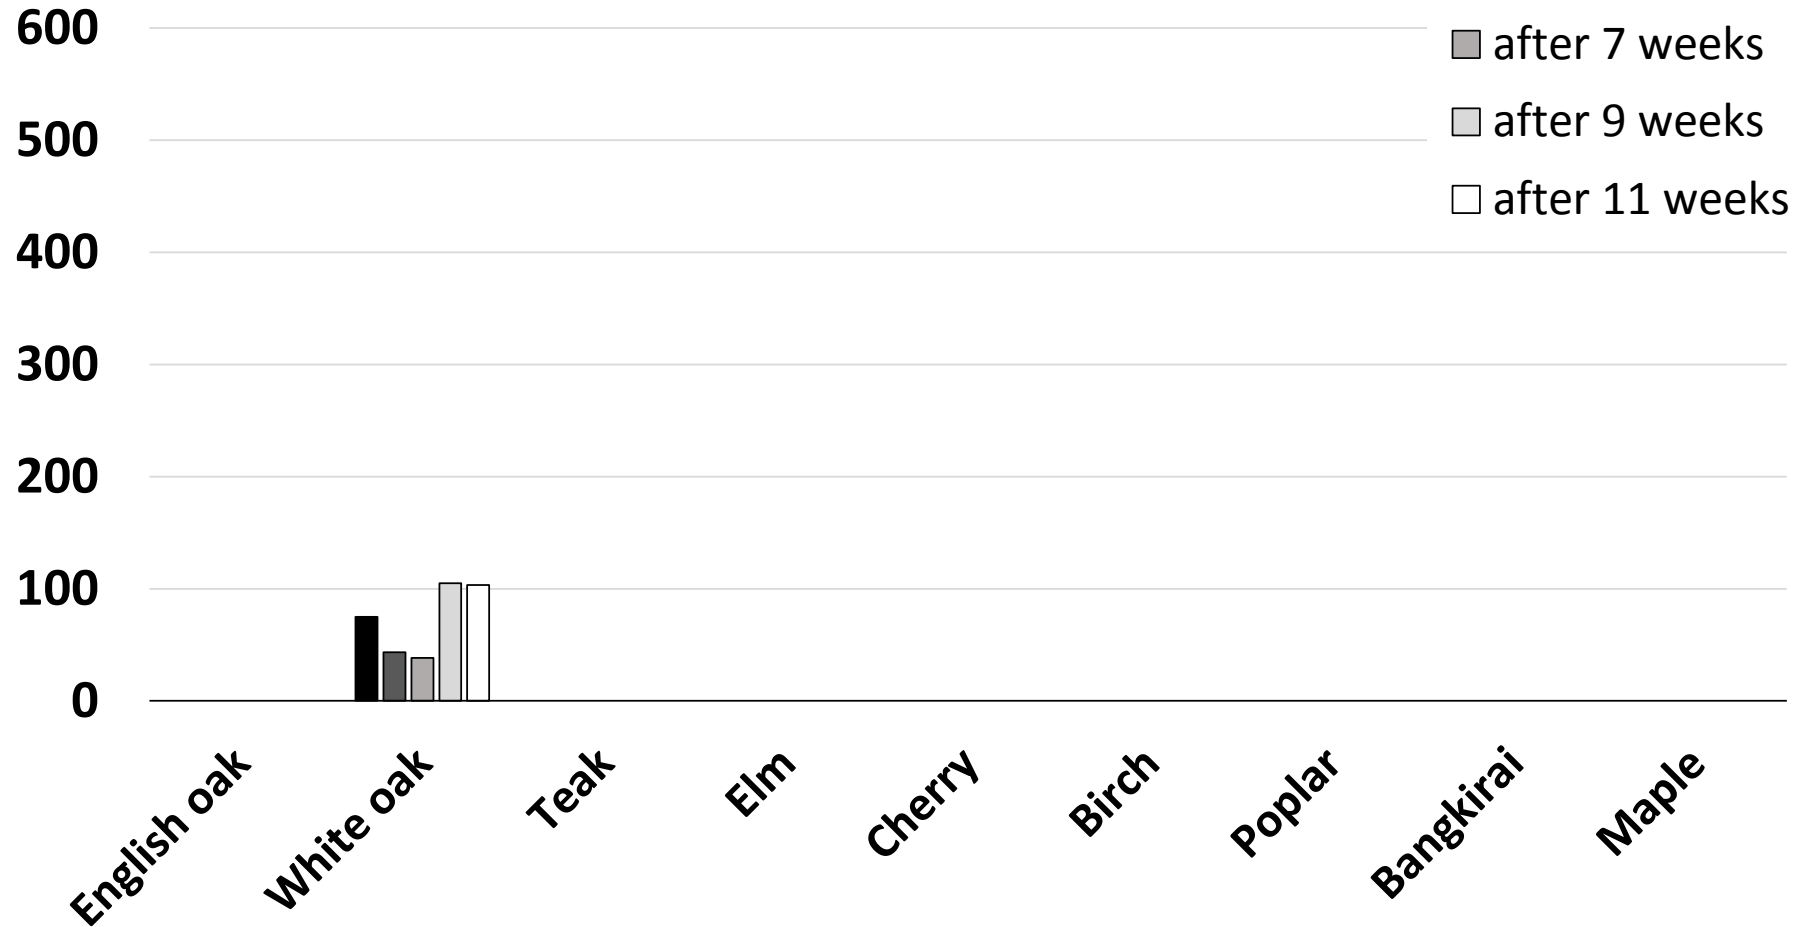
Untreated materials

Mean crack length sum [mm/specimen]

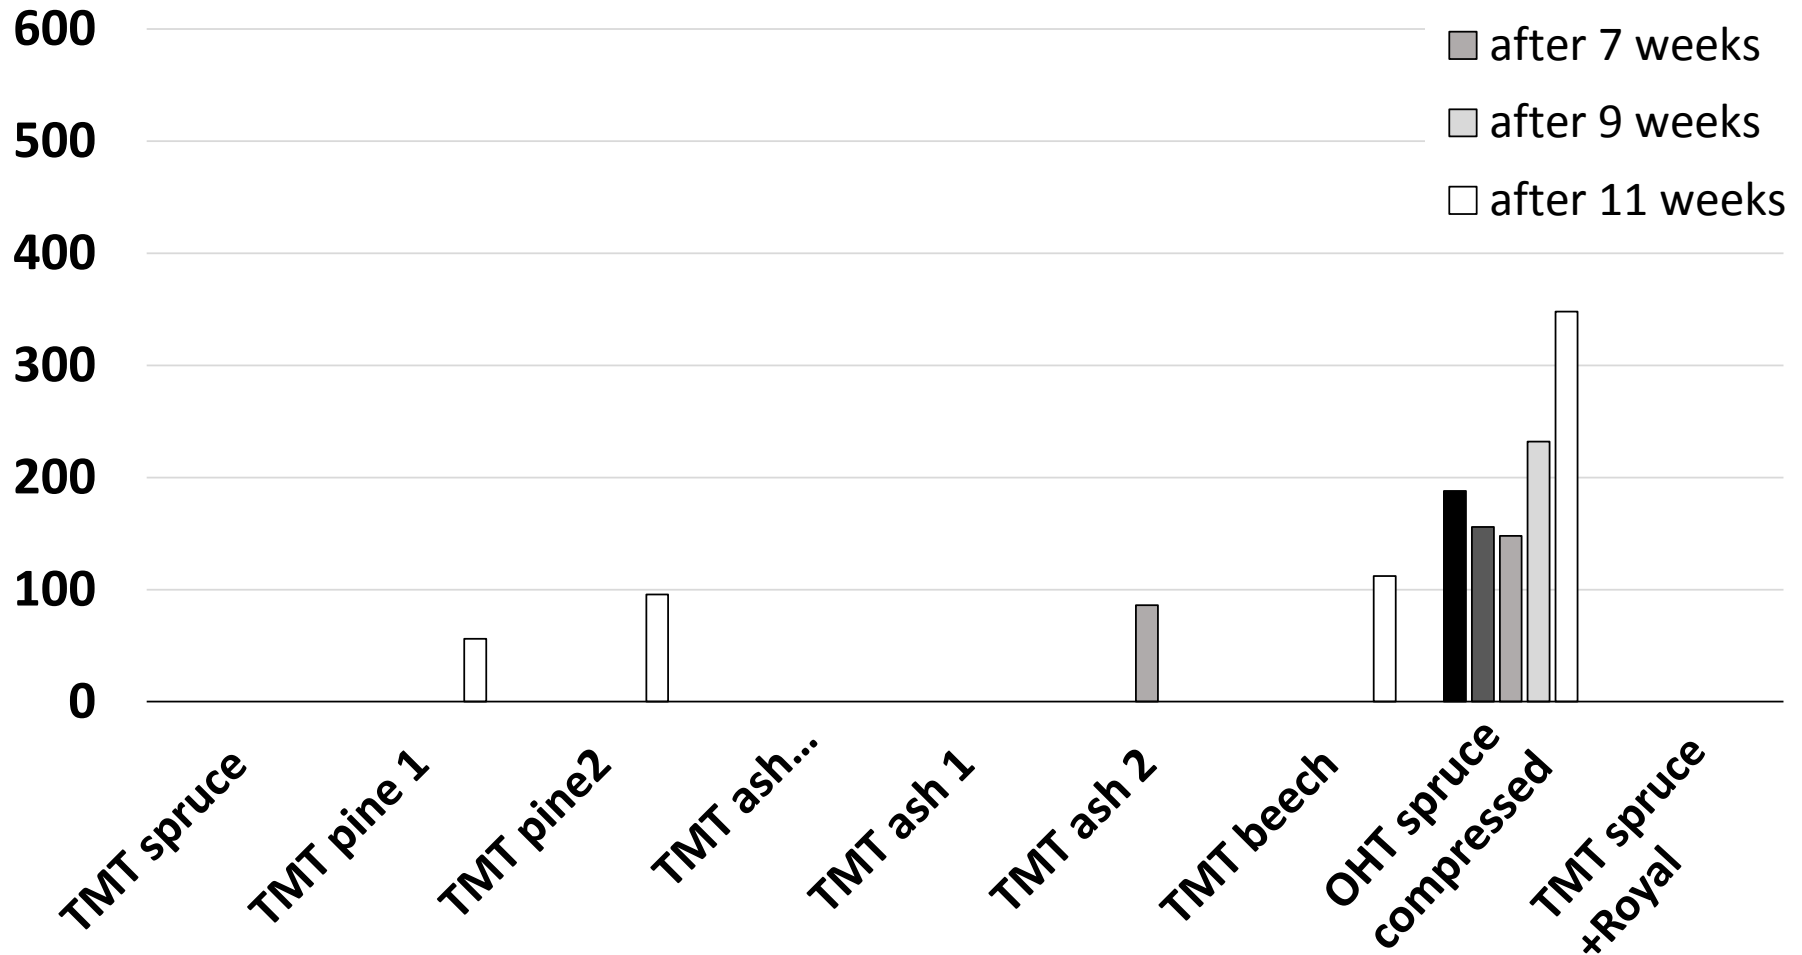
Treated materials

Mean crack length sum [mm/specimen]

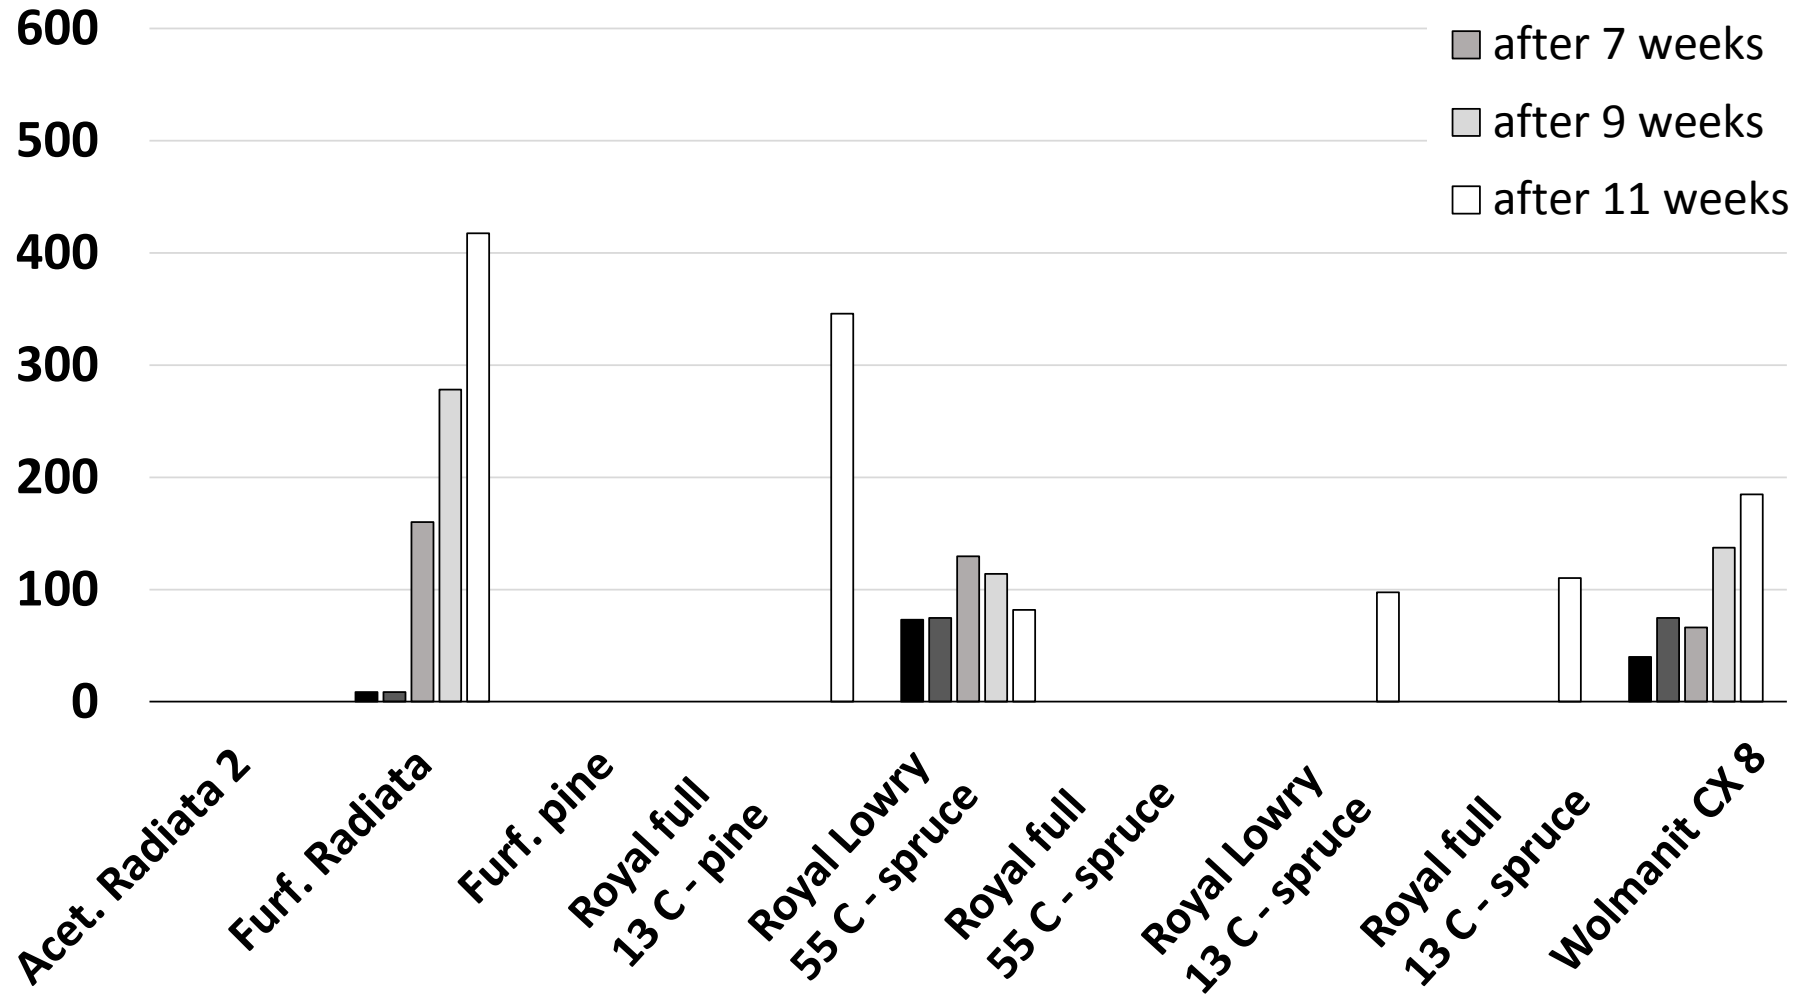
Treated materials

Mean crack length sum [mm/specimen]
