**THE INTERNATIONAL RESEARCH GROUP ON WOOD PROTECTION**

**Introduction of the COST FP 1303 Cooperative Performance Test**

Paper prepared for the 46<sup>th</sup> IRG Annual Meeting  
Viña del Mar, Chile  
10-14 May 2015

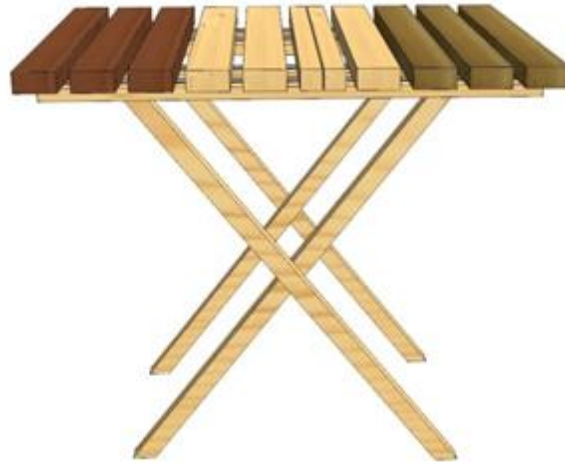
A folding table with boards made from three different materials, *i.e.* Norway spruce, English oak and thermally modified Norway spruce (Table 1) served as easy shippable and ready-to-use test object (Fig. 1). The boards were fixed with partly stainless and partly ordinary steel screws. The table was available in three different versions:

Fig. 1. Performance folding table.

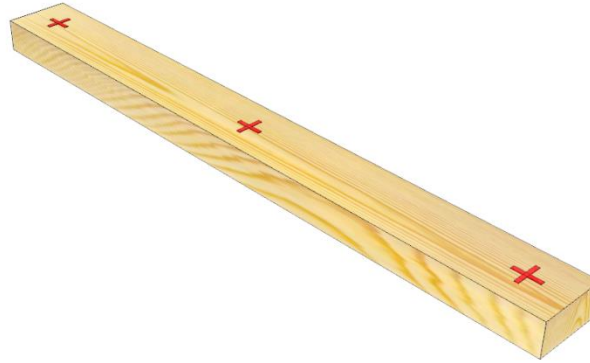
Colour measurements were recorded at three points on the upper surface of each specimen with a colorimeter. The measuring points were marked on each specimen through cross lines. The positions were centrally between the long sides of the specimens and 30 mm from the end-grain and in the middle of the specimen as shown in Fig. 4.

Fig. 4. Positions for measuring L\*a\*b\* colour values.
