***A case study: evaluation of state of conservation of wood panels and beams of a CLT kindergarten.***

***Proposal of a diagnostic approach and realization of an Italian register of service life condition of recent wooden buildings.***

*Sabrina Palanti and Nicola Macchioni*

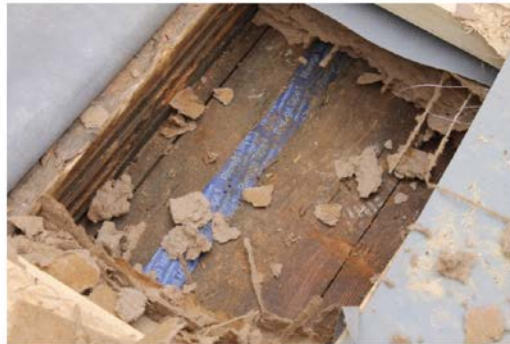
4 CLT panel

- The roof of the kindergarten is made of principal horizontal CLT panels, supported at the two ends by glulam transverse beams.
- The CLT elements support small section joists to create an insulating volume, filled with low density fibreboards and a sweating sheet, covered, on other small joists, with OSB panels and finally a impermeable layer.
- Over the impermeable layer in a first moment, was placed a hanging garden, removed after the occurrence of first moisture spots.

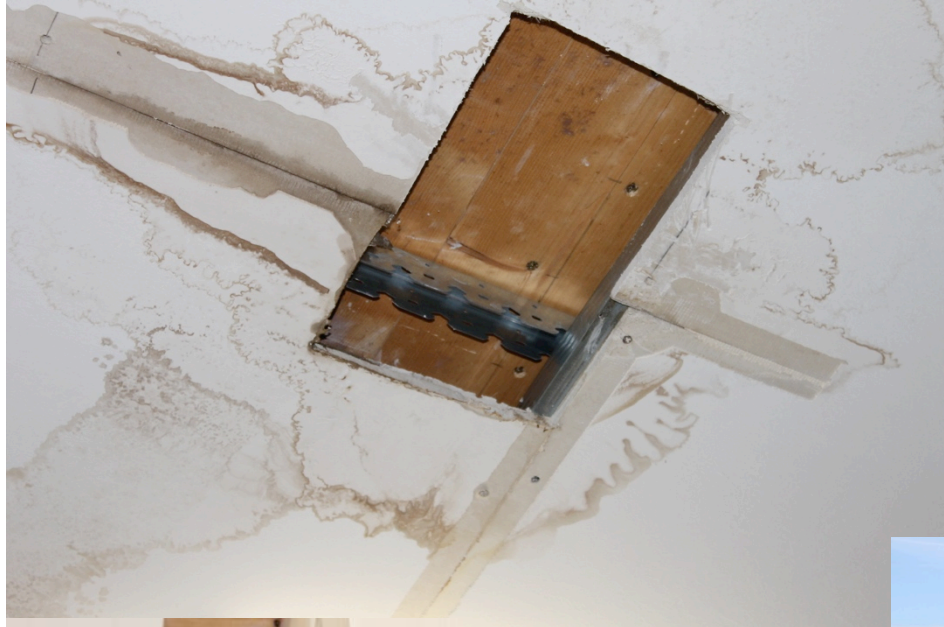
On the outside roof it was visible a great deflection, due to the collapse of OSB panels, completely decayed; we asked to analyse the wood structure from the extrados, directly by the roof, in order to correctly evaluate the state of preservation of the CLT panels.
