Designing with bio-based building materials – Challenges and opportunities

The problem of exterior structures built in Northern Spain climate in *Picea abies* due wood destroying fungi attacks. The example of a wood exterior structure in Pontevedra, Spain and the importance of design in the performance

Lorenzo, David, Juan Fernández, Manuel Touza, Manuel Guaita, Alfonso Lozano, Teresa de Troya

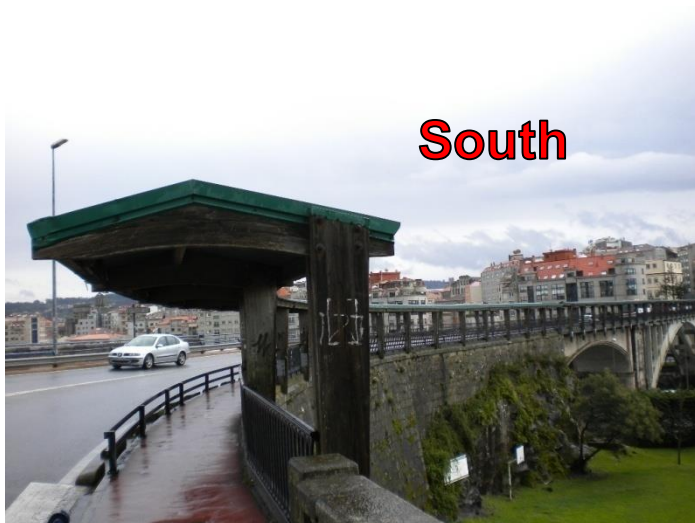
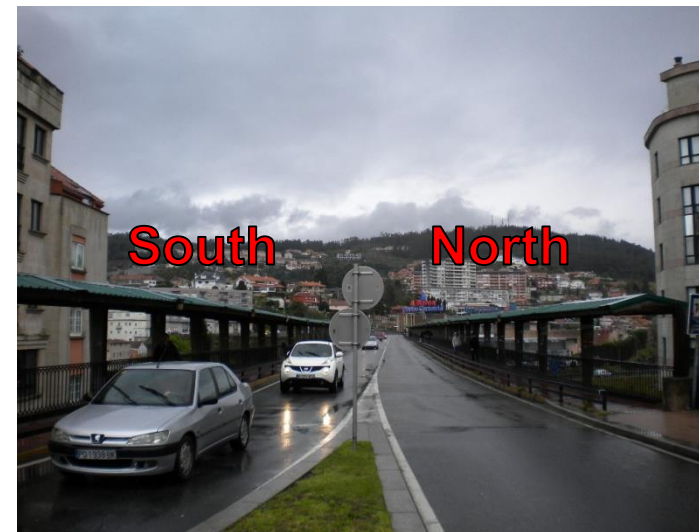
- Object: Covered bridge Pavement(Roof)
- Place: North-West coast of Spain
- Construction: 1995 (20 years)
- Porticos, pillars and beams
- Wood specie: Spruce.
- Wood type: sawn and glue lam
- Use classes: 2 (Under roof), 3.1 (vertical) and 3.2 (horizontal)
- Good Details design: Sheltering, distance from ground, etc.

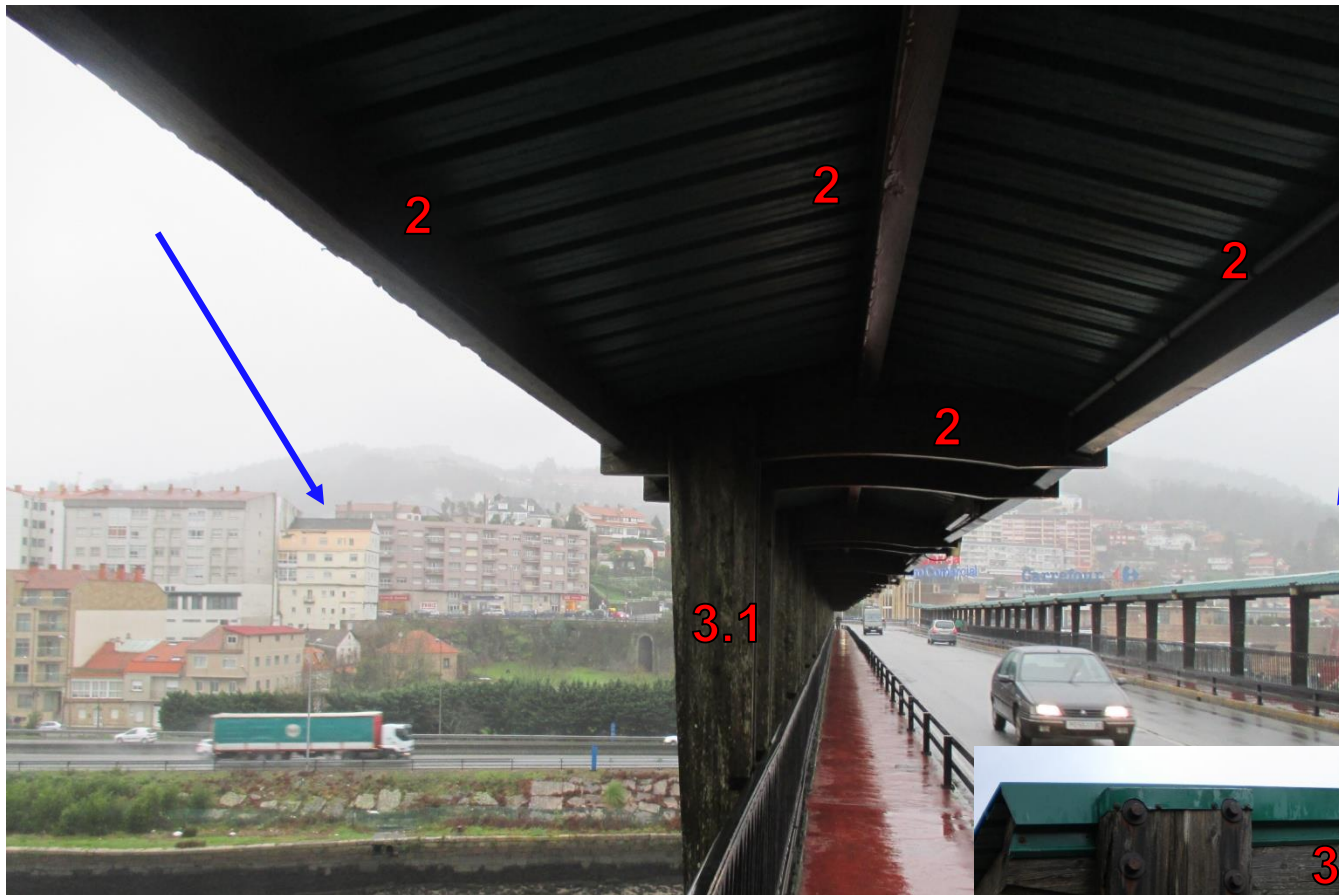
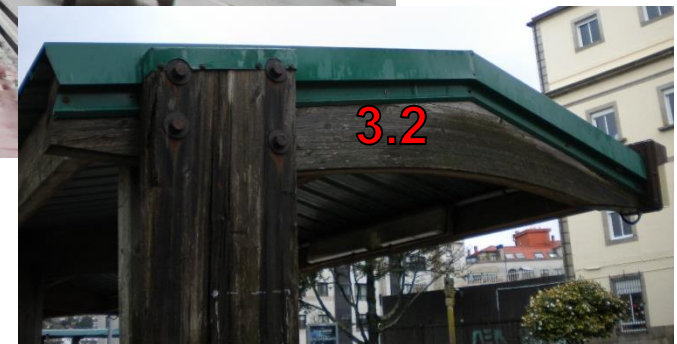
■ USE CLASSES (EN 335:2013)

- Roof and sheltering protection (2)
- Horizontal elements (3.2)
- Vertical elements (3.1)

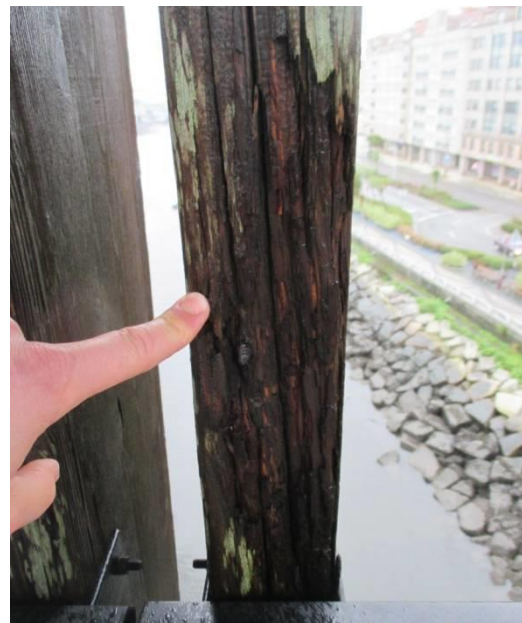
- After twenty years of service life in a first view the structure shows some **severe decay degradations**.
- In a detailed diagnosis **not all elements of the structure shows the same level of decay degradation**.
- The case study is aimed at understanding the **cause/s** of different level of decay degradation.

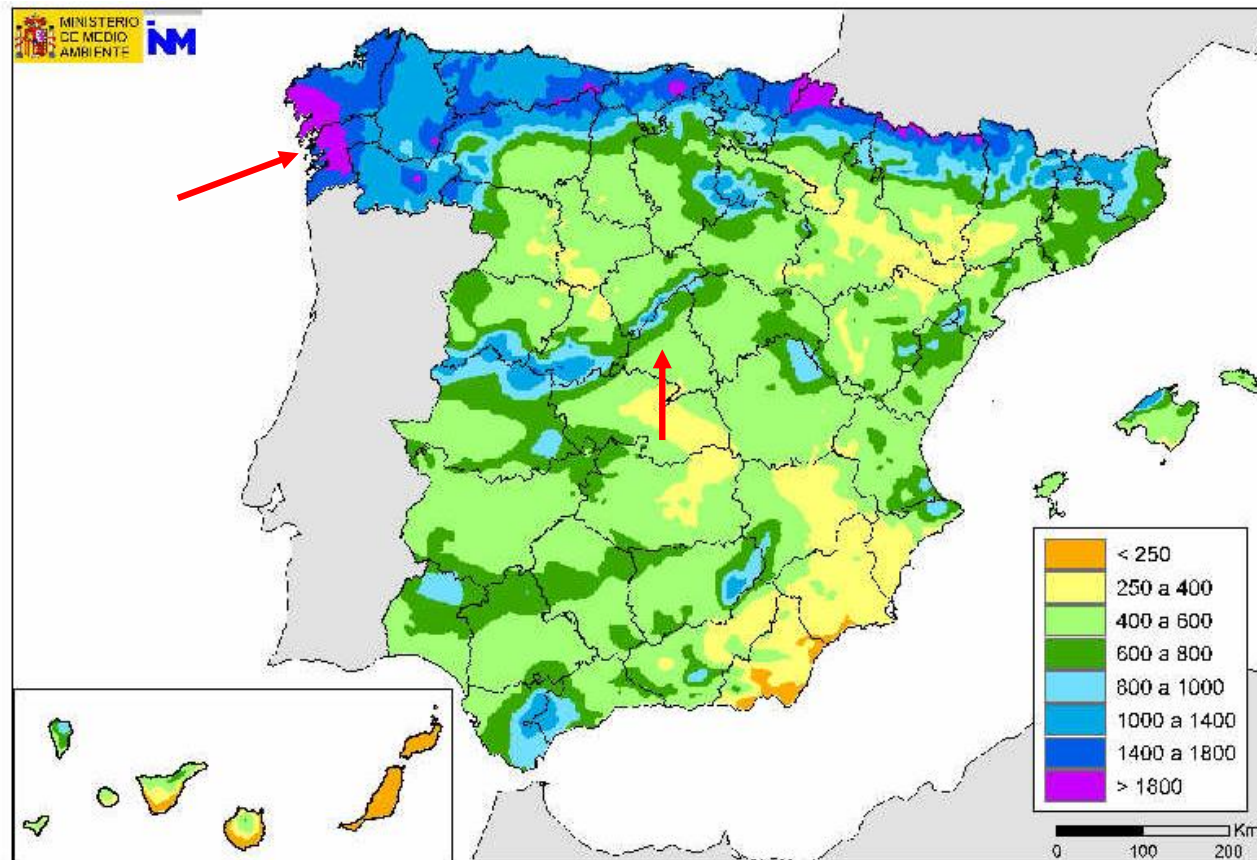
GEOGRAPHICAL LOCATION: CLIMATE

- North-West coast of Spain.
- Climatic conditions: Rainy (wet), warm, high RH.
- Sea level: Coast (South-West strong winds).

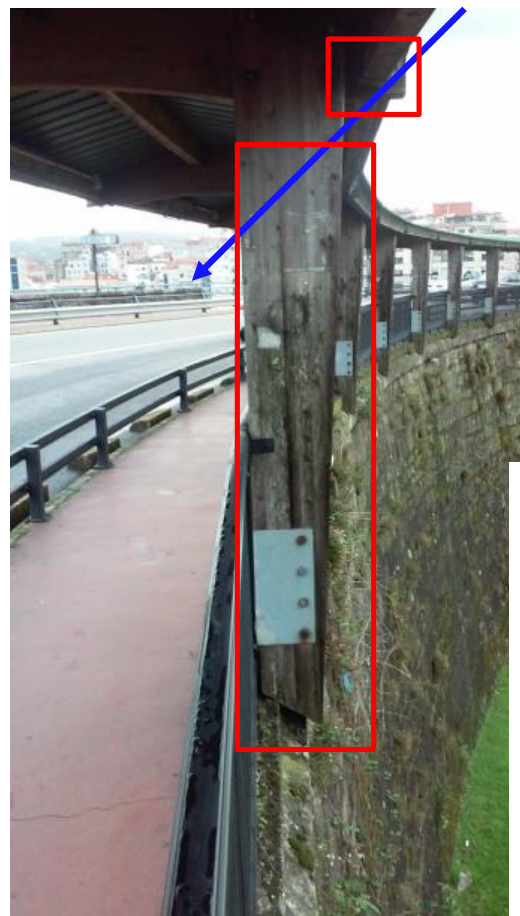
Major part of South structure exposed to weather

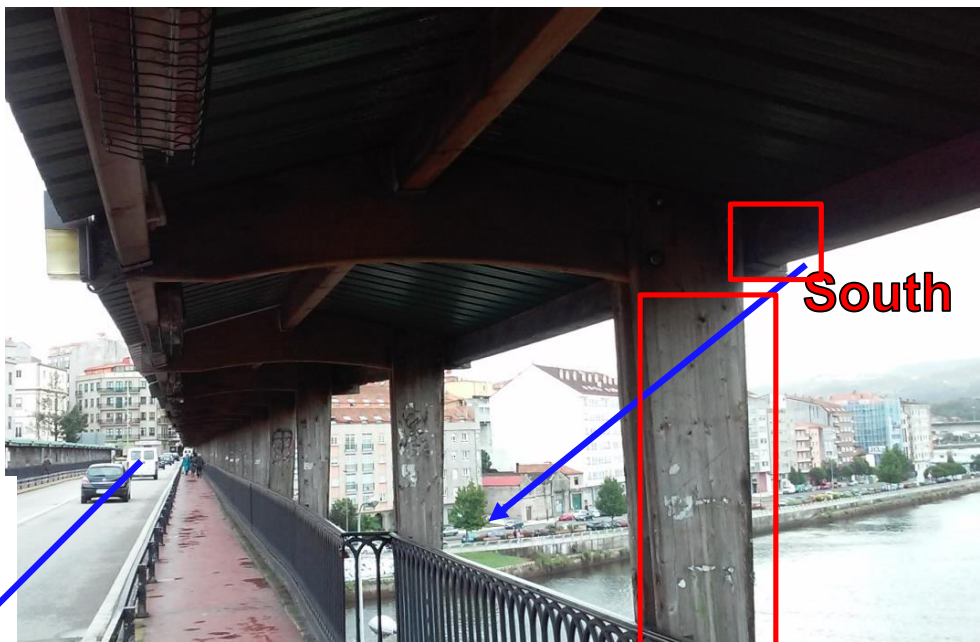
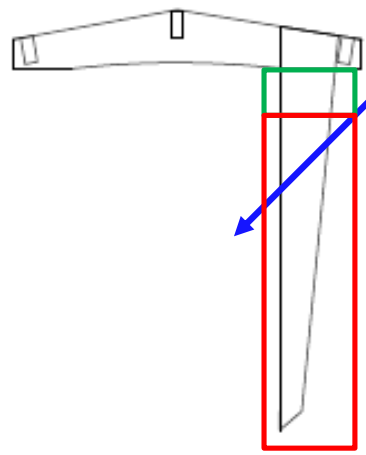
■ DETAILS DESIGN N.E: South Orientation

- Sheltering: No protection due strong South winds
- Lights: Protection

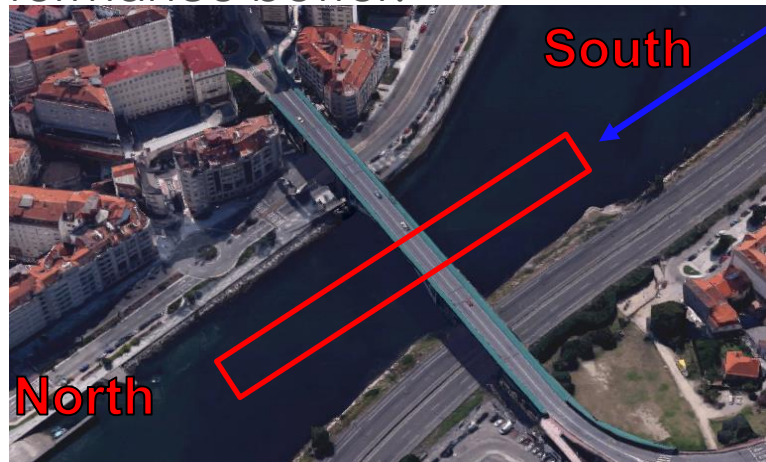
- In this exterior structure there are important **decays** degradation after 20 years and the question is if we change one or more parameters (climate, dimensions,...) how will be change the final performance of this structure.
- This exterior structure in the same site but with **another orientation** (North-South) would performance better.

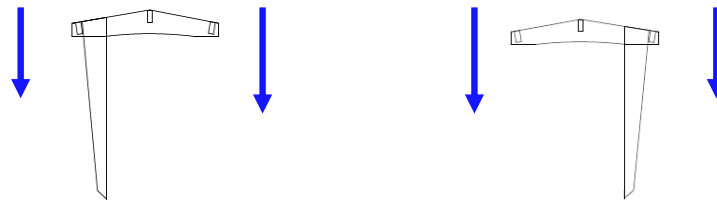
- This exterior structure in another site and same orientation (for example without strong South winds) would performance better
