# Example of a diagnosis on a new X-Lam building in Italy: material decay and monitoring needs

# X-Lam building diagnosis

The presentation shows a diagnosis performed on a pretty new X-Lam, box-framed building.

The building is located in Cervia, a summer vacation town on the Adriatic coast. It is a 4 storeys building, the three storeys above the ground are entirely made of X-Lam panels.

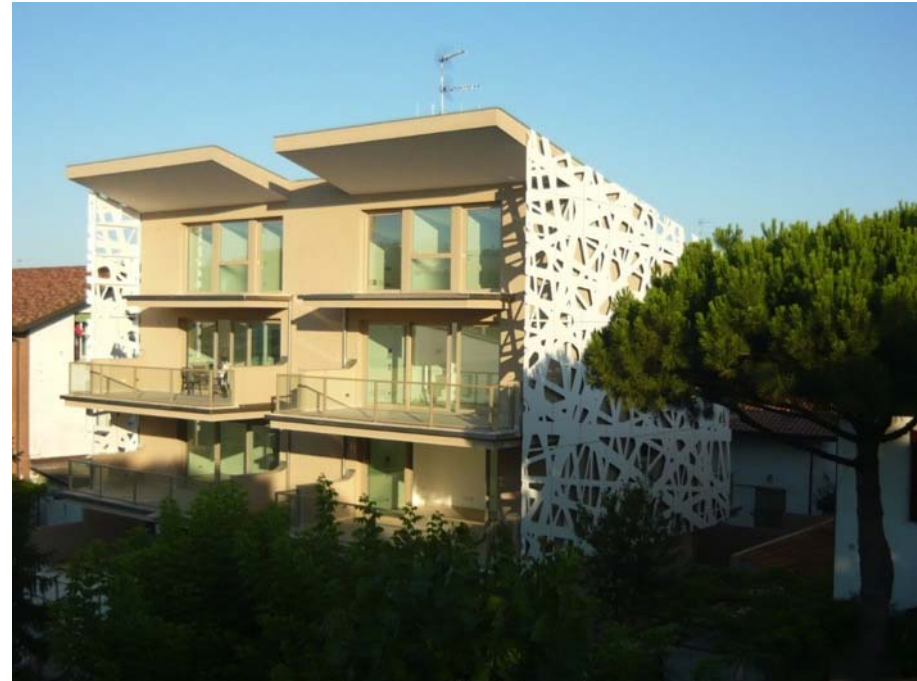
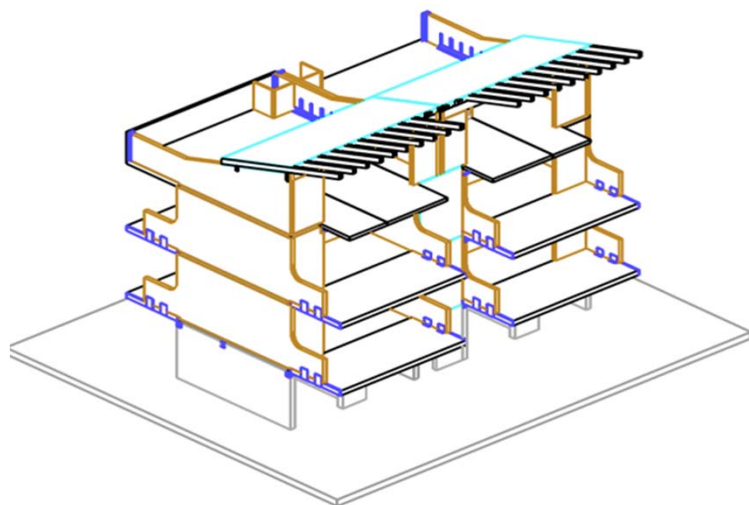
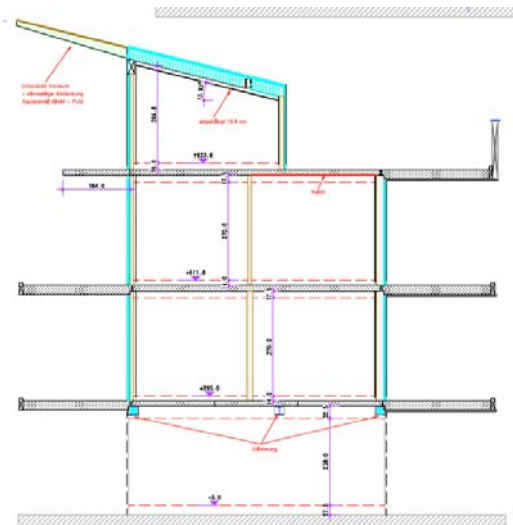
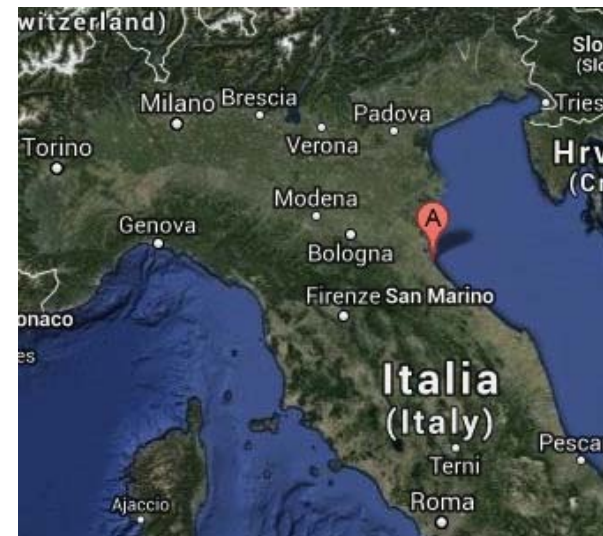
The request of *in situ* inspection was due to the fact that in the last level floor some staining and fungal attack on the wood panels were found at the end of winter season.

Apparently most of the problems correspond to the floor located below the solarium – terrace, partly overhanging.

A nylon vapour barrier in the bathroom caused the development of mycelium between the nylon sheet and the panel.

In this case study the X-Lam panels of the walls and floors have absorbed rainfall during construction, especially on the top floor.

Further, water percolation from the roof through the different floors of building occurred subsequently to the melting of an extraordinary snowfall in 2012 winter.

The tar paper on the outer surface and the layer of nylon on the inside part caused slower drying or even prevented the subsequent rebalancing of the wood with the relative humidity after the complete assembling of the building.

As consequence, severe fungal decay occurred during the first year after assembling.

This case study evidence the need for a monitoring of wood moisture content in critical parts of the building.

- clear assembling practices (a standard?)
- monitoring in possible critical points (bathroom floors?)
- let possible inspection windows in design practice
- Development of inspection practices

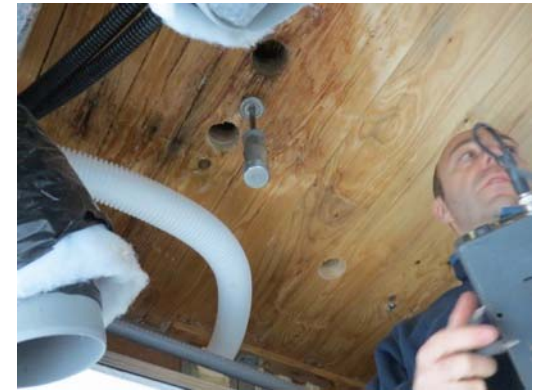
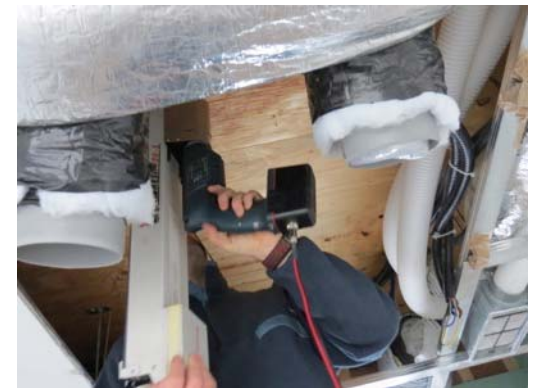
- Wooden panels are never directly visible, but hidden by a false ceiling that hides in the meanwhile the plant engineering.
- For this reason, the inspection was carried out only in the places where the false ceiling was previously removed.
