**COST ACTION FP1303**

**THERMAL PERFORMANCE WOODEN  
WINDOWS DAMAGED BY DECAY / case study/**

# 9 years old wooden windows in wellness

Tatranská Polianka (Slovakia)

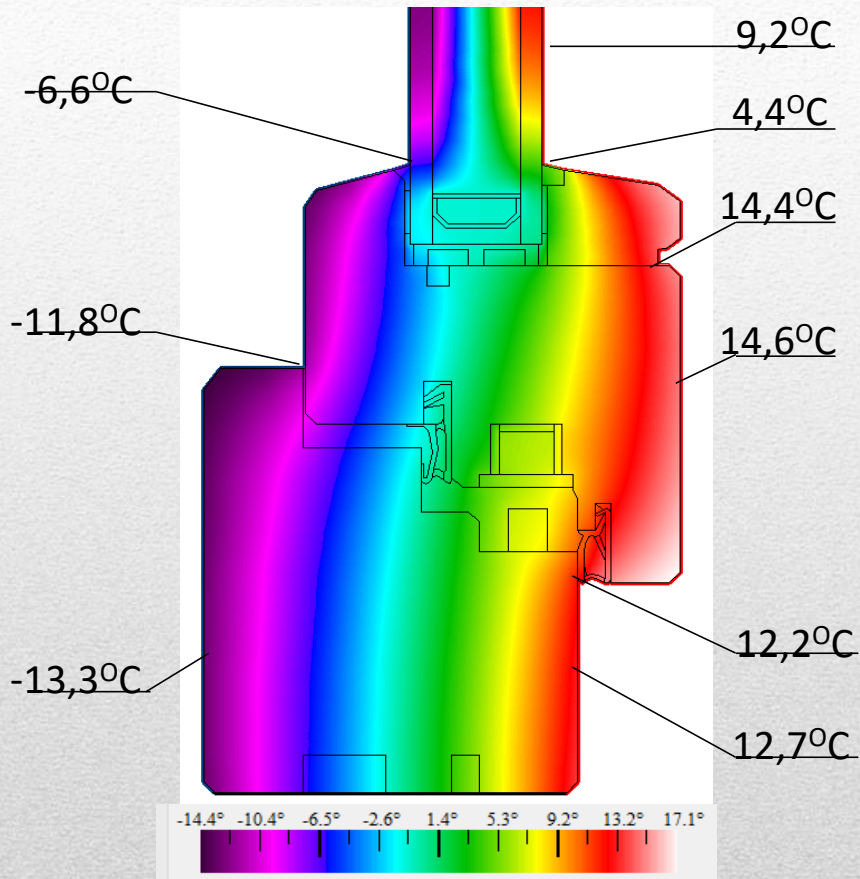
Window A	Window B
Material	Spruce – laminated wood	
Thick of wooden frame [mm]	68	78
Glazing	double	triple
Heat transmission coefficients of the glass $U_G$ [W/(m <sup>2</sup> .K)]	1.3	0.9
Leak under beading	no	yes

bathrooms, swimming pools, wellness, saunas

*Interior: Temperature -  $T_{IN} = 24 - 28$  °C,*

*Air relative humidity -  $RH = 30 - 60 - 99$  %  
constant and repeated high RH !!!*

*Exterior: Temperature -  $T_{EX} = -15$  °C*

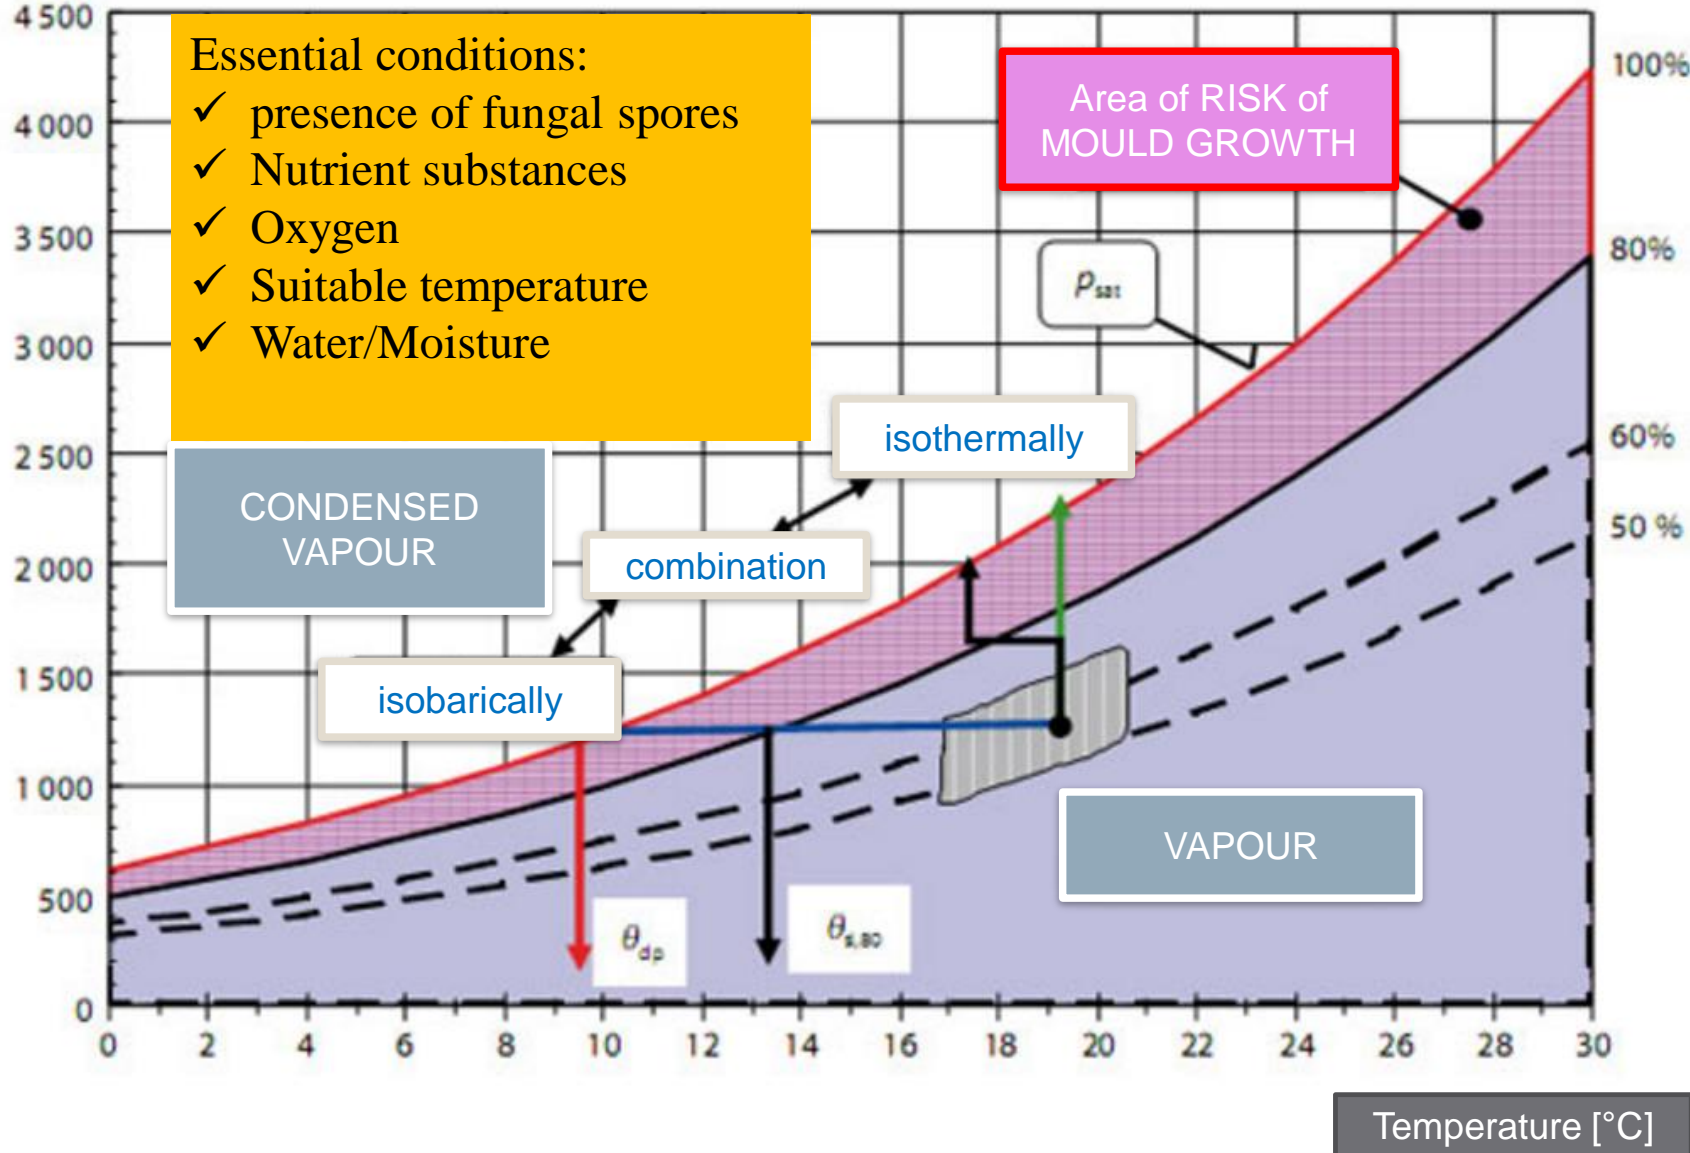
- Essential conditions:
- ✓ presence of fungal spores
  - ✓ Nutrient substances
  - ✓ Oxygen
  - ✓ Suitable temperature
  - ✓ Water/Moisture

# The risk of mould growth

Permanent MC in wood above 20%

Defect in finishing

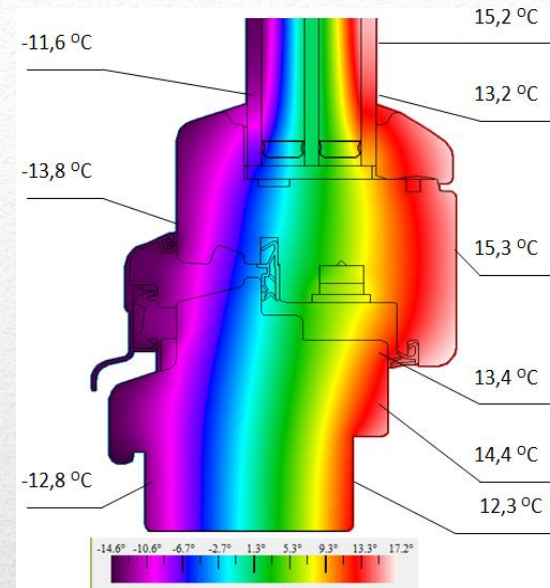
## BETTER: Window B

Window A	Window B
Material	Spruce – laminated wood	
Thick of wooden frame [mm]	68	78
Glazing	double	triple
Heat transmission coefficients of the glass $U_g$ [ $W/(m^2.K)$ ]	1.3	0.9
Leak under beading	no	yes

*Interior: Temperature:  $\theta_i = 20$  °C*

*Exterior: Temperature:  $\theta_e = -15$  °C*
