**“Designing, Application and Aesthetics of biobased building materials”**

**Performance of fir-spruce timber houses in North Spain. Examples of wood buildings. The importance of design details in the performance.**

***Lorenzo, David, Josu Benito, Juan Fernández-Golfín, Manuel Touza, Manuel Guaita, Alfonso Lozano***

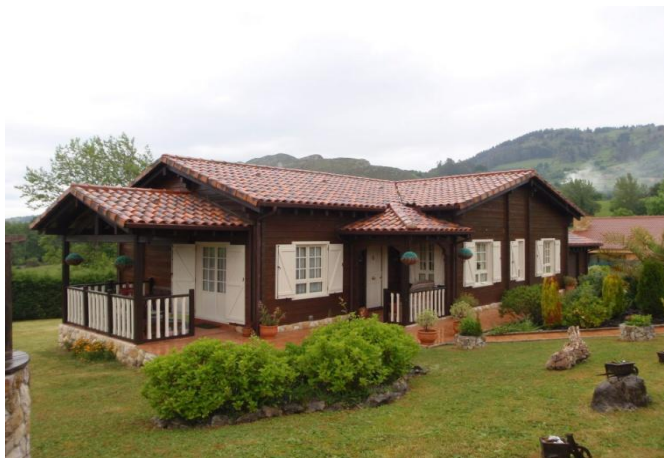
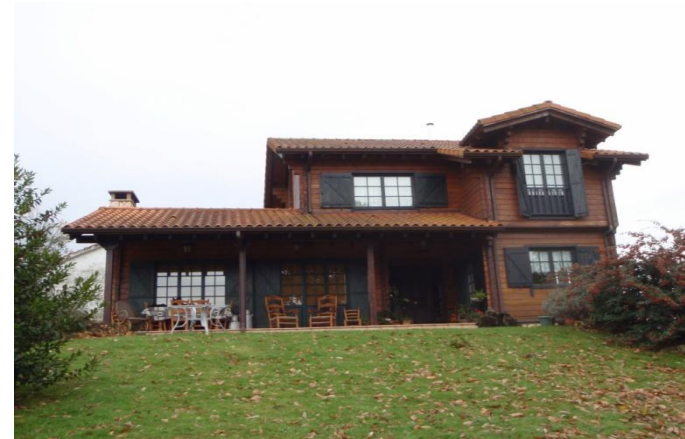
- **Timber houses:** Timber frame houses
- **Construction year:** 2009 (8 years)
- **Wood species:** *Abies alba* (fir) and *Picea abies* (spruce)
- **Treatment:** “Preservative treatment”
- **Coating:**
- **Wood type:** sawn wood
- **Use classes:** 1, 2, 3.1 and 3.2
- **Place:** North coast of Spain
- **Details design:** Sheltering, distance from ground, etc.
- **Performance:** “Early decays before 8 years”
