Performance of a noise barrier with different wood materials – results from a service trial after 20 years' exposure

Jöran Jermer

SP Technical Research Institute of Sweden
(now RISE Research Institutes of Sweden)

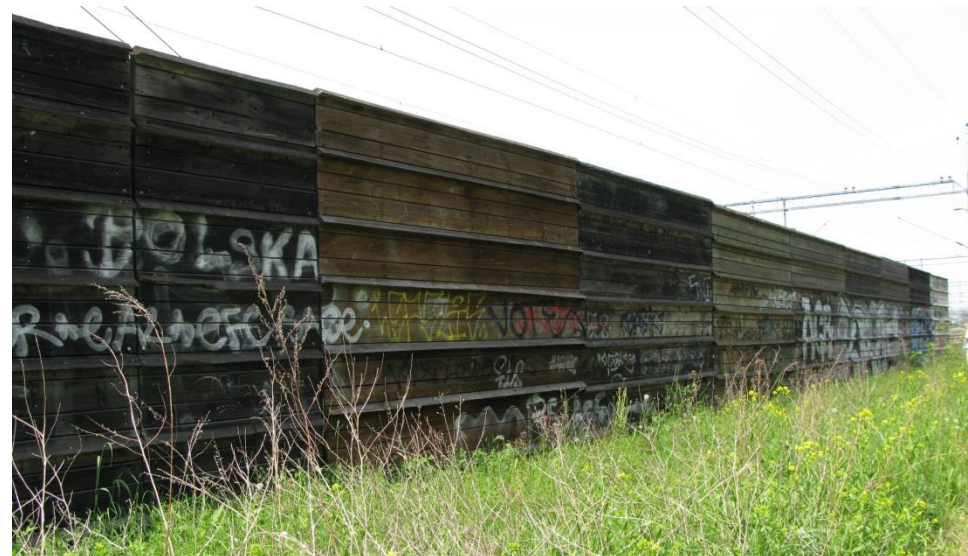
June 2016

- All sections were heavily subject to graffiti and it was not easy to evaluate any colour changes. However, the CCA-treated and Royal-treated seem to have kept their original colours best. The larch has become dark black and its colour is far from the pleasant original light reddish colour.
