COST FP 1303 Cooperative Performance Test – Results after two years outdoor exposure

COST FP1303 meeting - Sofia, 28.2.-1.3.2017

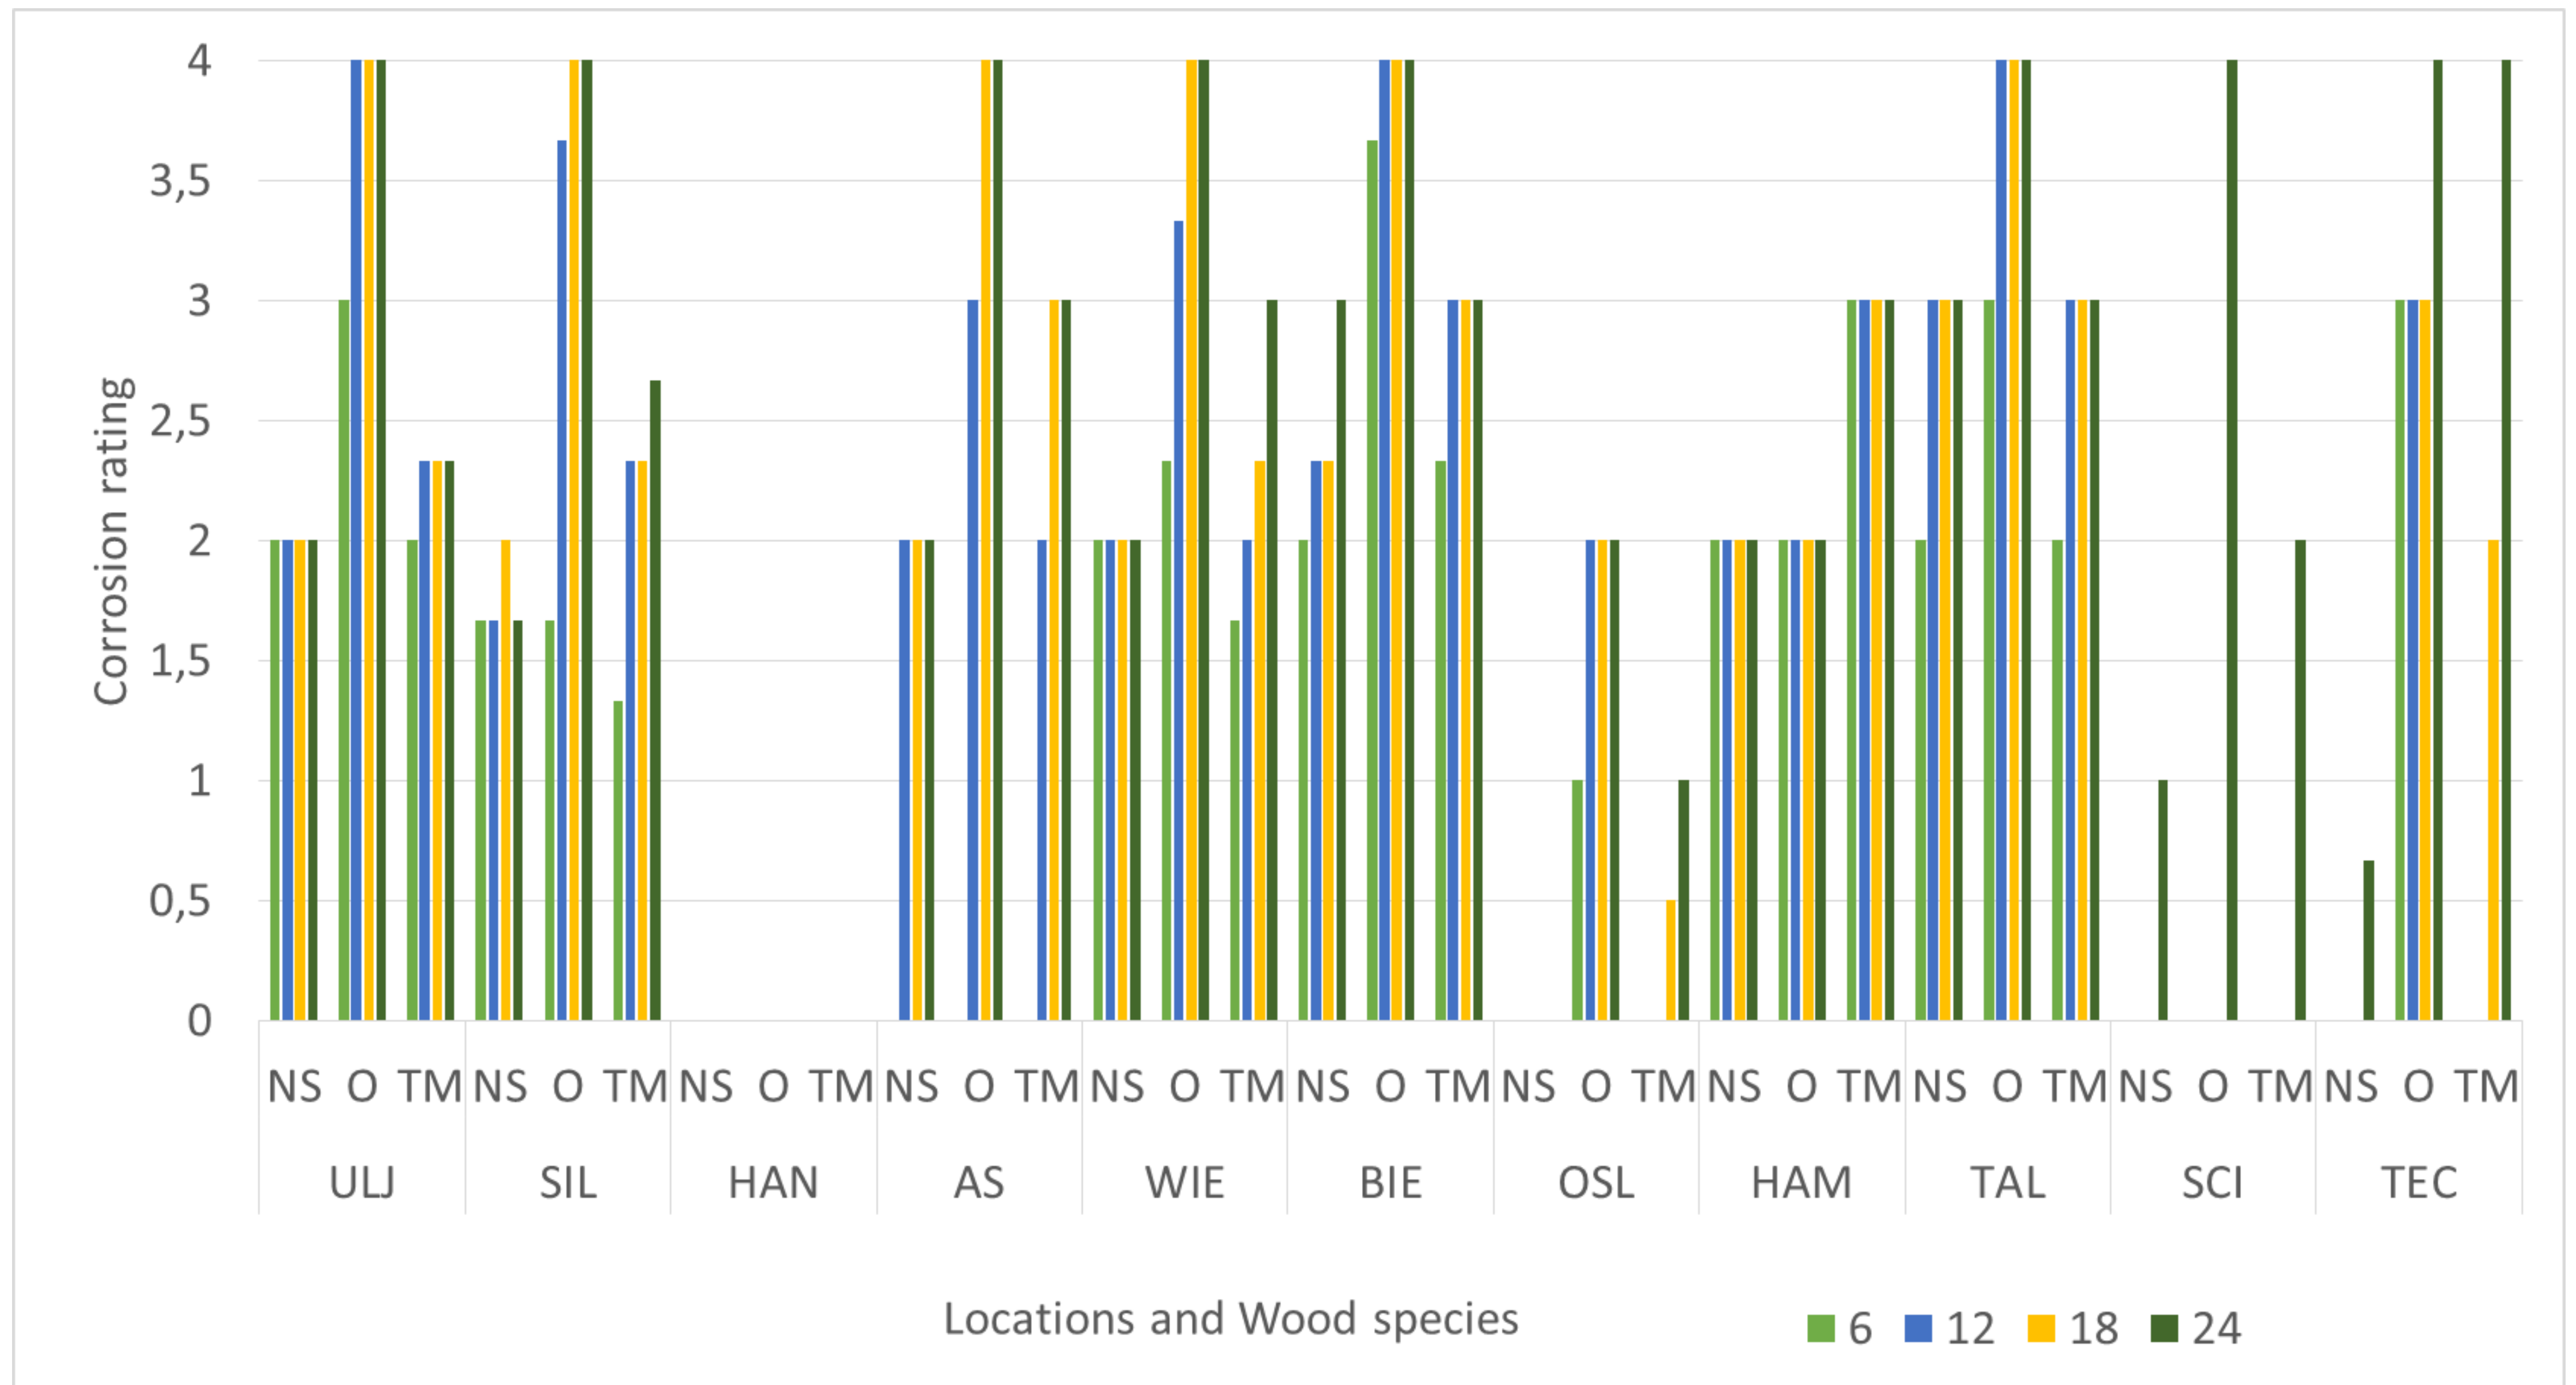
Results – Corrosion galvanized screws

- At the beginning slightly faster were colour changes fast of the TMT NS than NS or Oak
- Evaluation of disfigurement was in good coloration with colour change
- Crack formation is more relegated with sample orientation than the locations of the table
- Results of MC between locations are not comparable because of low number of measurements from some locations
- First decay was observe after two years on Norway spruce and Fir samples in Hamburg
- Galvanized screws corrode in Oak and slightly in TMT NS
