Deterioration of thatched roofs – moisture and temperature monitoring in a cold roof museum

C. Brischke, T. Bornemann, A.O. Rapp

Leibniz University Hannover

*COST FP 1303 Workshop
Tallinn [Estonia]
04-05 March 2015*

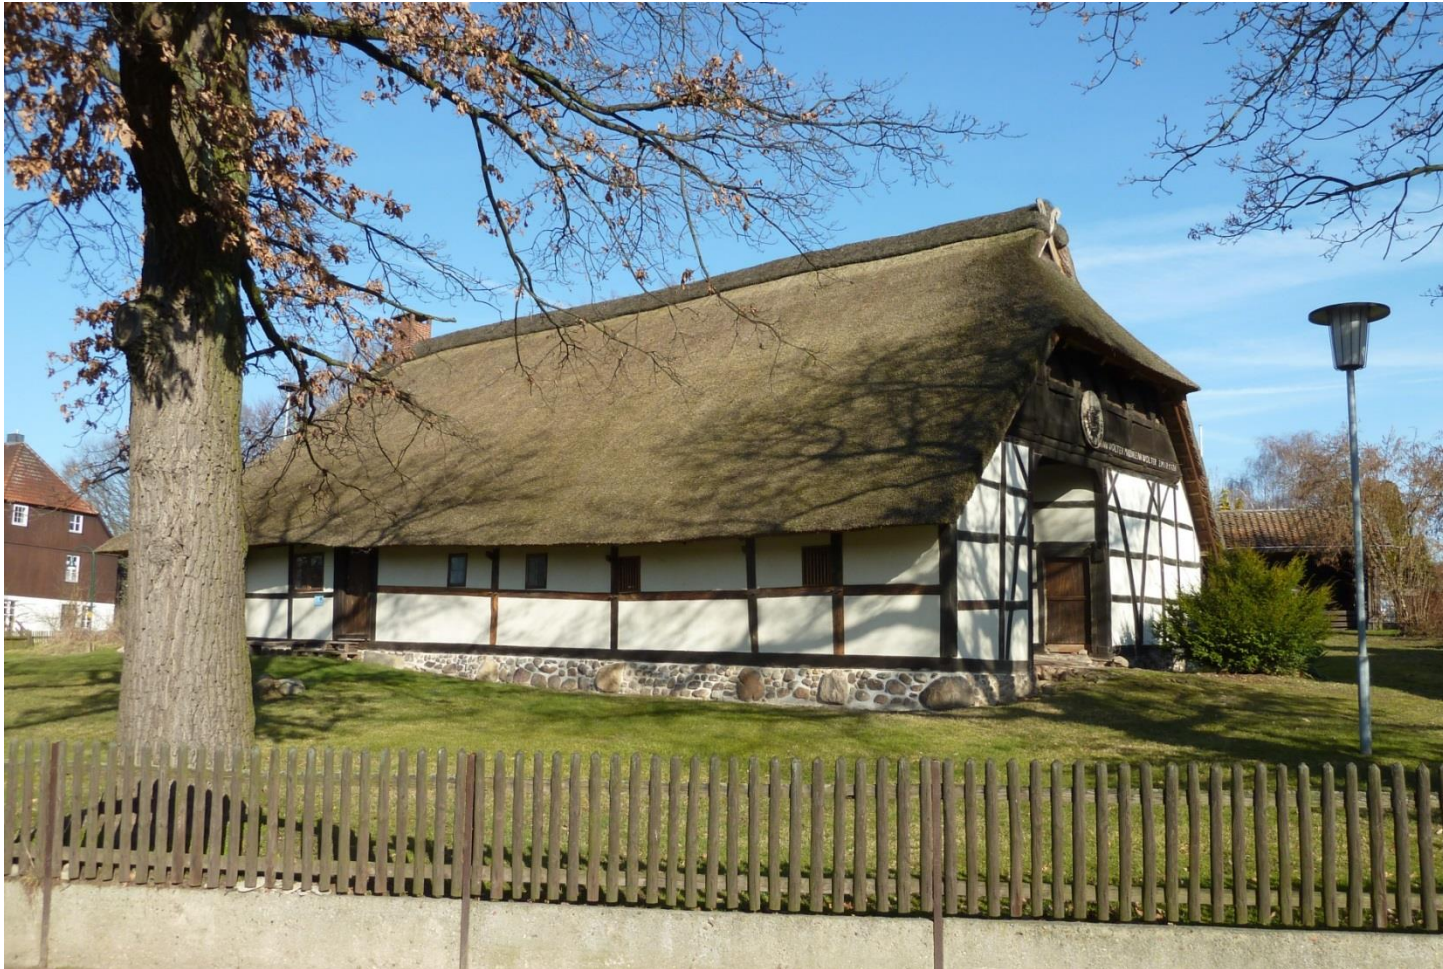
- Cold roof museum – built in 1639

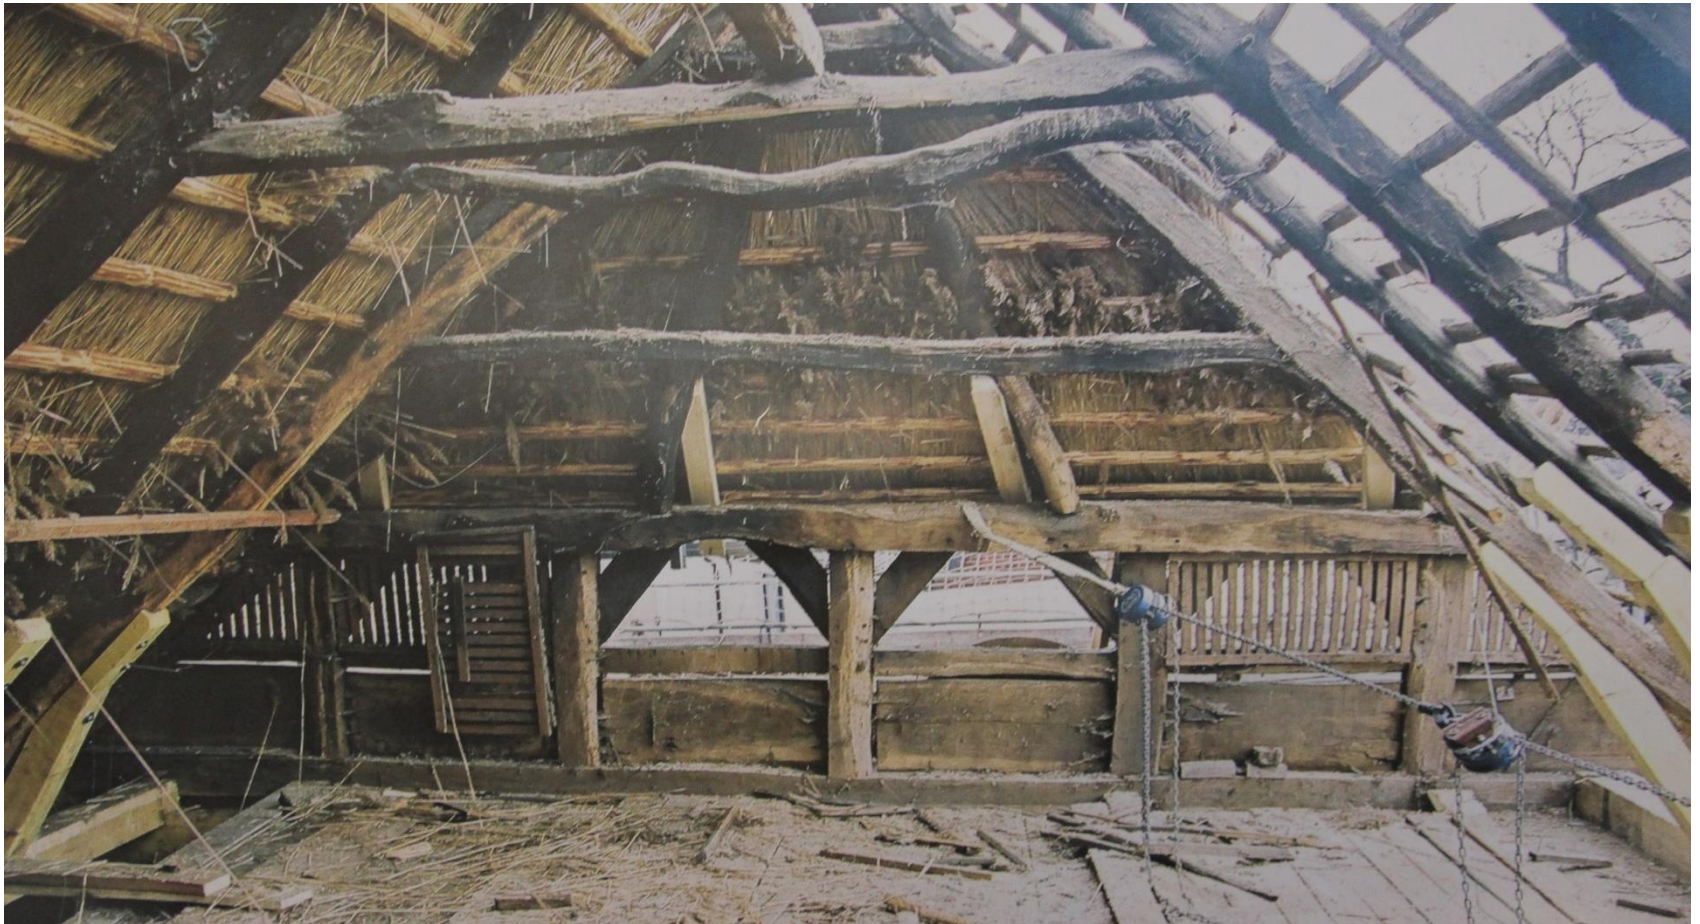
- Latest restoration started in 2006

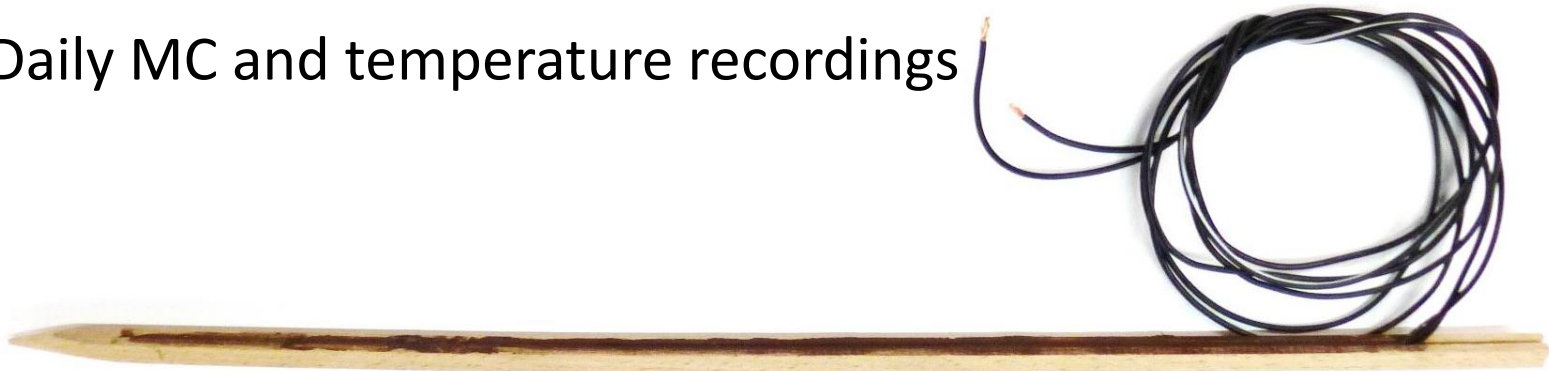
- Reed layer: 290 mm thickness
- Moisture monitoring at different depths
 - 35, 70, 105, 140, 175, 210 mm
- Measurement technique:
 - Substitute dowels (beech wood)
 - Electrical resistance measurements
 - Daily MC and temperature recordings

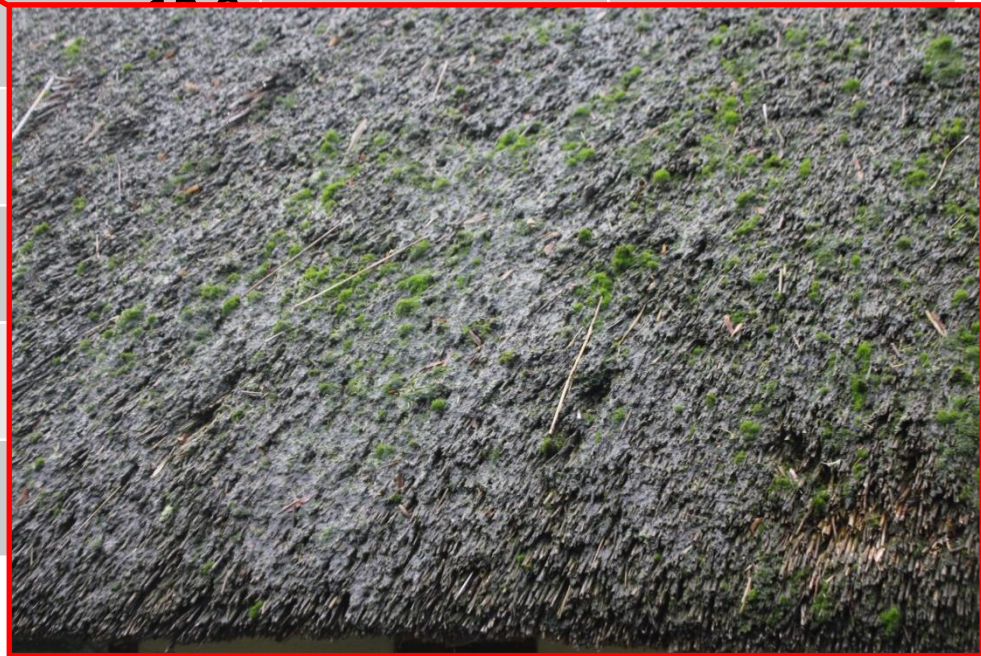
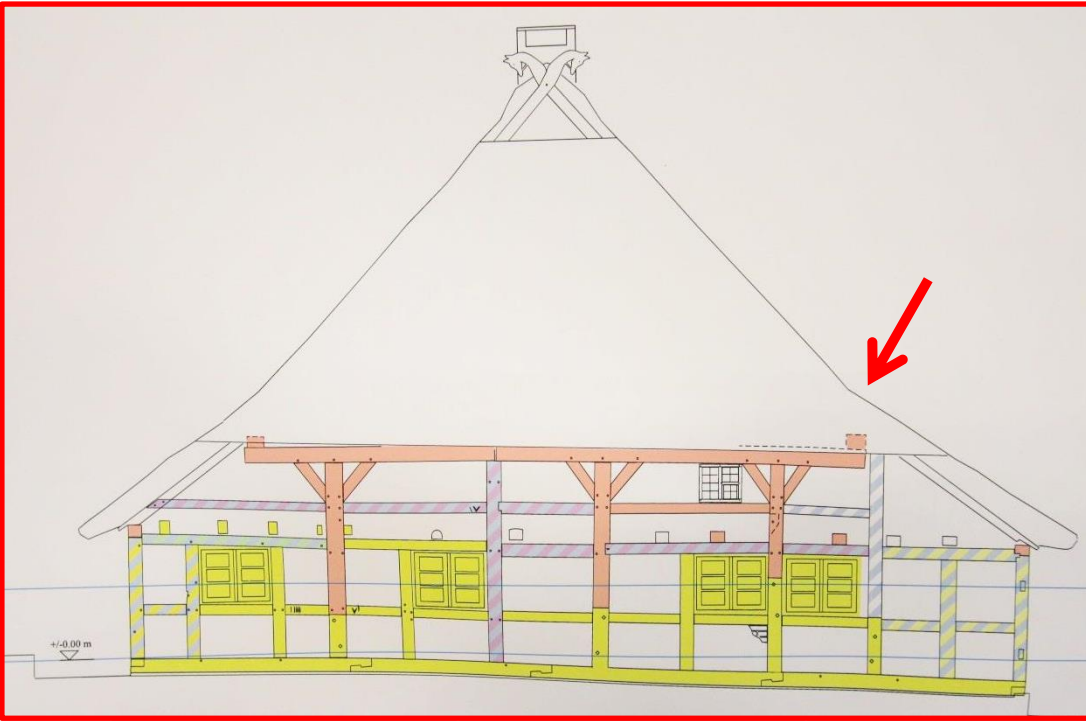
Average moisture content [%]

Lower roof		
		North*		South
	175 mm	12.5	12.7	13.7
	210 mm	12.3	12.8	
0.1		12.9		21.3
0.9				
0.3		12.6		19.6
0.9				
				16.8

- Highest moisture loads on outer layers of North roof
 - plus severe rot, and superficial growth
- Algae and mosses:
 - Cause or consequence of high MC?
- High MC where roof pitch turned from steep to flat
- Reason for premature failure not clearly identified
 - Further analysis needed!
 - Initial reed quality?
 - Storage conditions?
 - Pests? Preinfection?
