HYGROTHERMAL PERFORMANCE OF CROSS LAMINATED TIMBER AS EXTERNAL WALL LAYER

Villu Kukk, Jaan Kers

Chair of Woodworking, Department of Polymer Materials,
Tallinn University of Technology

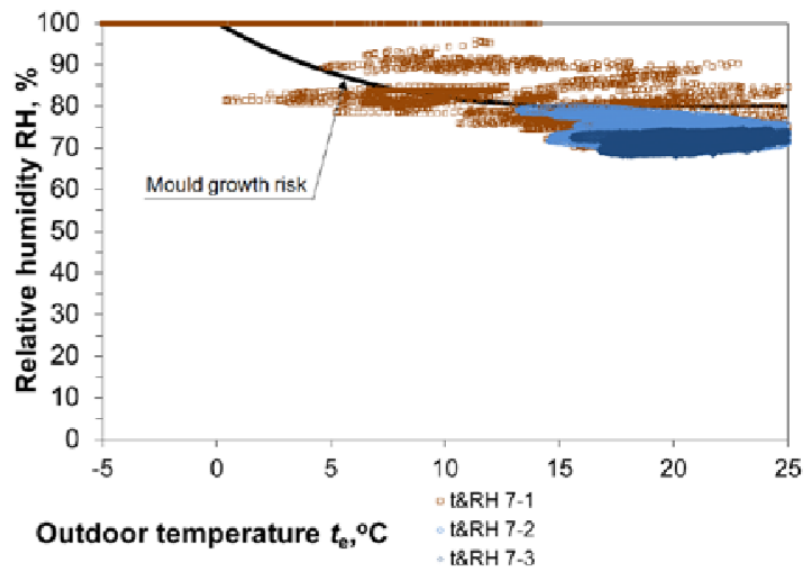
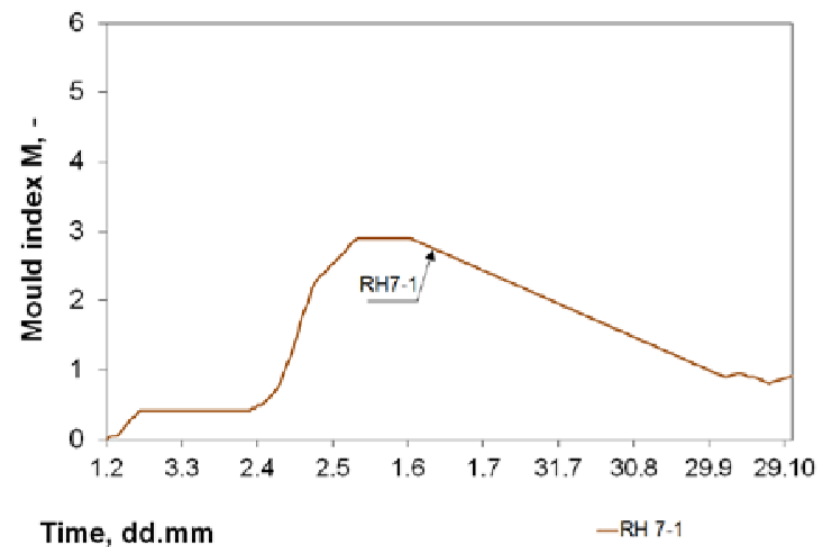
FIG 9 Temperature and RH between the cellulose insulation and the 12 mm thick wood fiber sheathing board (left) were suitable for mould growth, according to the mould growth index (right).

- Results showed high temperature readings in most of the rooms, (large windows in south). Small heat loss of the building envelope.
- Due to the high indoor temperatures, the relative

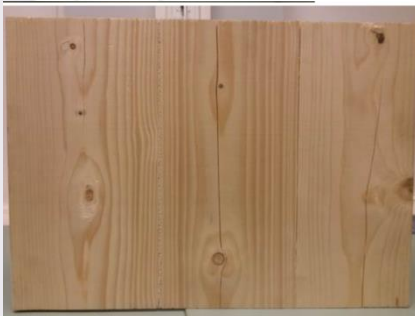
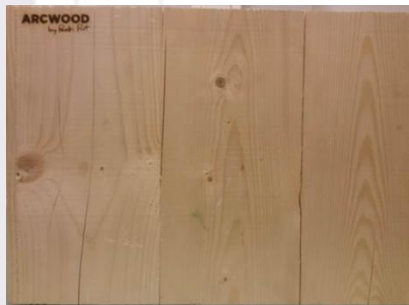
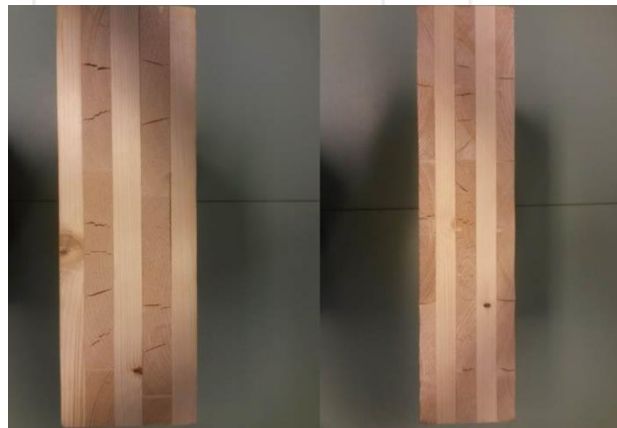
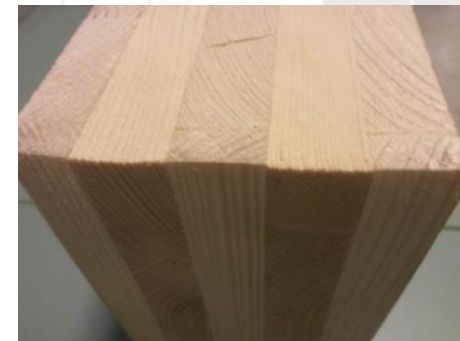
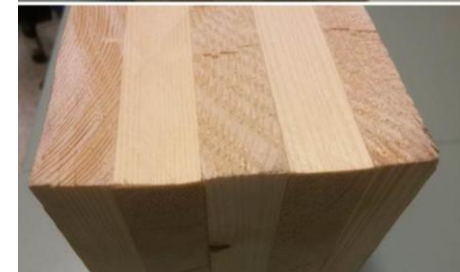
- CLT sample panel dry-out (initial MC 12%) in classroom 11.2014-03.2015
- Continuous cracking noise and visible deformations due to low RH (23...25%) and room temperature 23...24°C

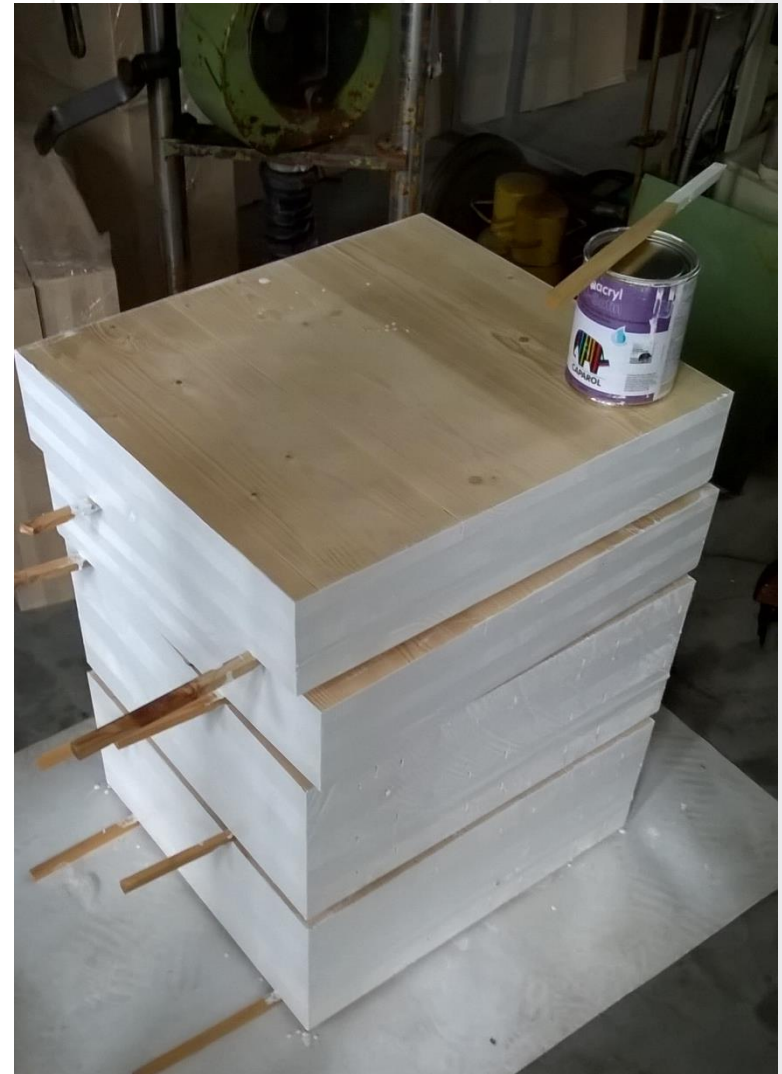
Four samples of:
W=500 mm,
H=450 mm

2pc 5x20=100 mm
2pc 5x40= 200 mm

- CLT panel edges were sealed with acrylic paint
