Model house for monitoring of performance of wood and quality of insulation envelope

Miha Humar*, Davor Kržišnik, Boštjan Lesar, Sergej Medved, Nejc Thaler, Mojca Žlahtič

Joint COST ACTION FP1303 & FP1404 Workshop
Tallinn, Estonia 4th – 5th March 2015

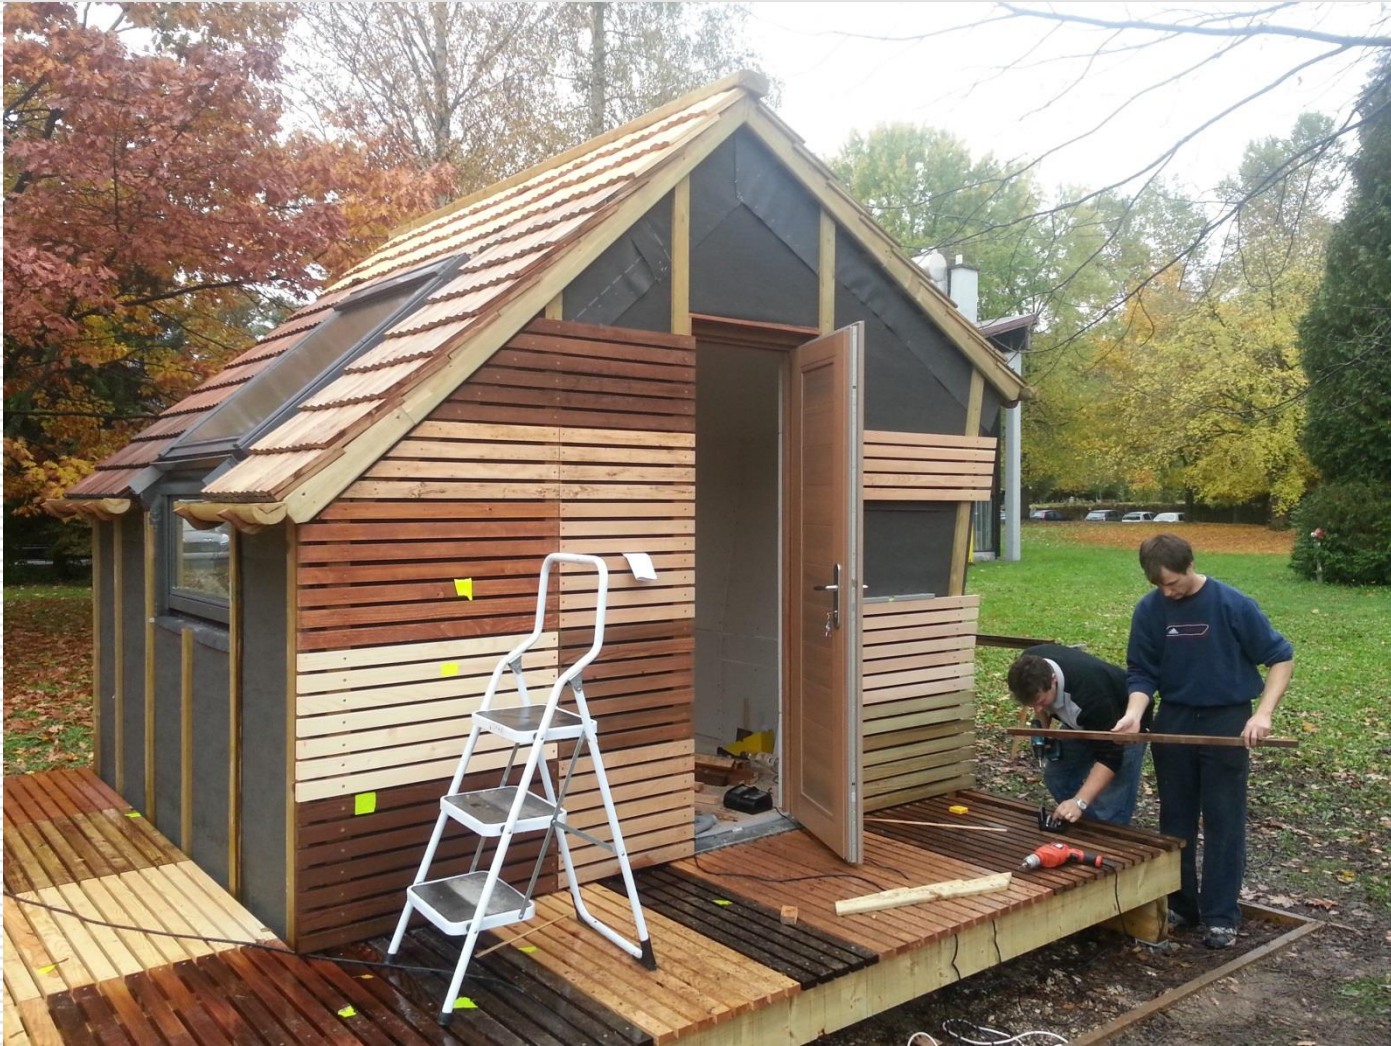
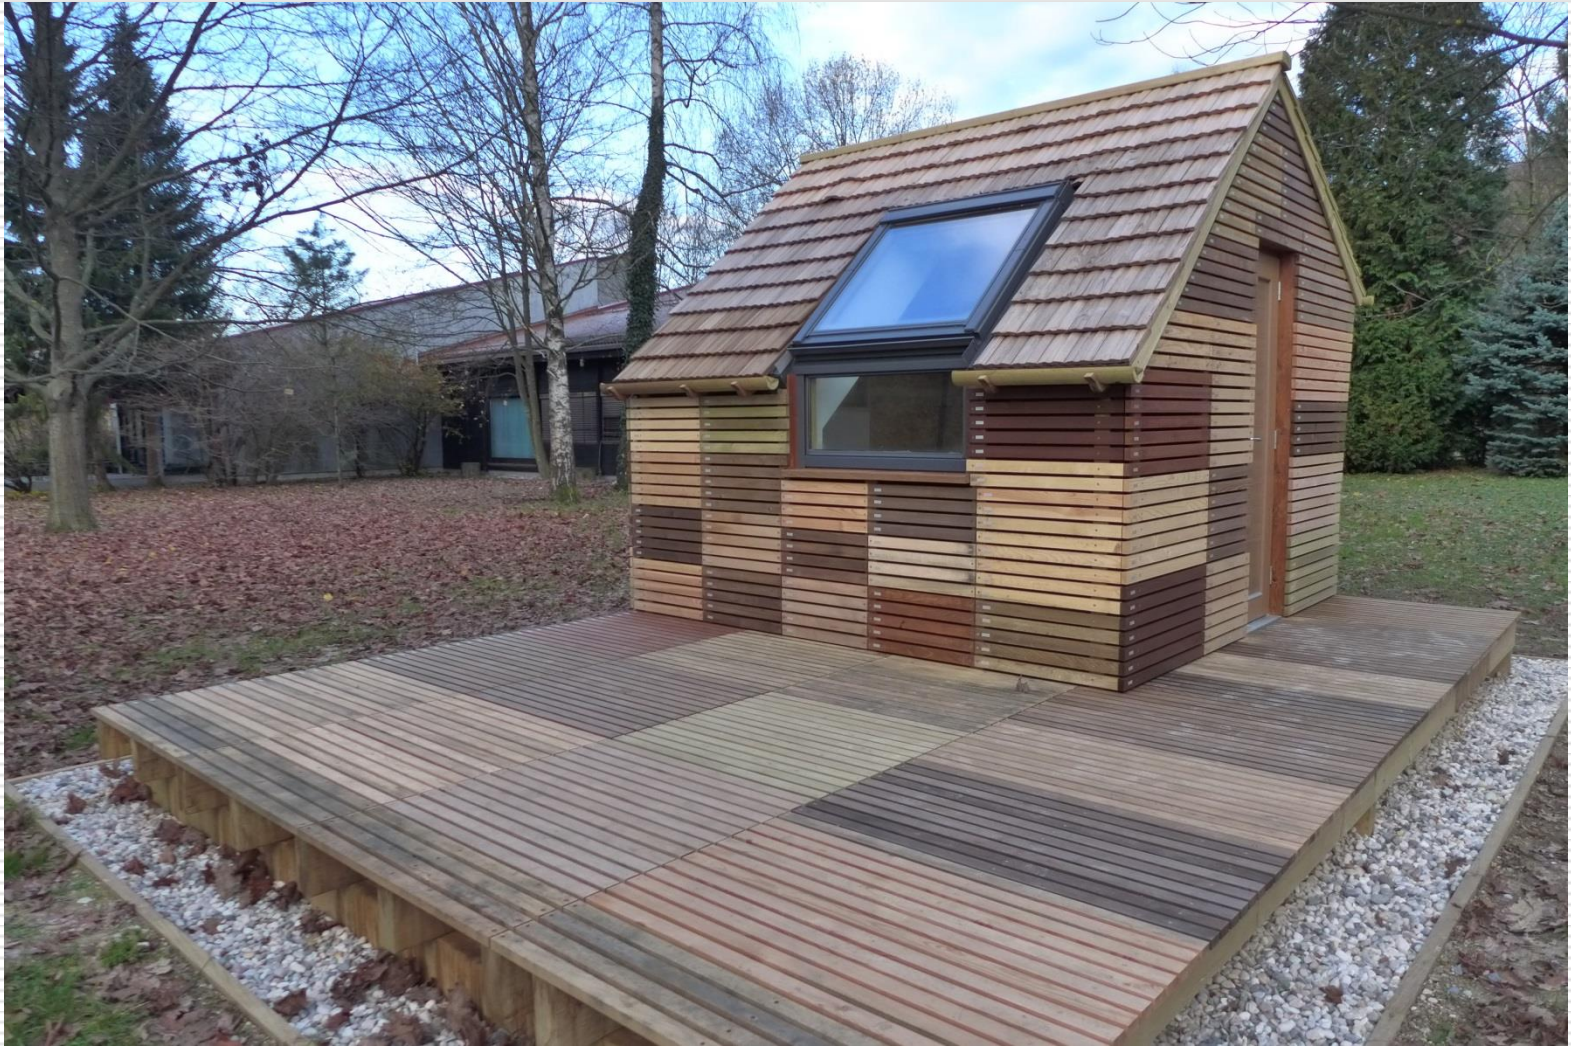
Façade and decking

Materials used in the façade and decking application on the model house

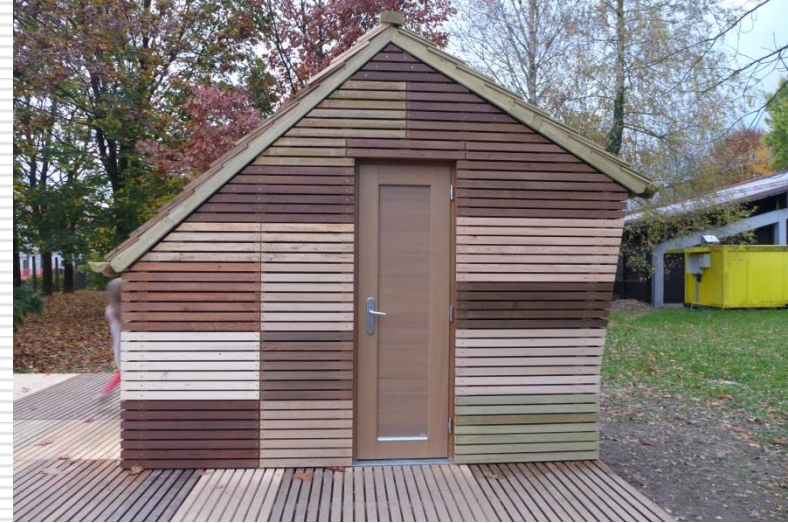
October
2013

- Color changes
- CIE $L^*a^*b^*$

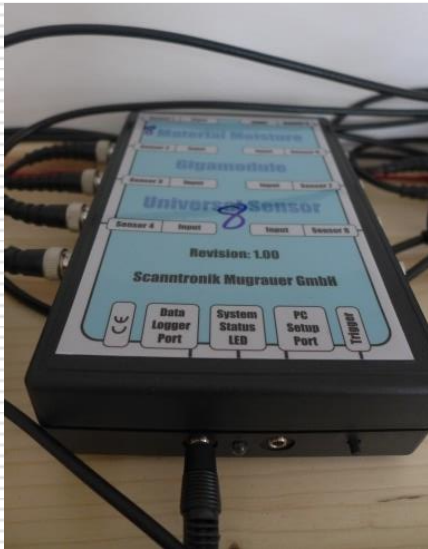
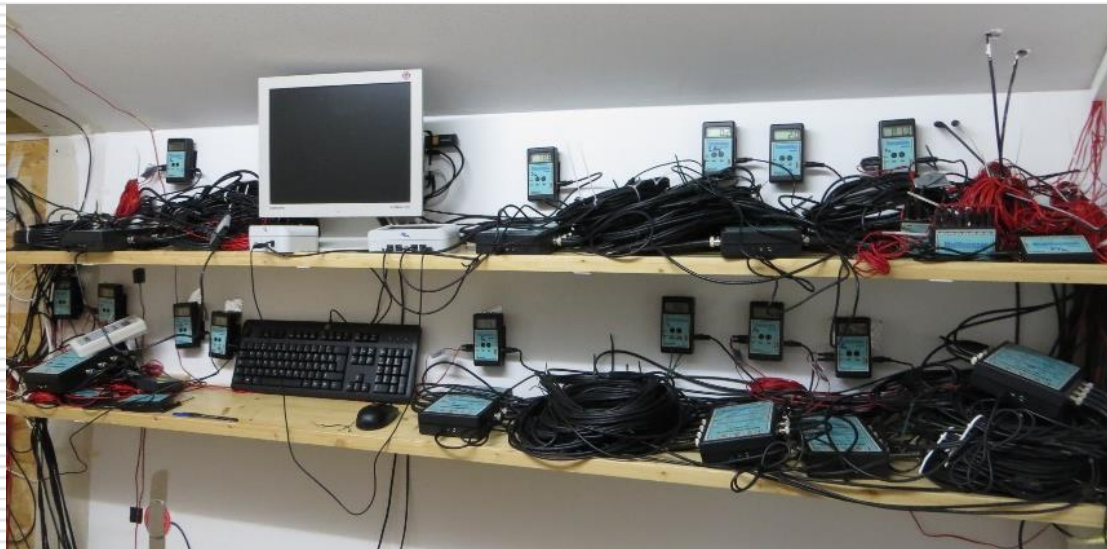
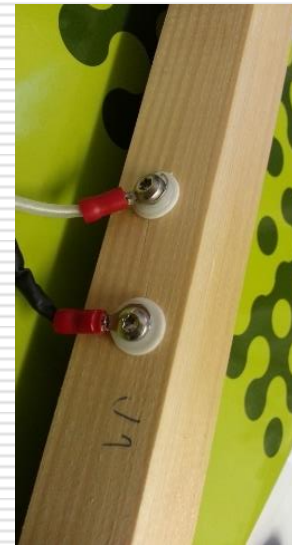
- Color changes
- Fungal disfigurement
- Corrosion
- Moisture content (160 MC sensors)
- Scanntronik Gigamodule

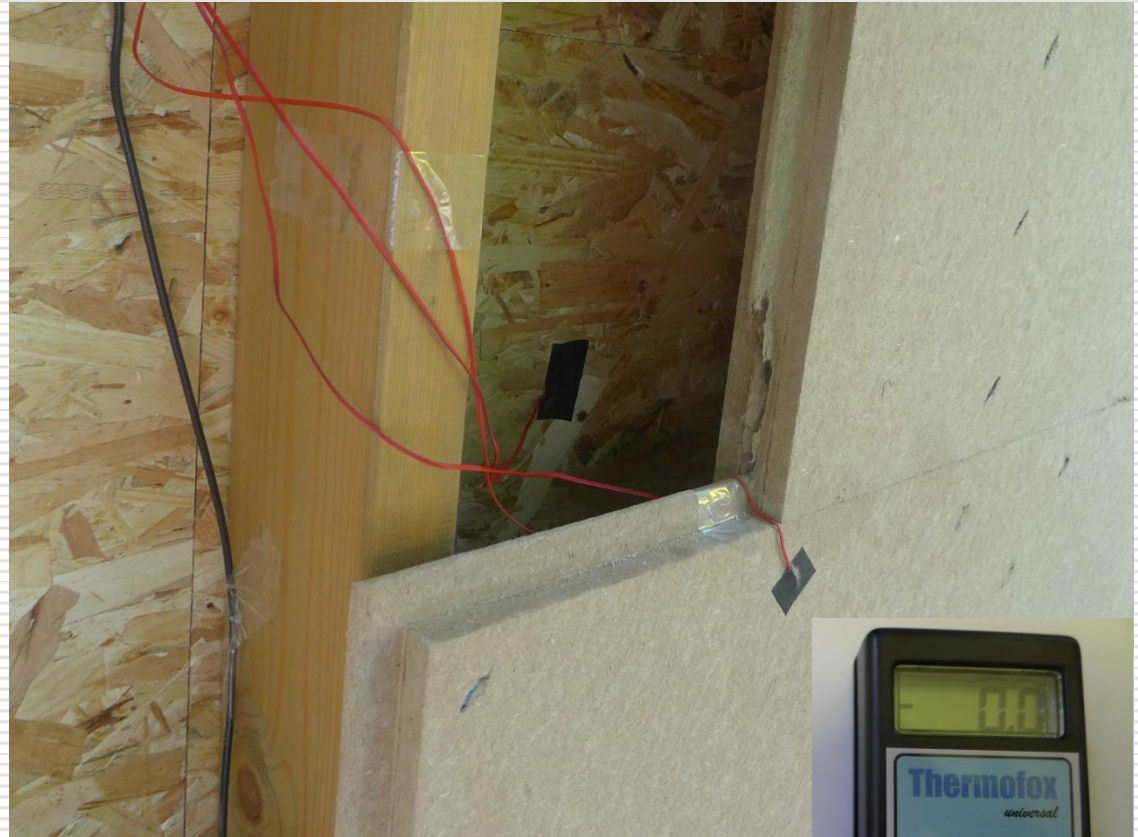
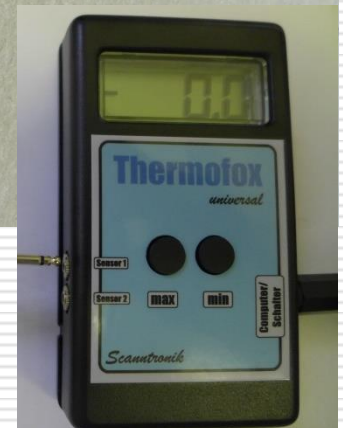
- Color changes
- Fungal disfigurement
- Corrosion
- MC
- Temperature

Scantronik,
thermofox

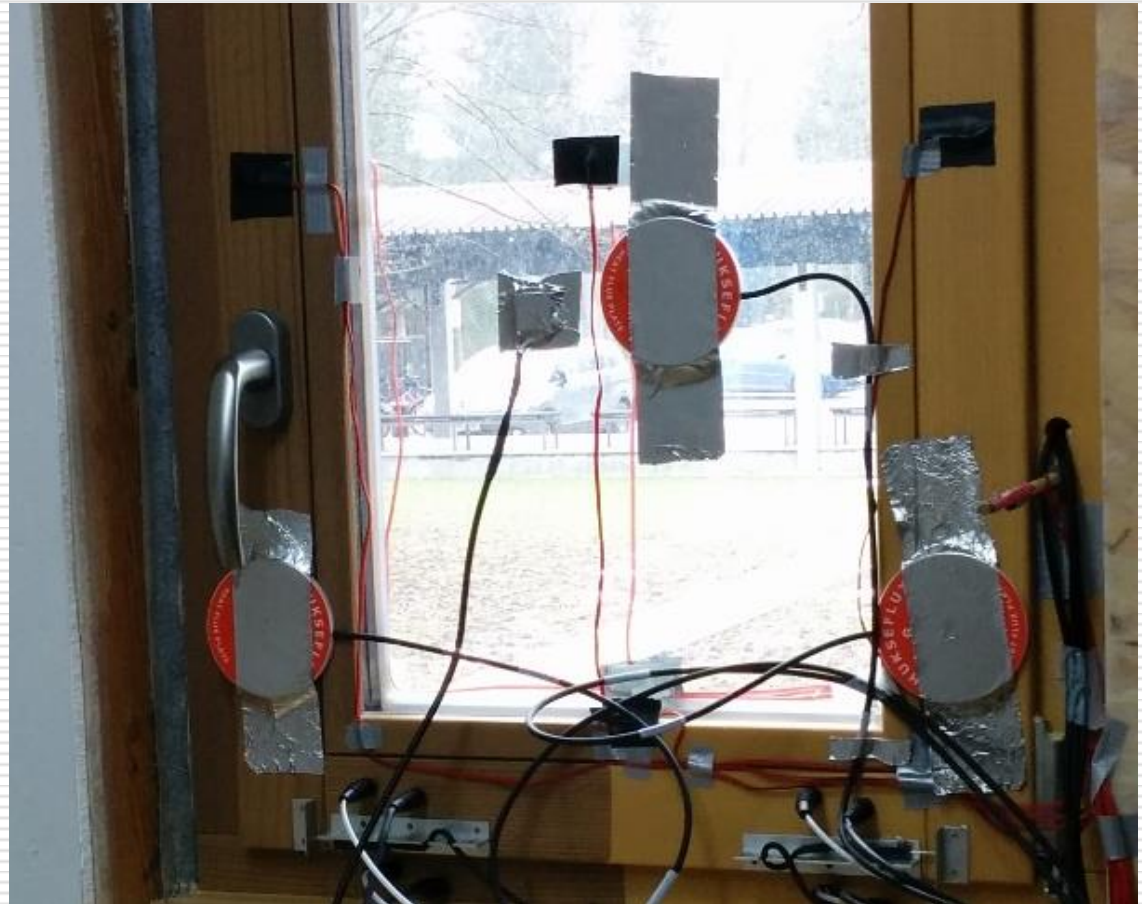
- Color changes
- Fungal disfigurement
- Corrosion
- MC
- Temperature
- Heat flux
 - Huxeflux

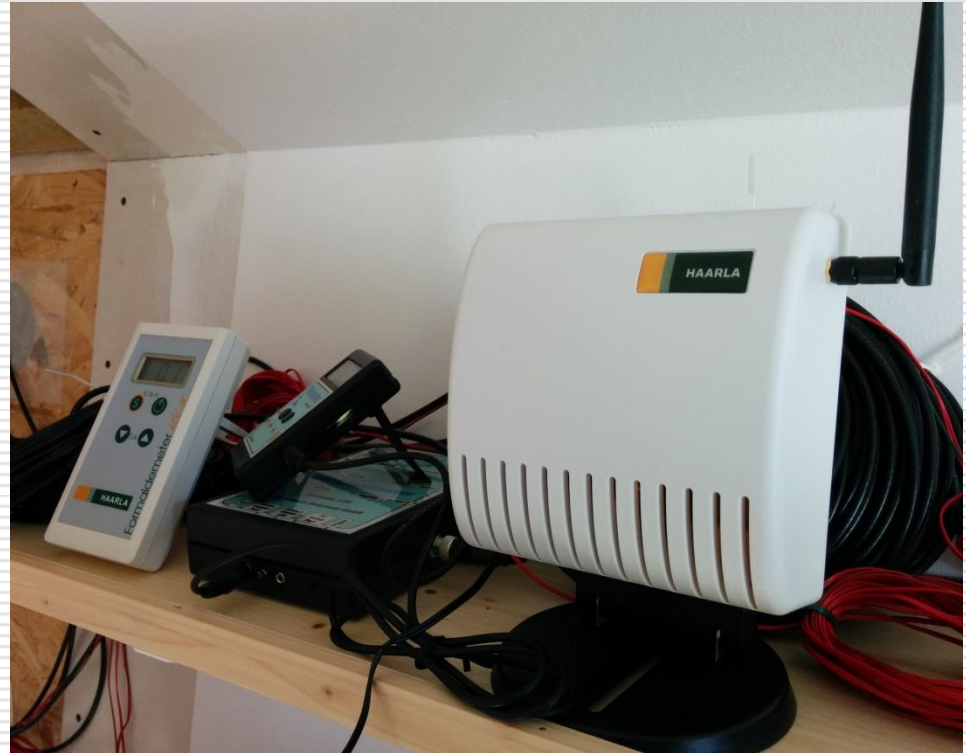
- Color changes
- Fungal disfigurement
- Corrosion
- MC
- Temperature
- **t, HCHO, VOC, RH**
 - Haarla

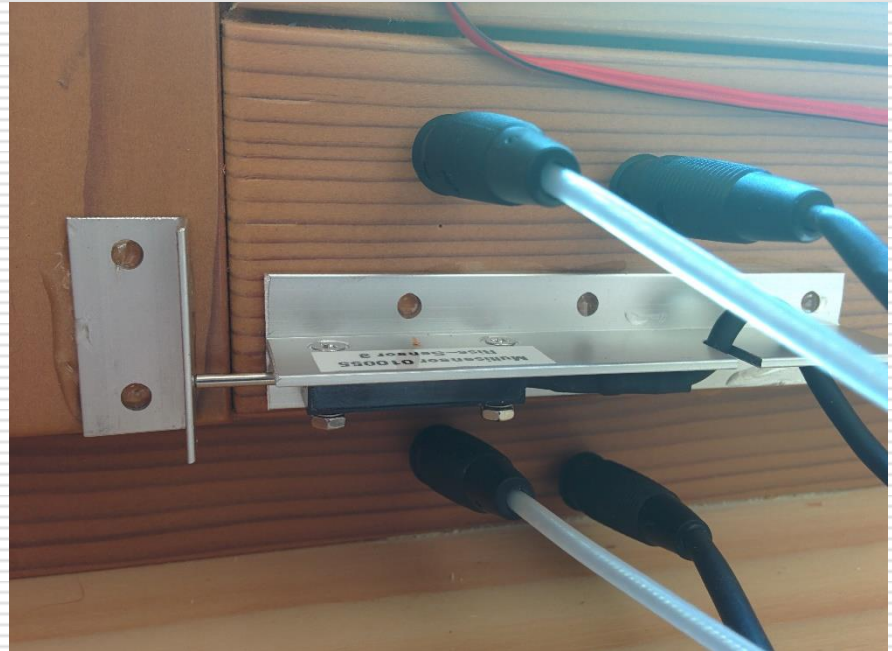
- ❑ Color changes
- ❑ Fungal disfigurement
- ❑ Corrosion
- ❑ MC
- ❑ Temperature
- ❑ t , HCHO, VOC, RH
- ❑ Cracks

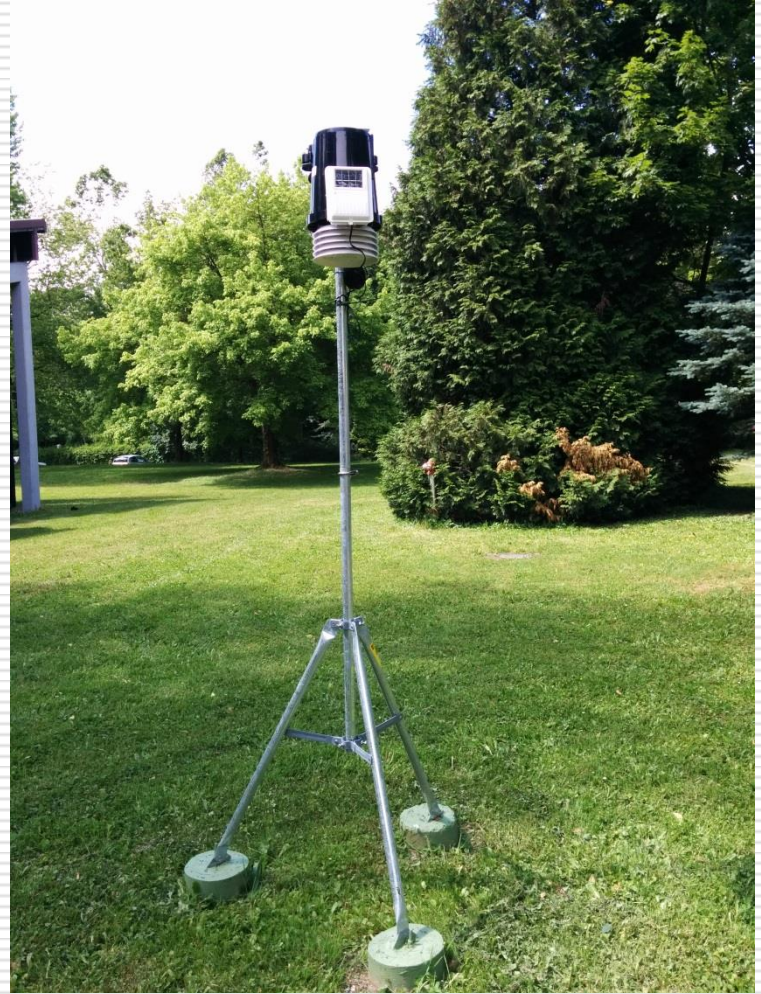
- Color changes
- Fungal disfigurement
- Corrosion
- MC
- Temperature
- t , HCHO, VOC, RH
- Cracks
- Weather
 - t , RH, precipitation, solar radiation...
 - Davis

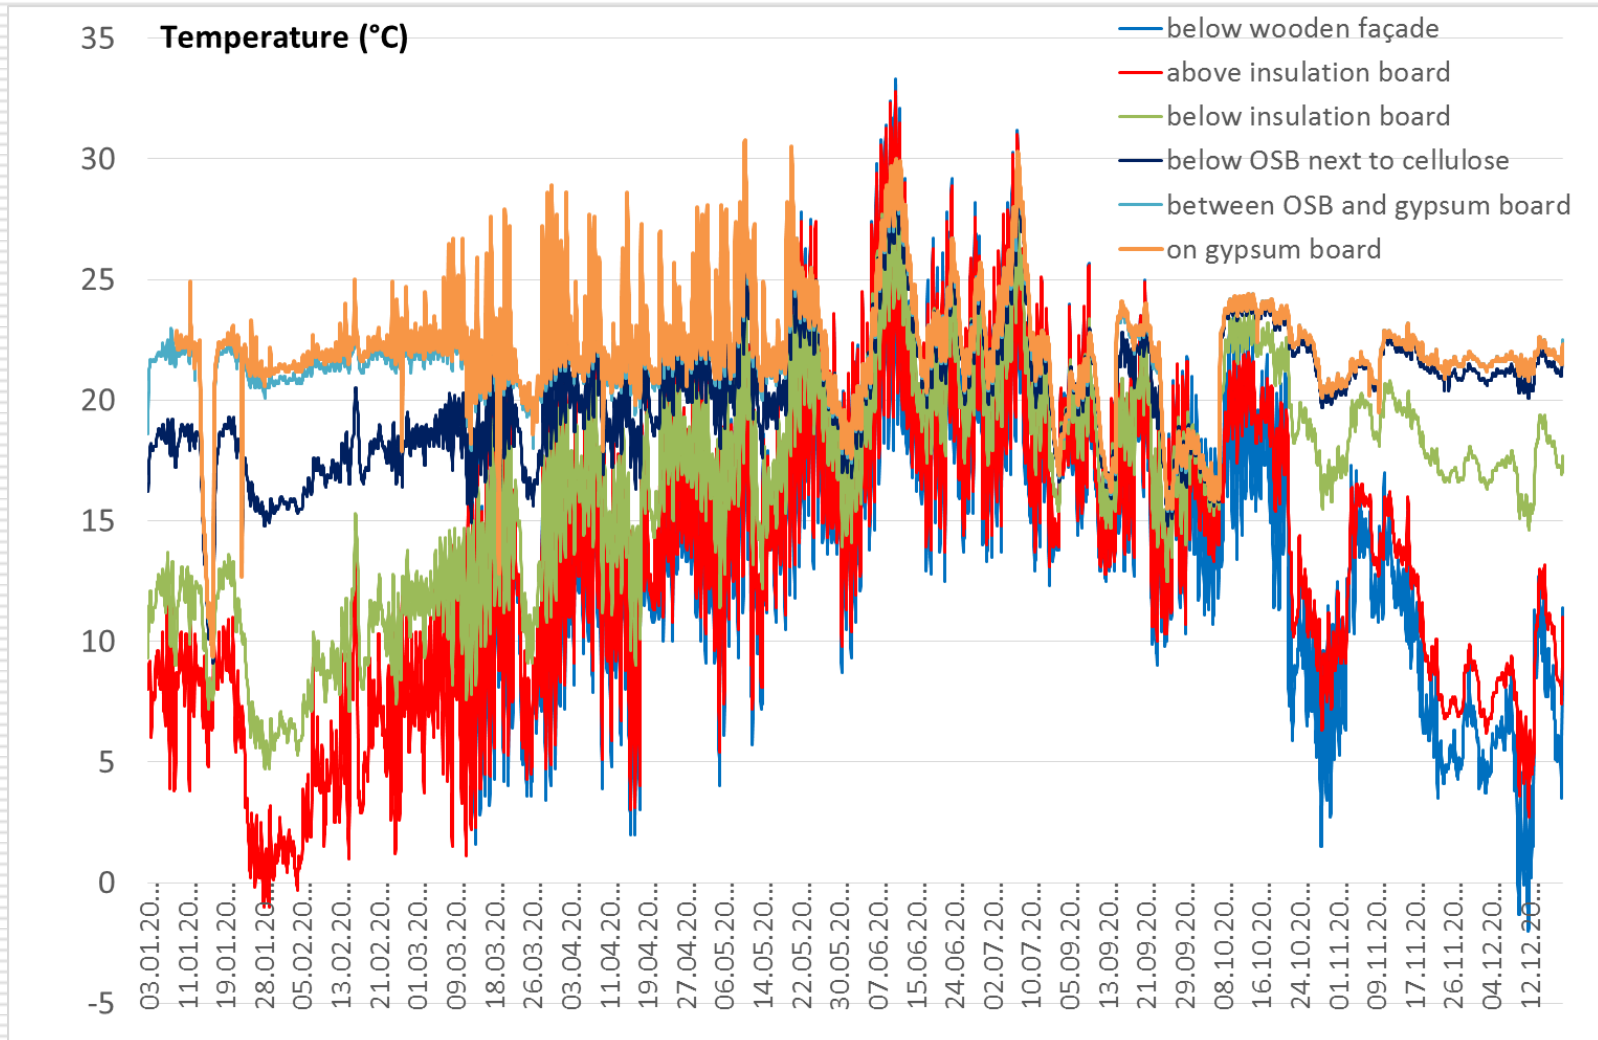
Temperature distribution through the wall

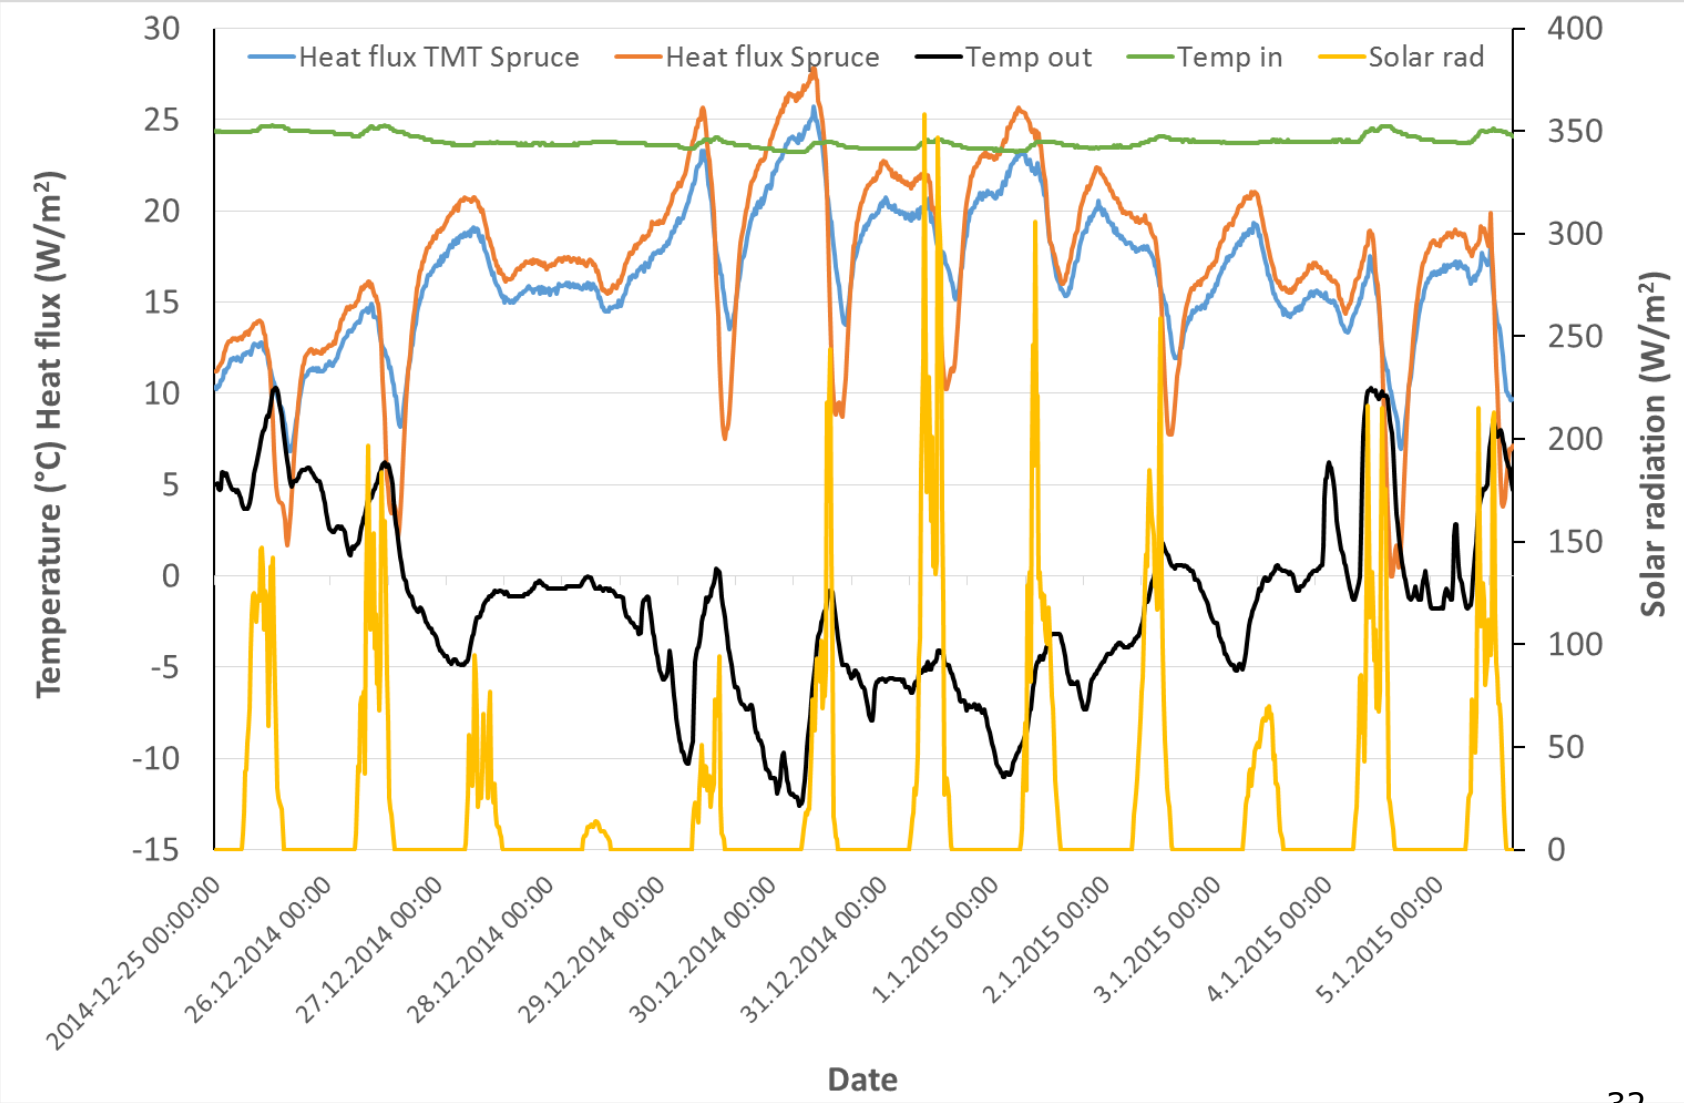
Heat flux – window TMT vs spruce
