# Moisture monitoring in buildings in different micro-climate environments

Miha Humar, Davor Kržišnik, Boštjan Lesar, Ajda Pogorelčnik, Nejc Thaler

University of Ljubljana, Biotechnical Faculty, Ljubljana, Slovenia

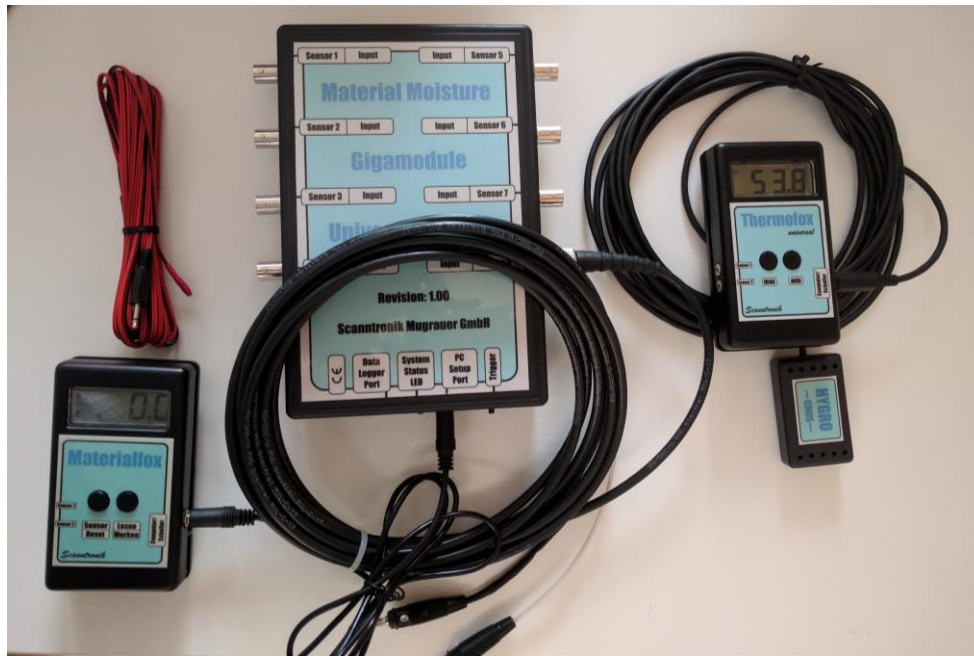
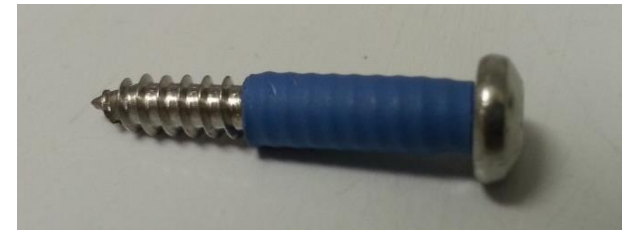
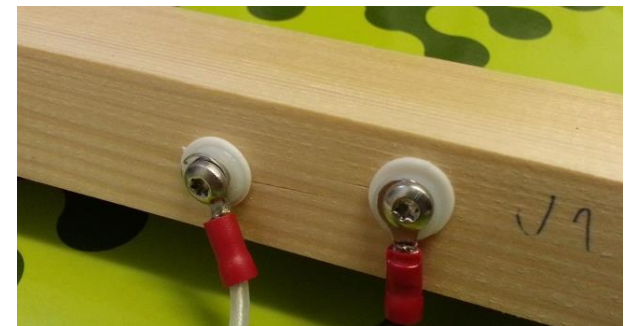
# Technical equipment

- Scanntronik equipment
  - Gigamodule – MC
  - RH and temperature sensors
  - Thermofox – data logger

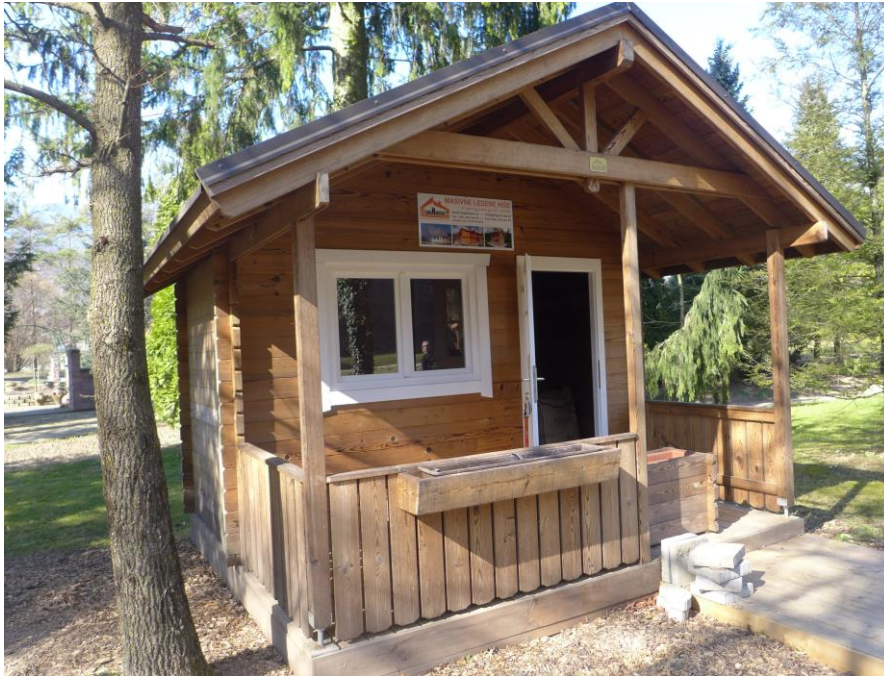
# A. Mozirje

- House located in the park
- Made of TM modified spruce wood (Silvapro, Silvaproduct)
- Finished in 2009
- Monitoring: March 2015
- 8 MC measurements

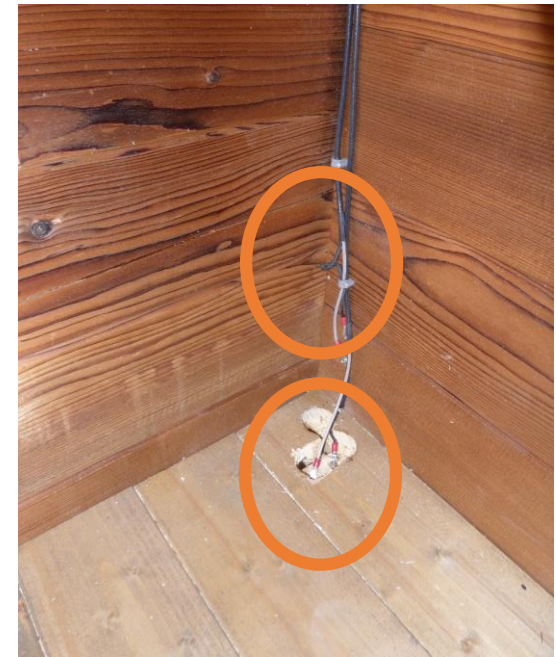
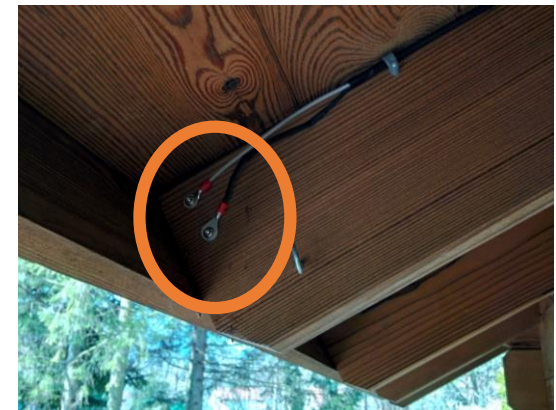
# Measurements locations

M1	TM spruce	Outside wall, close to the ground.	3.1
M2	TM spruce	Rafter, inside.	1
M3	TM spruce	Outside wall, 1.5 m above ground.	2
M4	Spruce	Lath, close to rafter, inside.	1
M5	TM spruce	Rafter, outside.	2
M6	TM spruce	Beam inside.	1
M7	TM spruce	Beam outside.	2
M8	Spruce	Support beam for flooring.	2

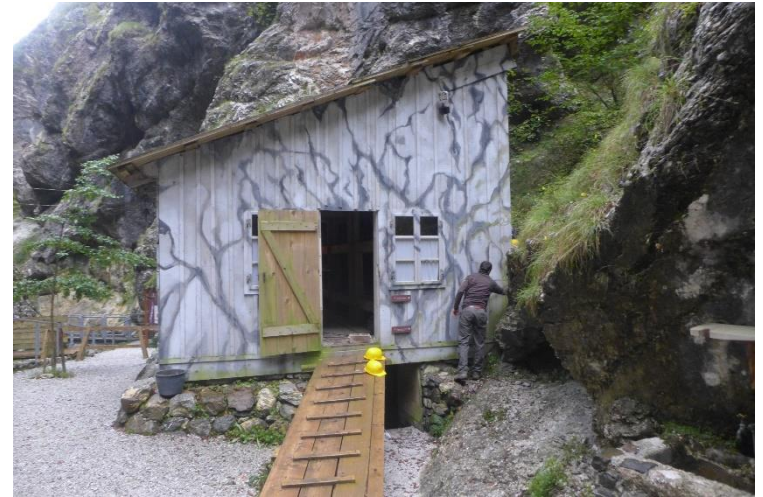
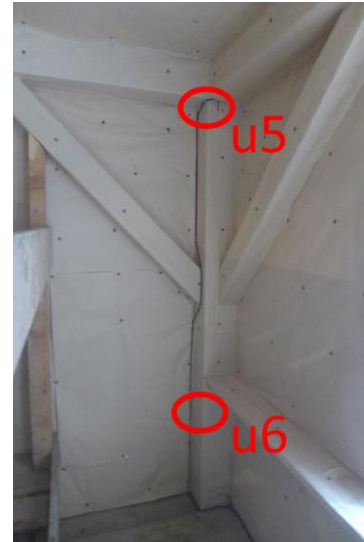
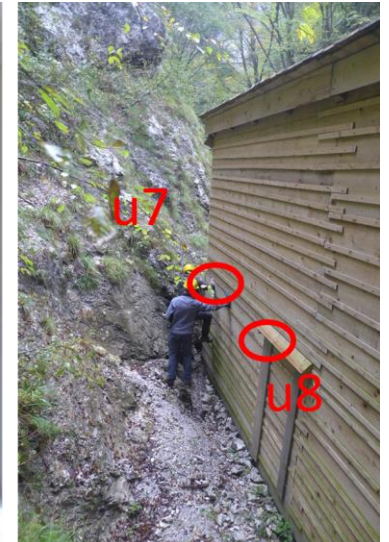
# Material climate monitoring

F1	Cu-EA spruce	Cellar. Plank is covered with soil from one side.	4
F2	Cu-EA spruce	Cellar. Wood plank; part of the ceiling/floor.	4
F3	Cu-EA spruce	Cellar. Beam; part of the ceiling.	4
F4	Cu-EA spruce	Cellar. Wood plank can be dried from both sides.	4
F5	Cu-EA spruce	Pillar on 1st floor. 1.8 m above the floor. Indoor.	1
F6	Cu-EA spruce	Pillar on 1st floor. 0.5 m above the floor. Indoor.	1
F7	Cu-EA spruce	Façade, corner, 1.8 m above ground.	3.1
F8	Cu-EA spruce	Above the door, part of façade.	3.2

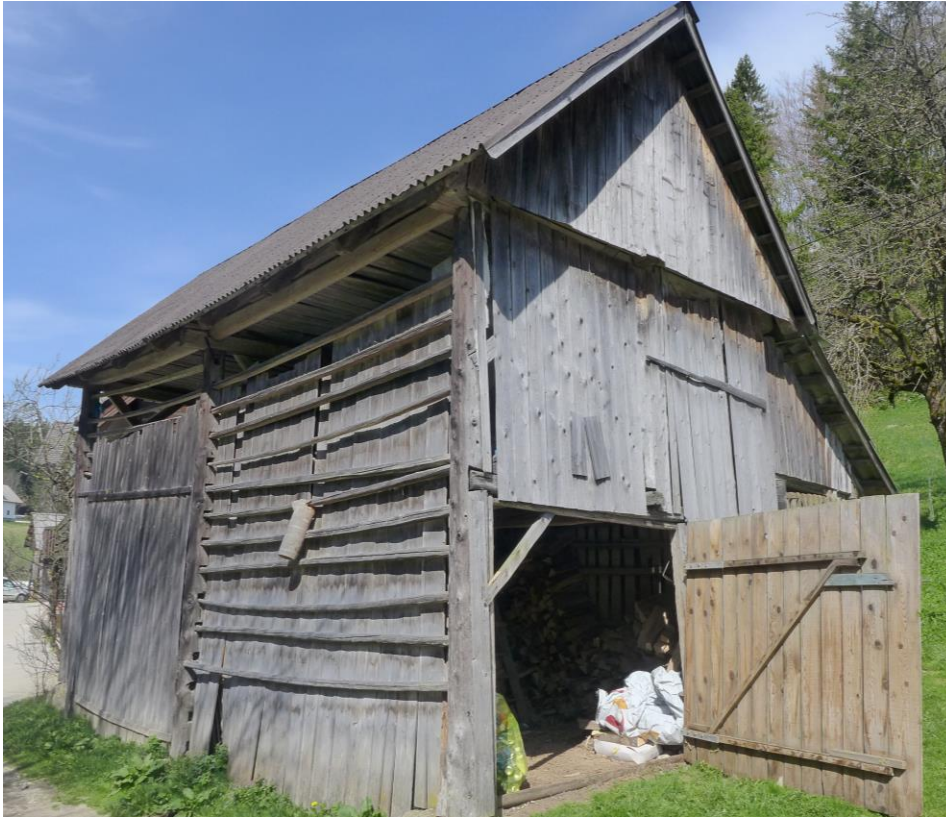
# C. Pokljuka - Koprivnik

- Hayrack
- Object located in the Alpine plateau Pokljuka 1000 m
- Made of spruce and larch wood
- Approximately 100 years old
- Monitoring: April 2016
- 8 MC measurements

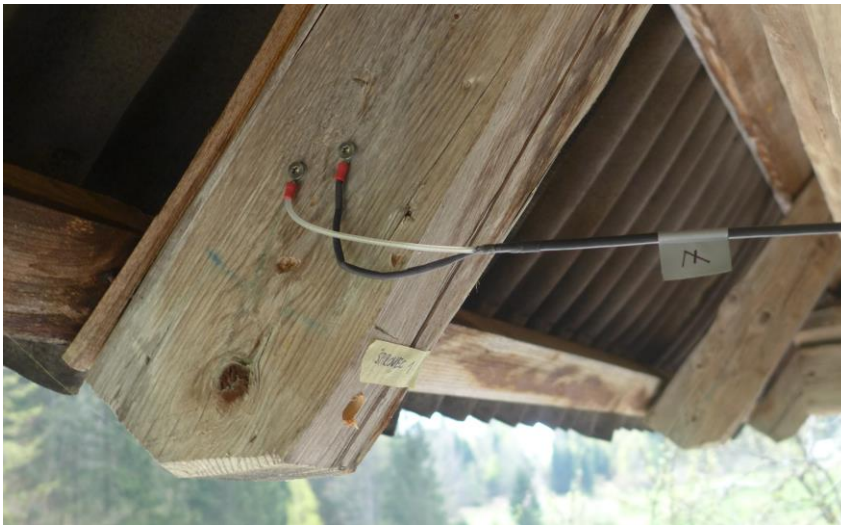
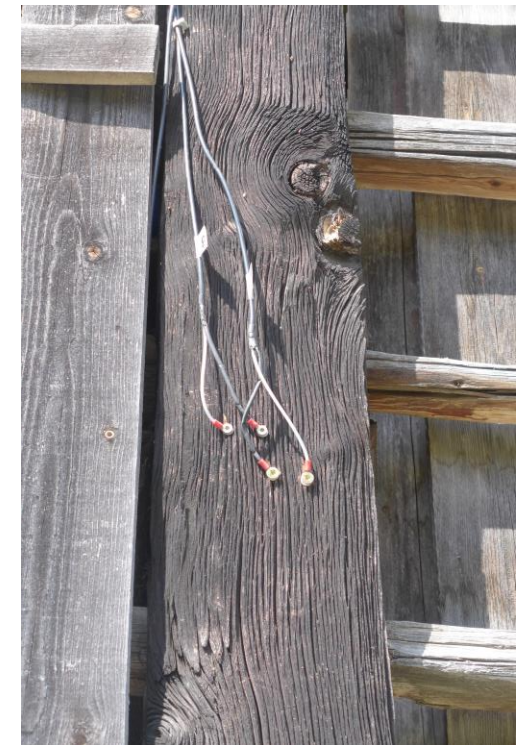
# Material climate monitoring

P1	Larch	Pillar, close to the ground, 2 cm deep.	3.1
P2	Larch	Pillar, close to the ground, 6 cm deep.	3.1
P3	Larch	Pillar, 1.5 m above ground, 2 cm deep.	2
P4	Larch	Pillar, 1.5 m above ground, 6 cm deep.	2
P5	Larch	Pillar, 4 m above ground, 2 cm deep.	2
P6	Larch	Pillar, 4 m above ground, 6 cm deep.	2
P7	Spruce	Rafter.	2
P8	Spruce	Beam.	2

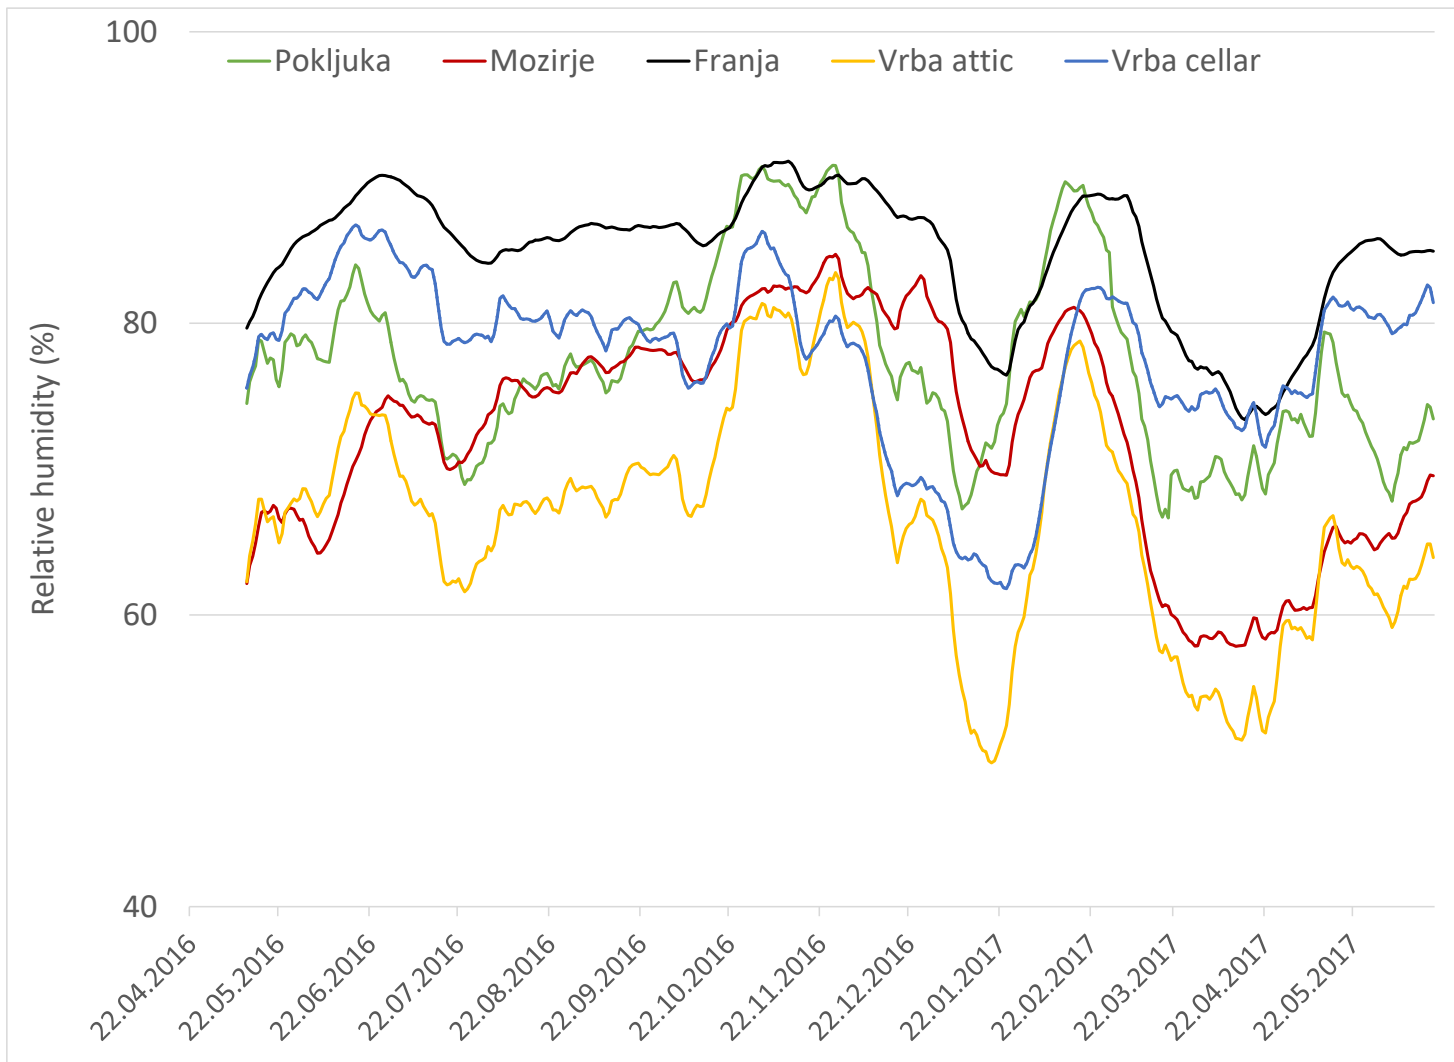
# RH

(moving average) April 2016 – June 2017

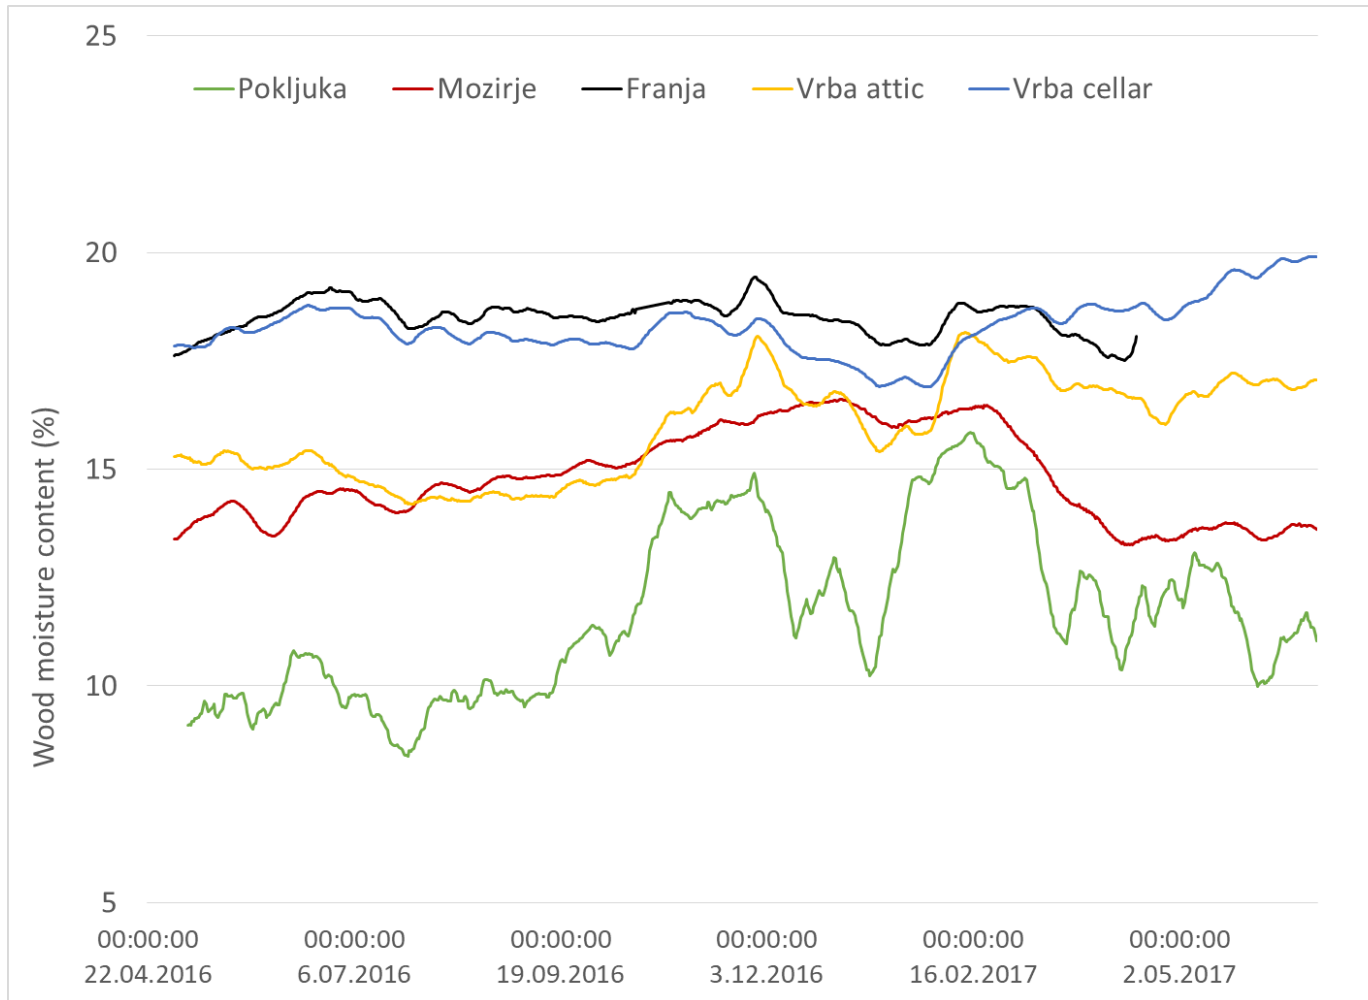
# MC of wood (UC 1)

(moving average) April 2016 – June 2017

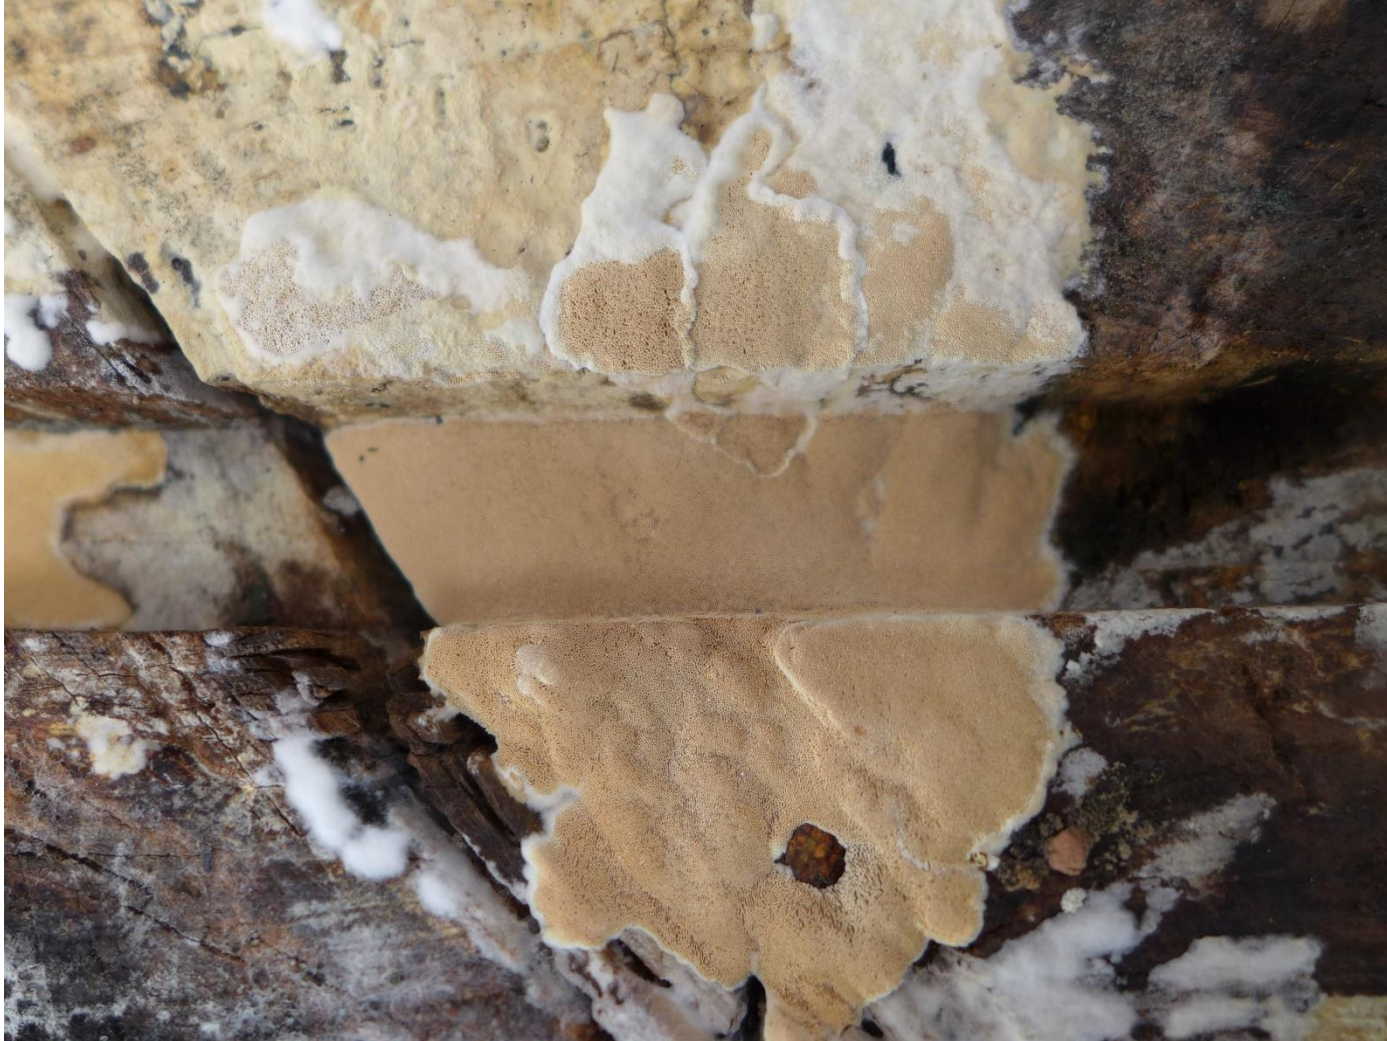
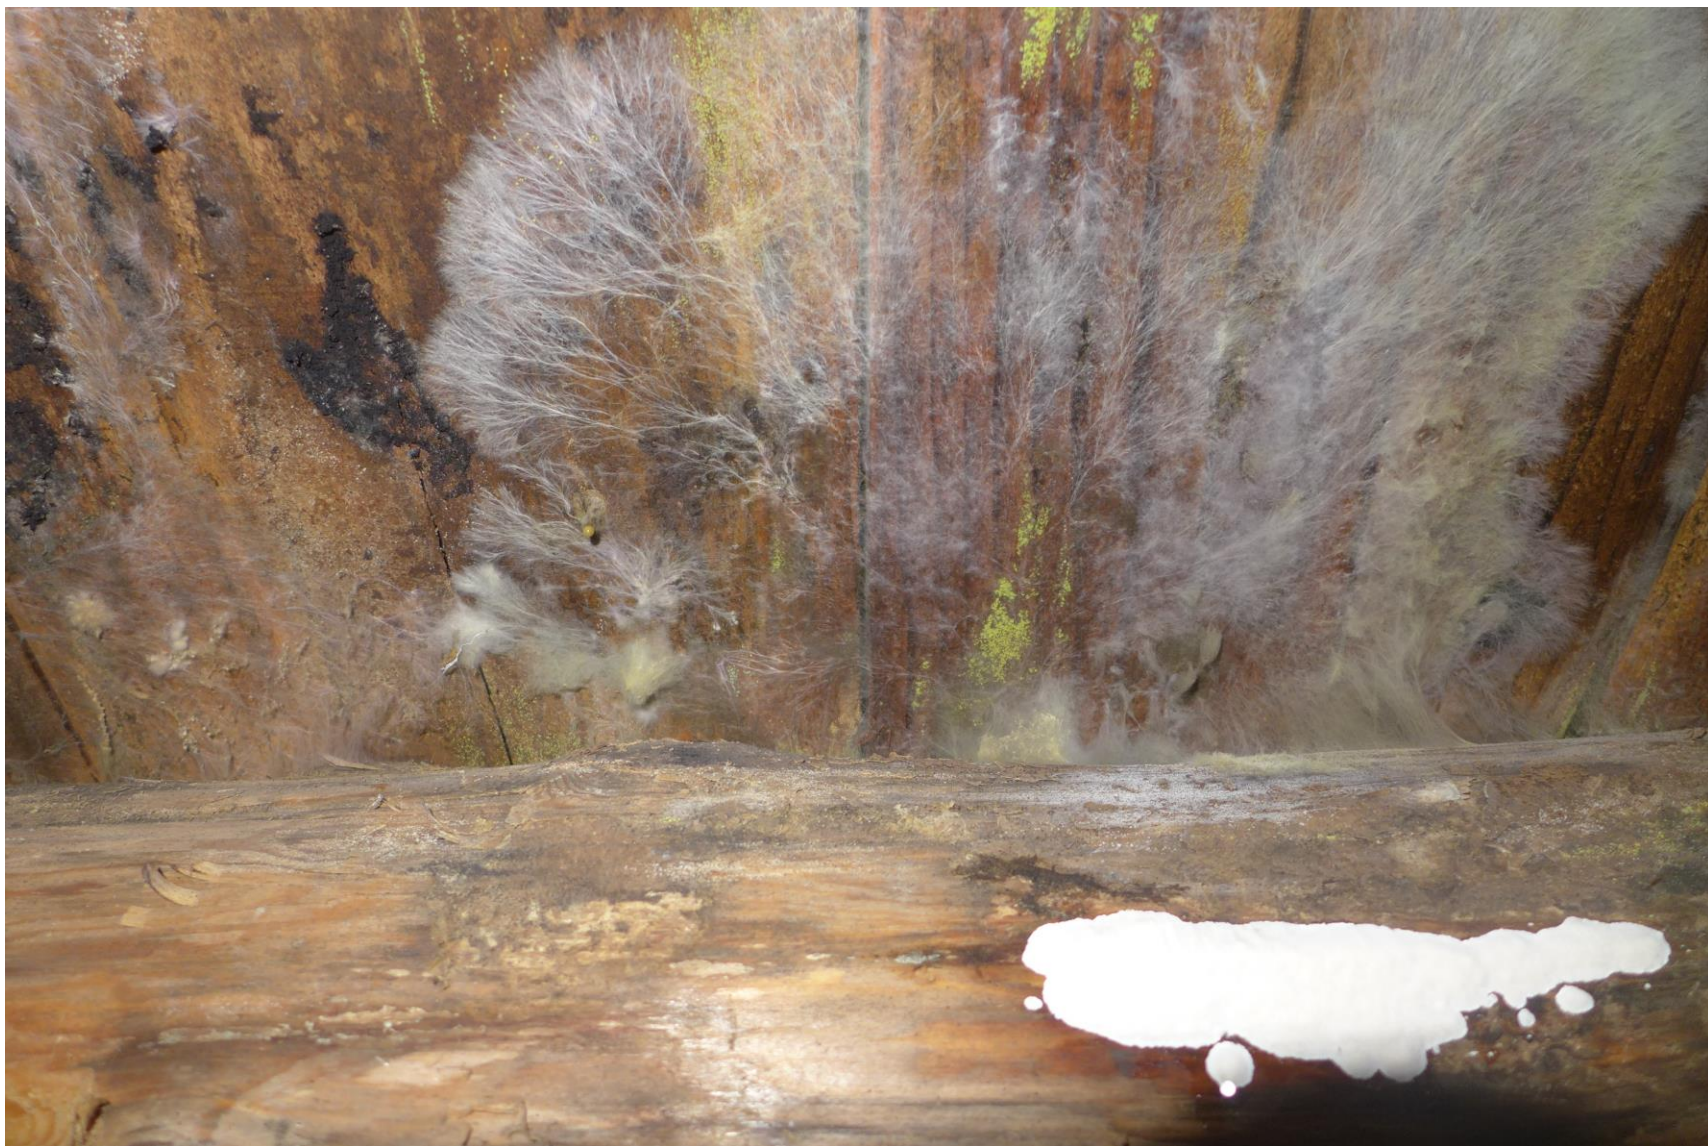
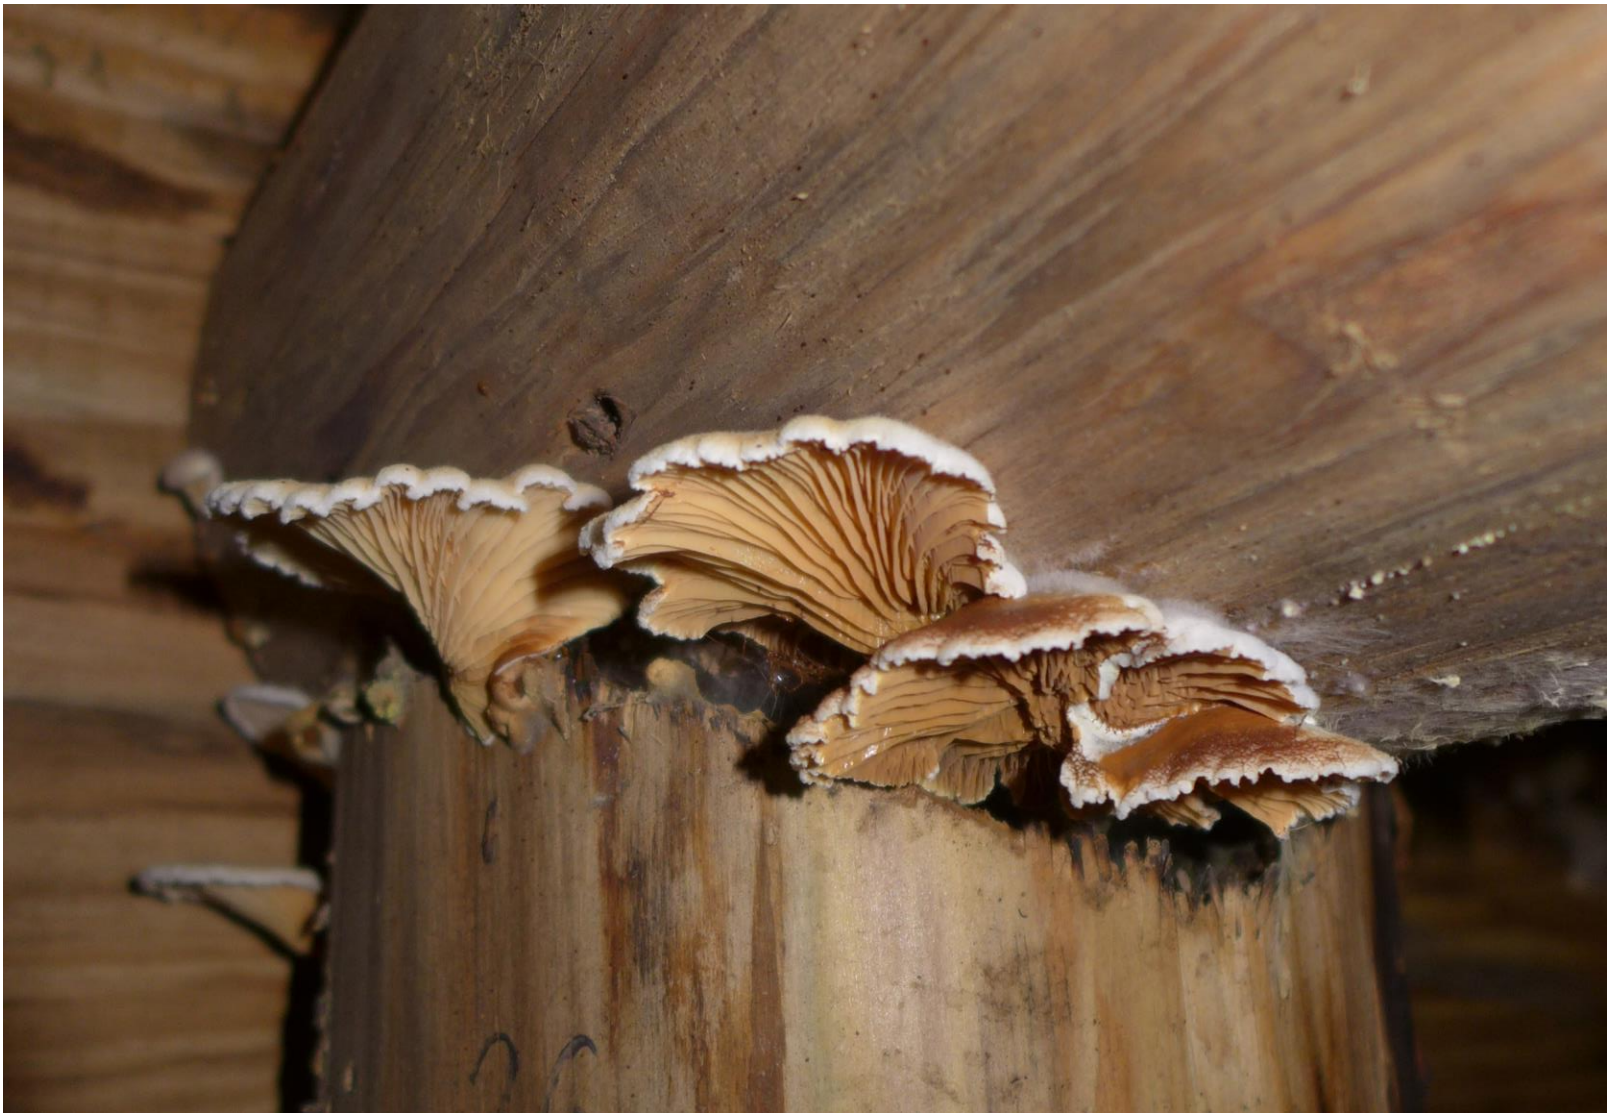
# Severe decay

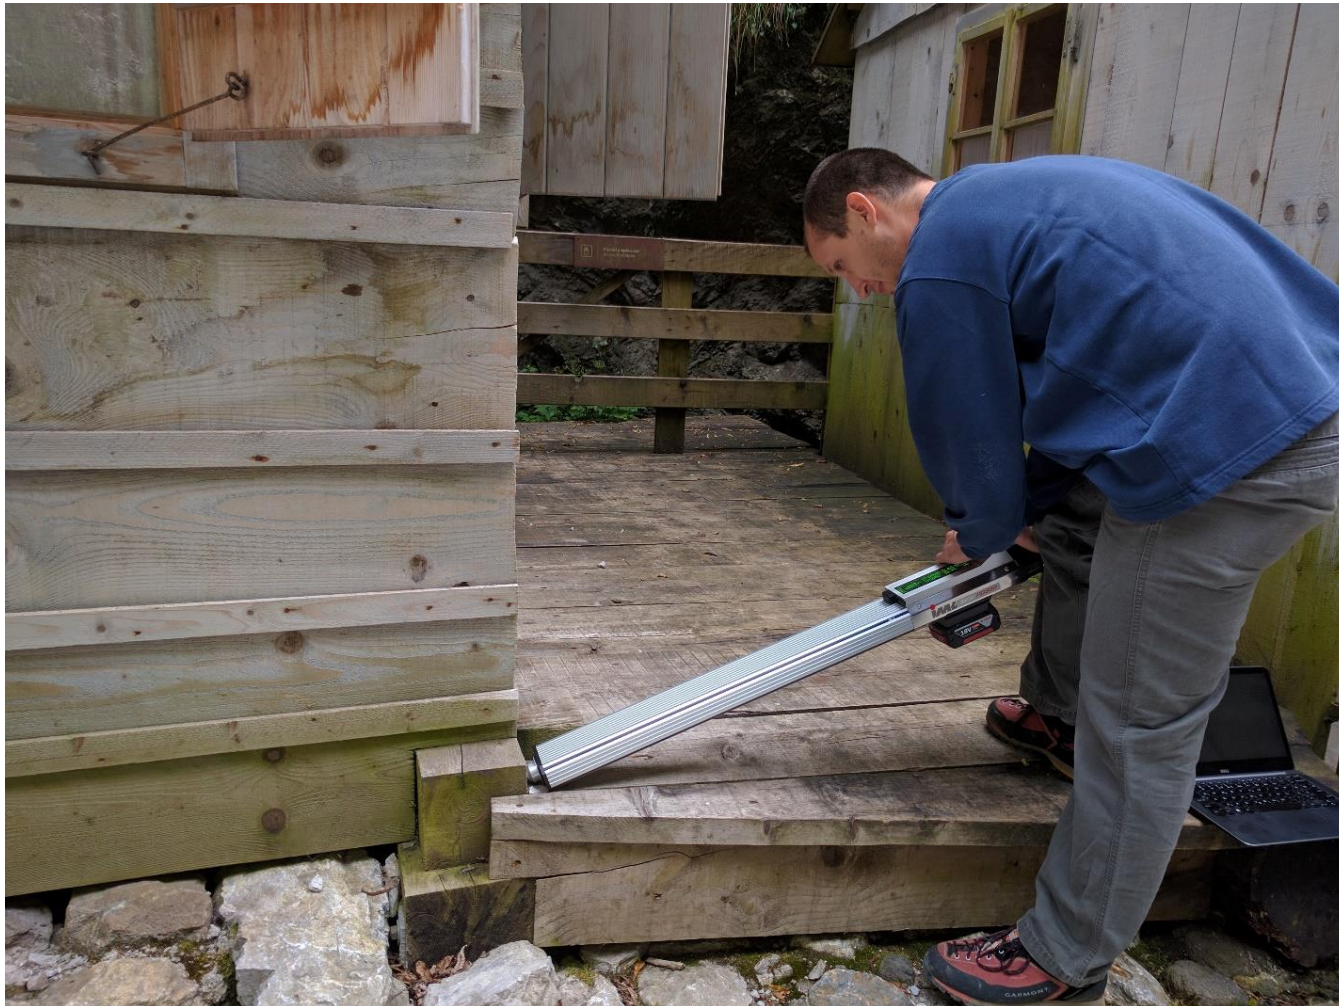
# Resistograph measurements

% of the degraded crosssection

1	0 - 10 %
2	11 - 30 %
3	31 - 60 %
4	61 - 80 %
5	81 - 100 %
